Monaro Rail Trail

Trail Development Plans – Stage 1a

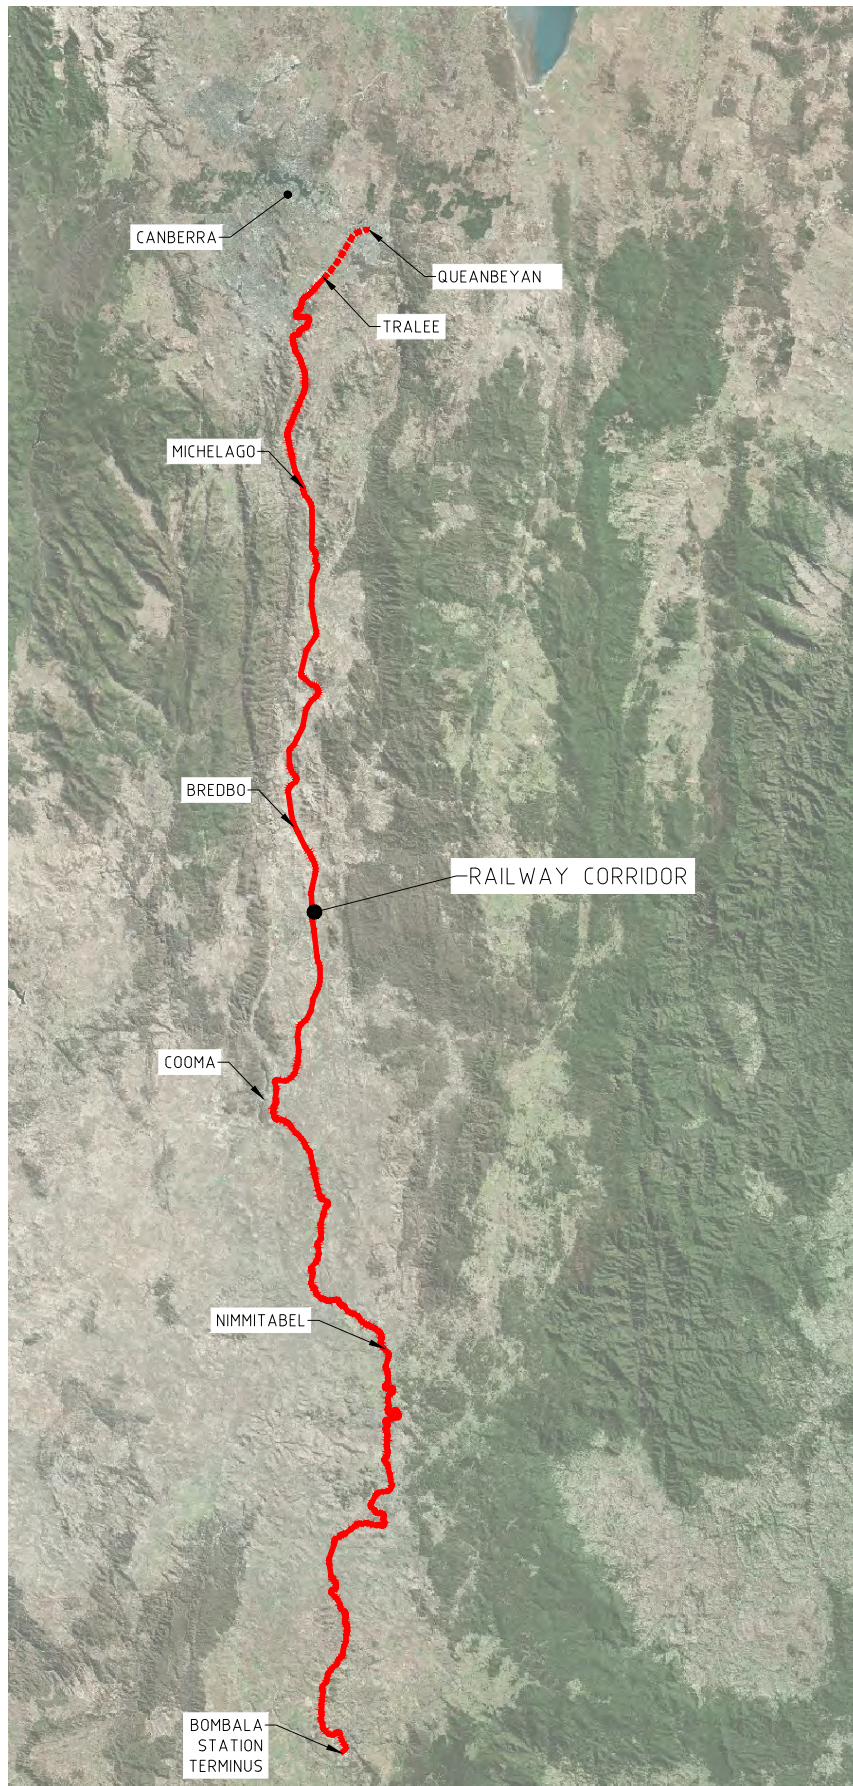
In preparing the detailed Trail Development Plan, the relevant corridors were traversed by foot in January 2022 and as a result much more is known about the requirements to convert the former railway corridor to a rail trail. These inspections revealed a corridor that has been disused for some time and consequently a number of conditions have developed which will impact on constructability and costs. These are not unexpected given the last train services ran in the 1980s but they are conditions that need to be dealt with. These include:

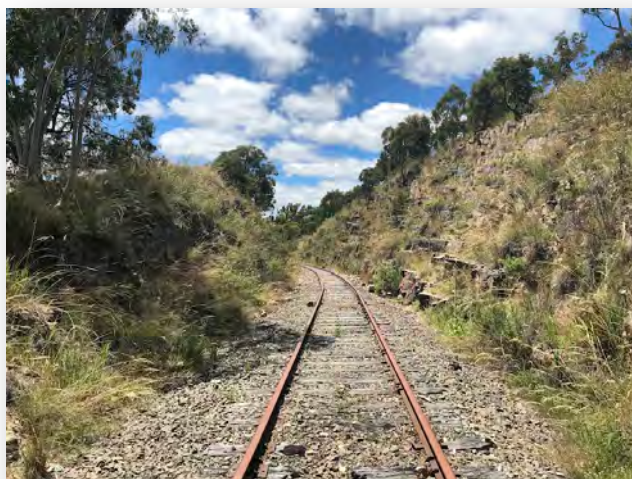
The old drains of the many cuttings along the proposed rail trail will require attention to ensure they still perform the task of clearing water from the cuttings.

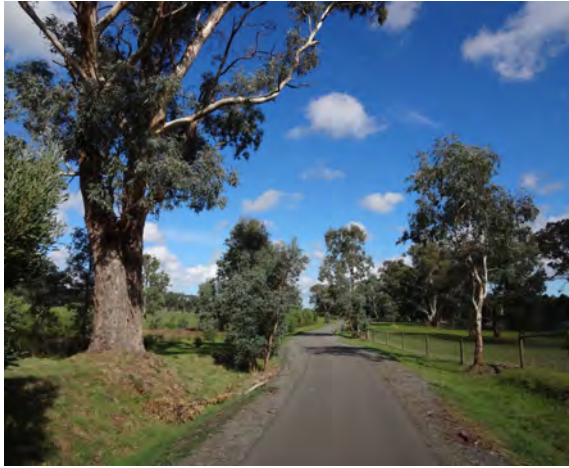
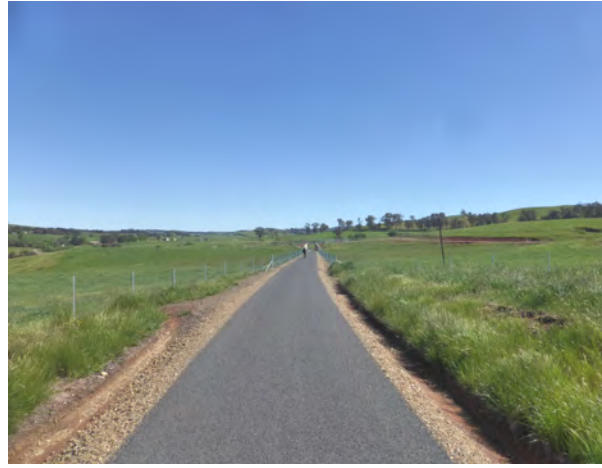
Above left: The Amy Gillette Rail Trail (SA) – an asphalt trail. Above right: The Tumbarumba Rosewood Rail Trail (NSW) – a chip seal rail trail.

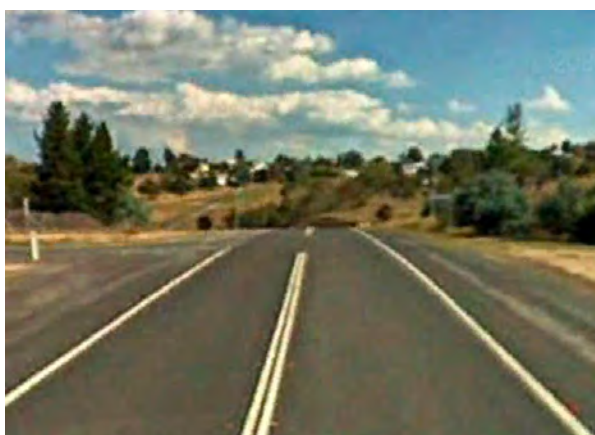
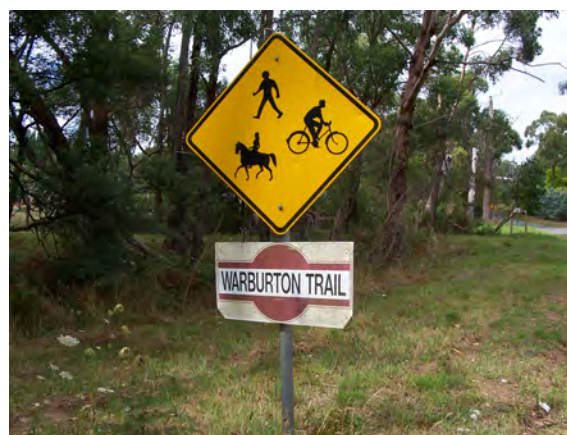
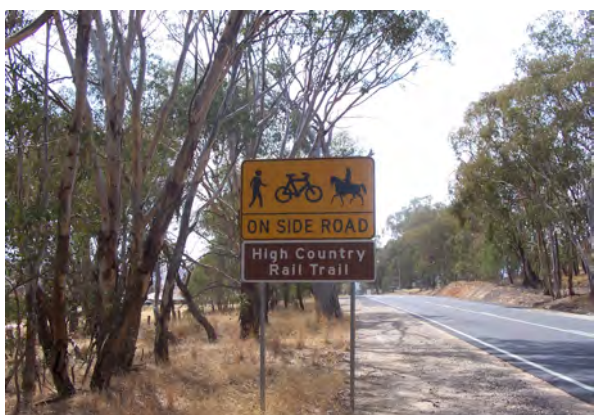
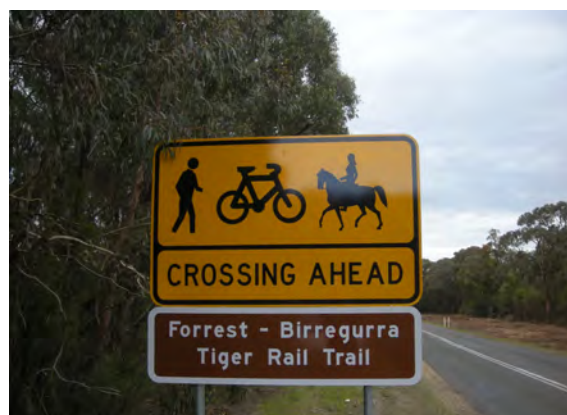
Road crossings often present a challenge. Crossing the Monaro Highway twice at Bombala presents a particular challenge (top left). The suggested solution is to include a large trail name sign at the bottom of the standard trail sign crossing sign (as shown above on three Victorian rail trails).

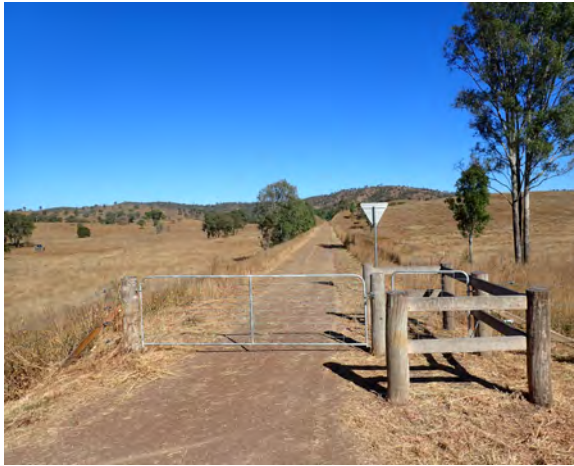
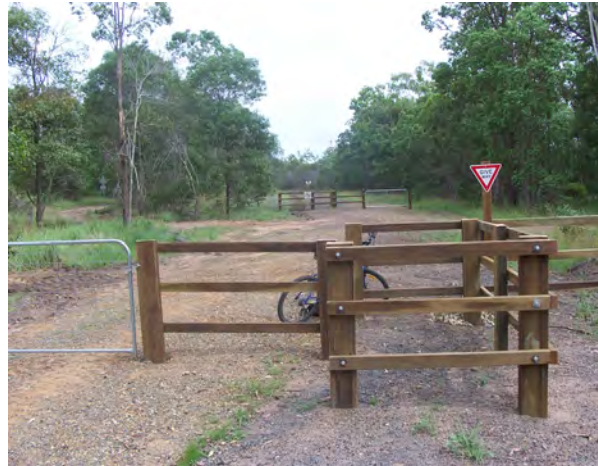
The preferred chicane gating system at road crossings shown on the Kilkivan Kingaroy Rail Trail in Queensland (above left) and the Brisbane Valley Rail Trail in Queensland (above right)

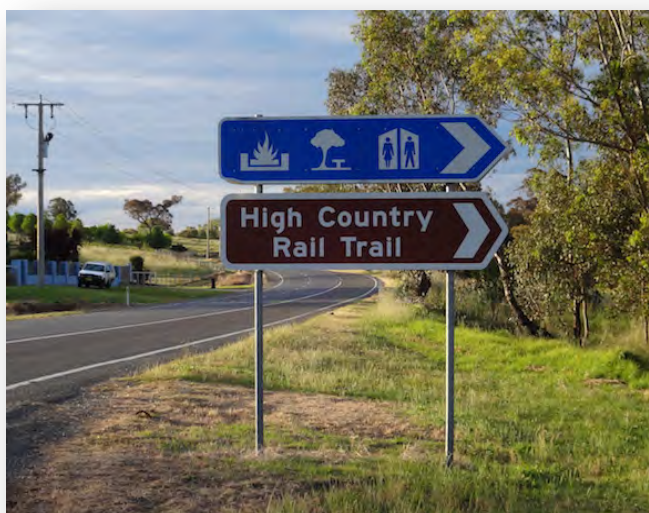
Signs pointing in to the "Trailhead", as used on the High Country Rail Trail in Victoria, are an excellent means of directing trail users to a Trailhead and serve to promote the existence of the rail trail to passing motorists, tourists and local people.

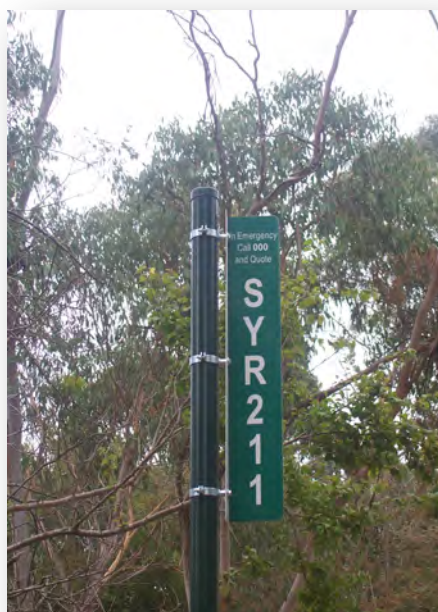
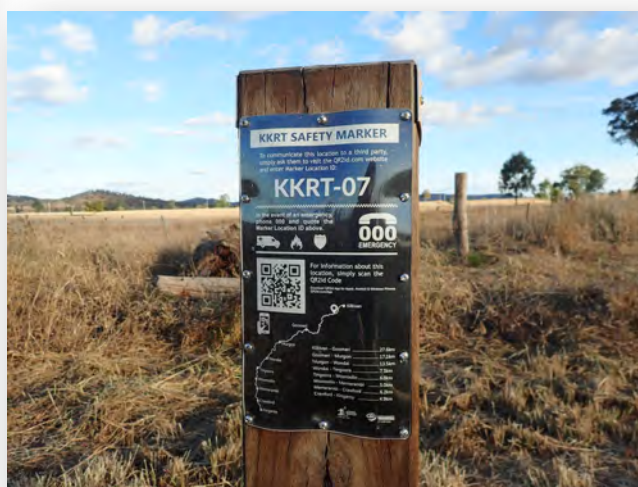
Above left: An Emergency Marker sign on the Lilydale Warburton Rail Trail in Victoria. Above right: An Emergency Marker on the Kilkivan Kingaroy Rail Trail in Queensland.

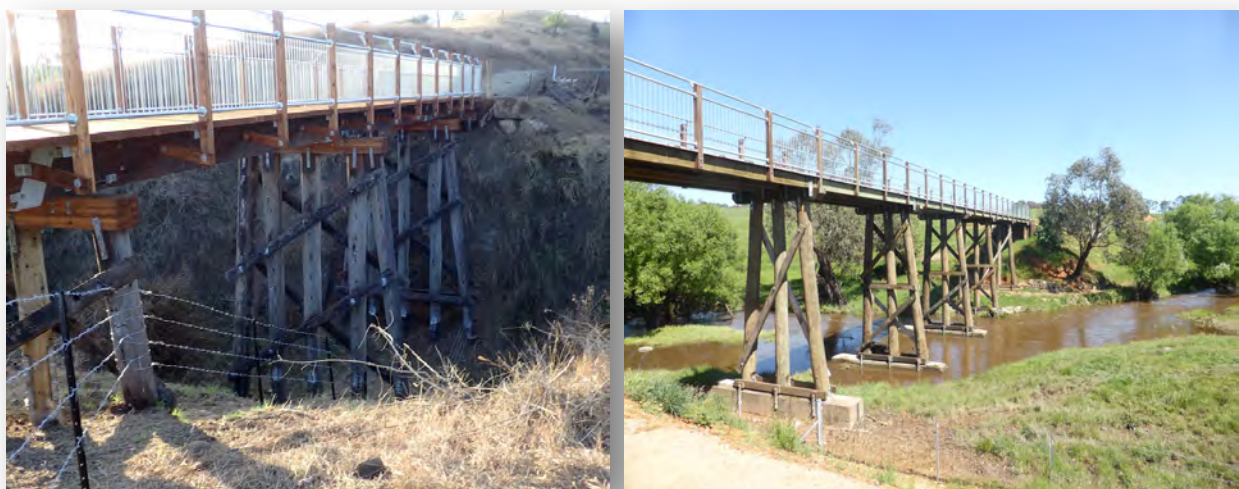
Renovating original railway bridges adds significantly to the trail user's experience. The bridge on the left is on the Brisbane Valley Rail Trail while the bridge on the right is on Tumbarumba-Rosewood Rail Trail. Both are restored in accordance with designs by WRD and both are good examples of restored railway bridges. Both use a combination of old (existing) and new timbers.

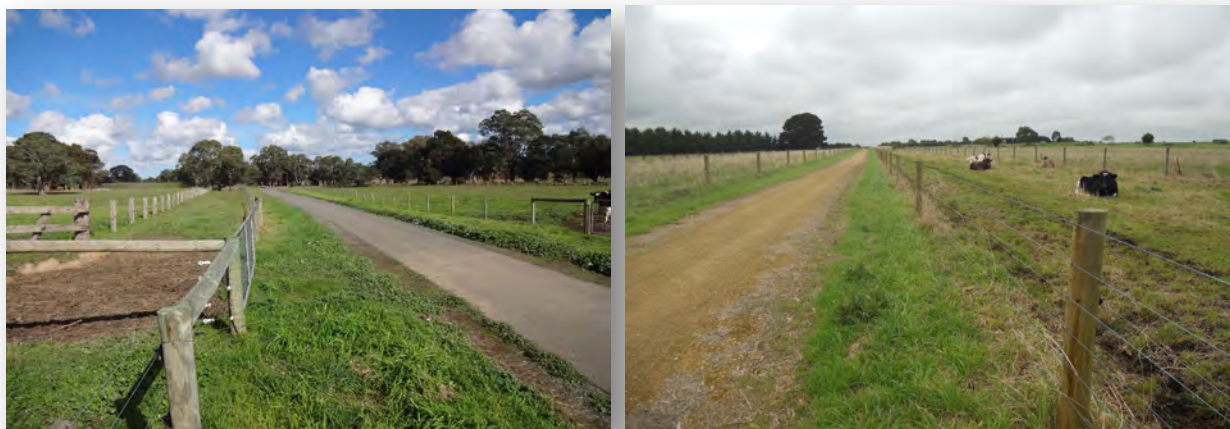
An option for managing the corridor beyond the trail is to fence a narrower trail corridor and allow adjoining landholders to graze the “excess” corridor. In both examples above, the original railway corridor boundary fence has also been retained (on the left hand side) on the Amy Gillett Rail Trail (above left) and on the right side on the Port Fairy Rail Trail (above right).

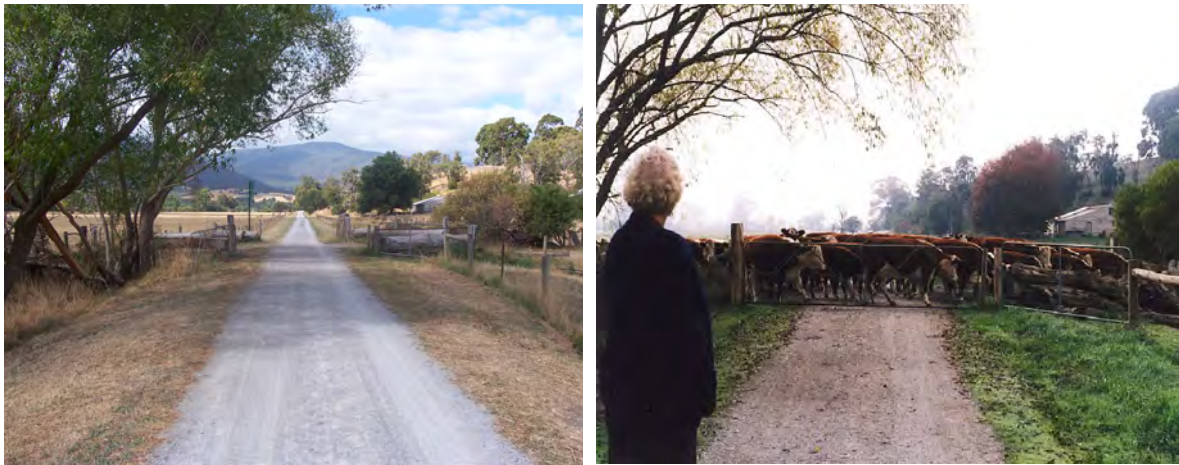
On the Lilydale Warburton Rail Trail (Vic), gates are open to the trail user (above left) and are only closed to the trail when stock are moved across in a mob. Other trails (Otago Central Rail Trail (NZ) – bottom left and Port Fairy Warrnambool Rail Trail (Vic) – bottom right) use similar systems.

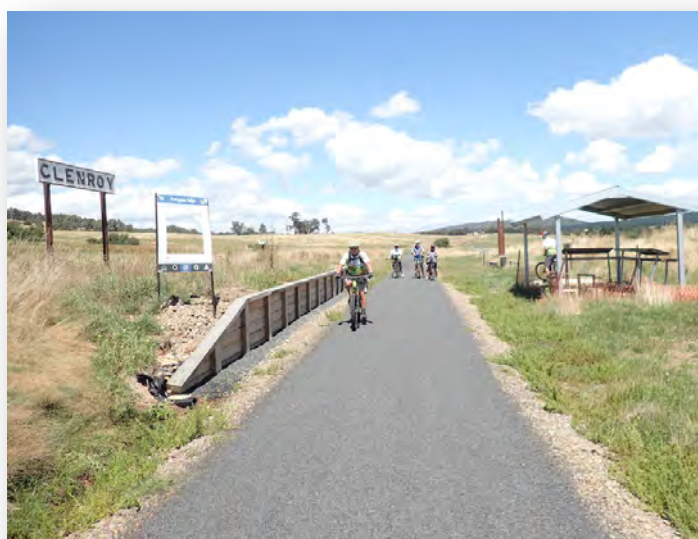
*Above: Glenroy Siding on the Tumbarumba Rosewood Rail Trail.
Siding platform rebuilt by the Tumbarumba Men's Shed.*

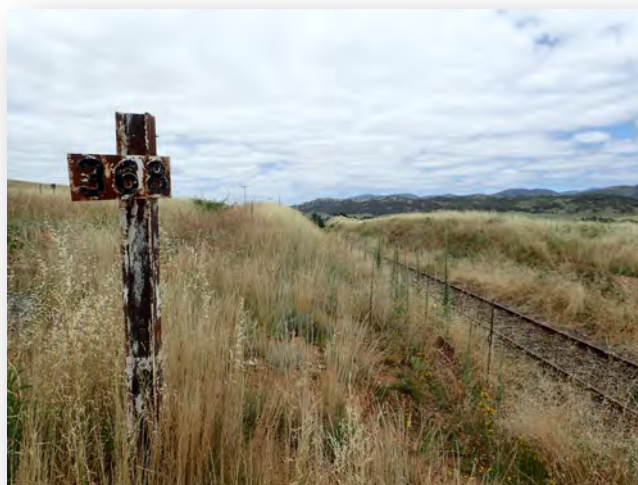
Retention of all old distance pegs, and other signage, is strongly recommended.

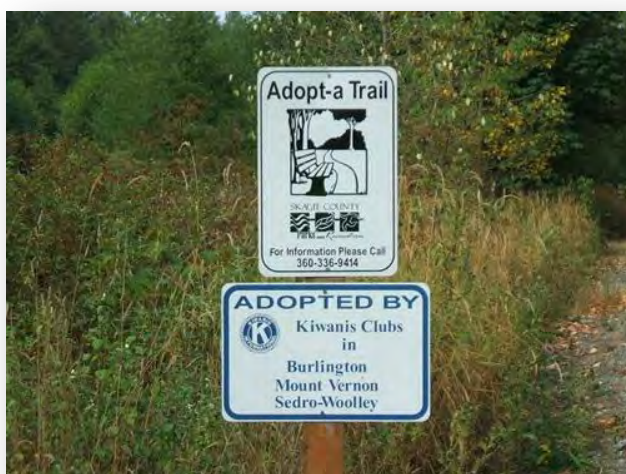
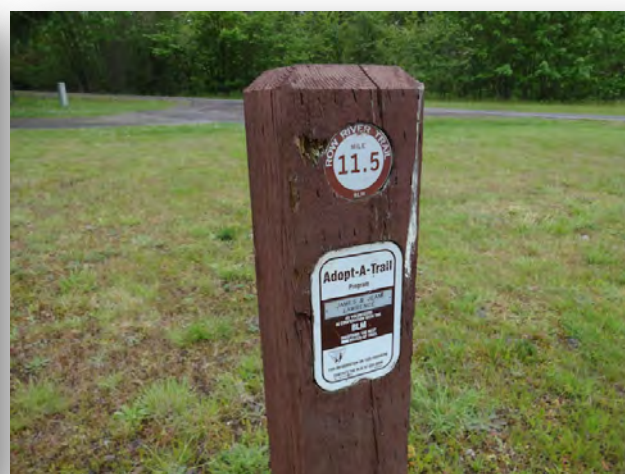
Trail managers and “Friends of...” groups often arrange ‘Adopt-a-Trail’ programs to ensure the rail trail is well maintained – by volunteers. The majority of some trails, such as the Bibbulmun Track, are maintained by volunteers.

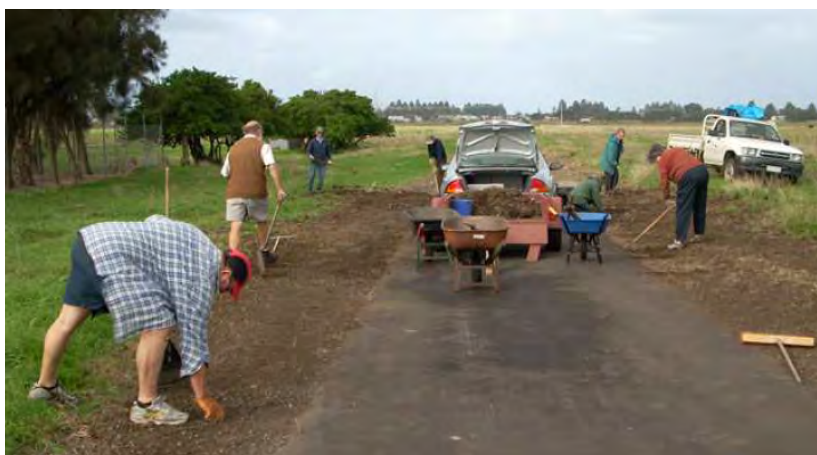
Volunteers organised by the Committee of Management at a busy bee to undertake maintenance work along the rail trail near Port Fairy in Victoria.

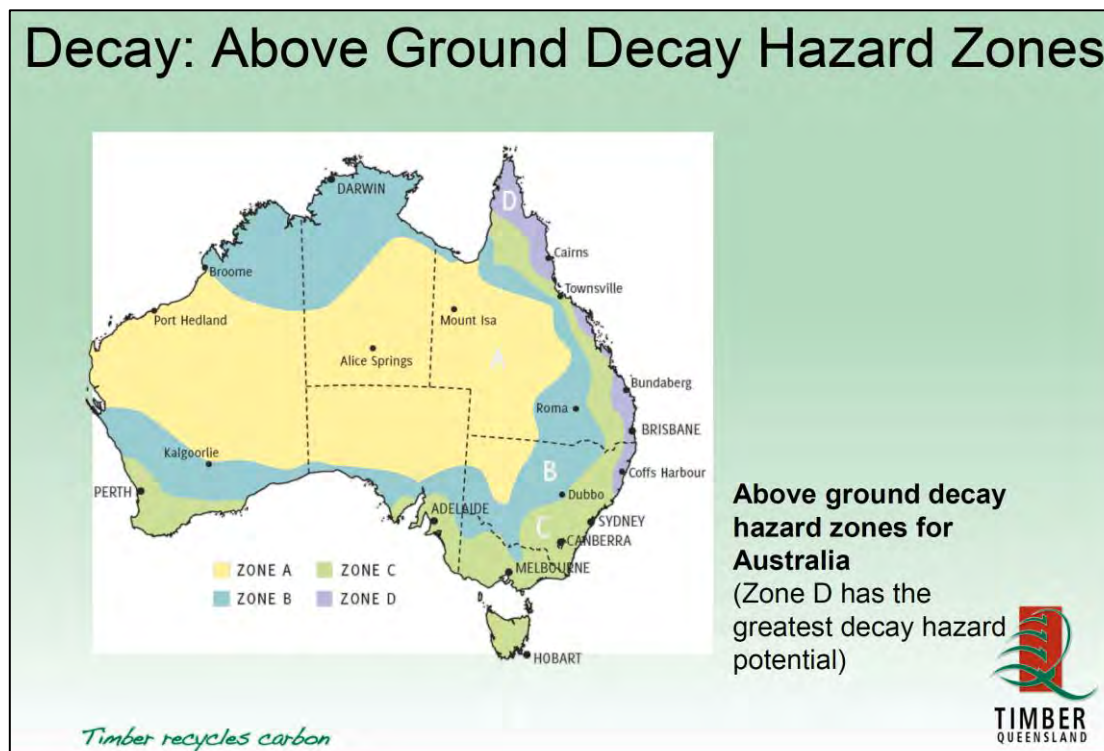
Figure 3-1: Decay Hazard Map for Australia showing that the proposed Monaro Rail Trail bridges are in Zone C of the decay hazard zones in Australia. The typical moisture contents in these timber bridges are 16.4% for open deck bridges and 14.2% for closed deck bridges. Decay doesn’t begin in wood till the moisture content reaches 22%. The majority of decay in timber elements is due to vertical fasteners and design details that allow moisture to accumulate in and around timber elements.

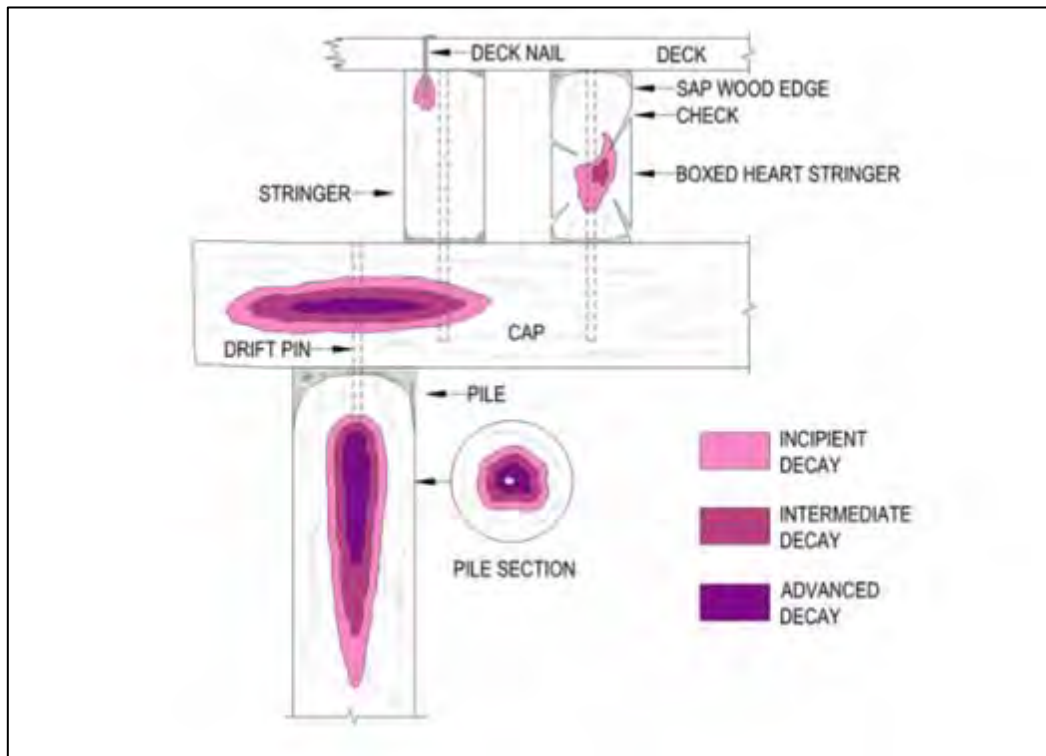
Figure 3-2: Shows the level of decay that occurs in timber due to the use of vertical fasteners. Vertical fasteners increase the rate of decay in timber as they allow moisture to travel down the fastener into the heartwood of the headstock (cap), girders (stringers), corbels and piles, therefore increasing the moisture content in the middle of these elements. The heartwood of a log element is less capable of breathing and expelling moisture than the sapwood that surrounds it, so vertical connectors funnel the moisture directly into the heartwood accelerating decay. Once the moisture content exceeds 22%, timber consuming fungi are activated, and the decay process begins.

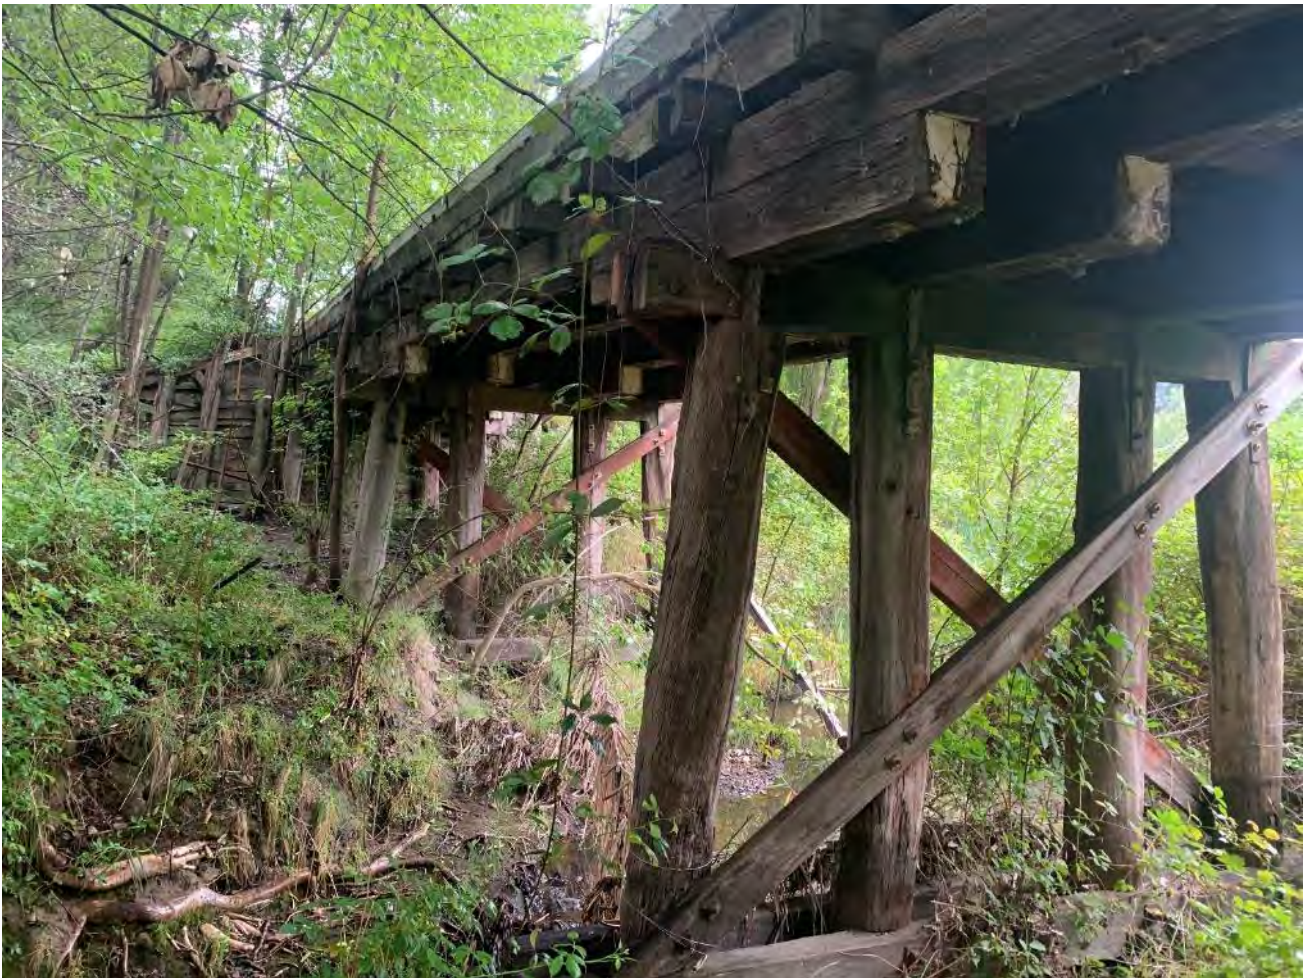
An essential step in evaluating the condition of a structure is undertaking a visual inspection. The visual aspect of the investigation is used to pick up missing or failed elements, cracks and splits, cavitation, connection details, abutment condition, undermining and debris build-up, among other important information. Gathering this information is essential for completing a comprehensive investigation and considering the surroundings in addition to the main structural elements. See **Figure 4-1** through **Figure 4-9** below for a summary of findings as well as the description of each bridge.

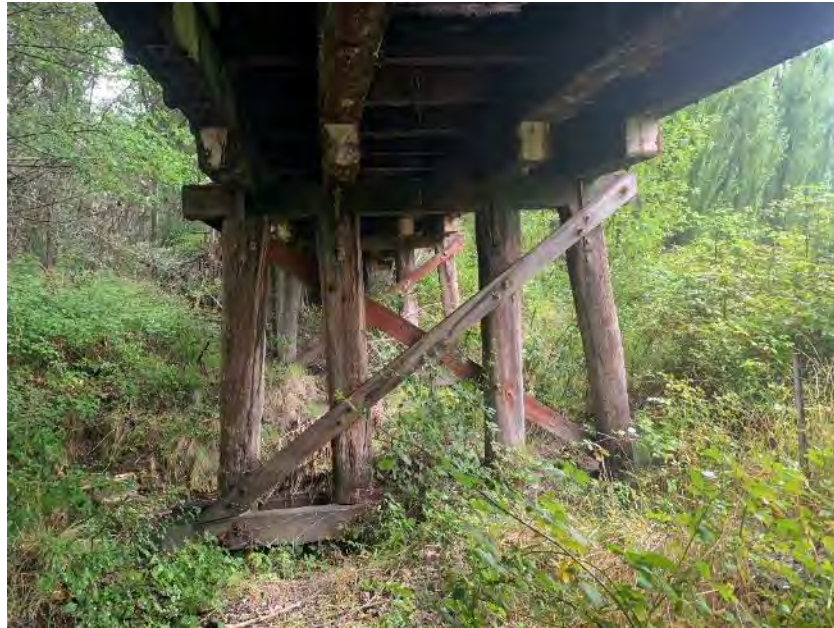
Figure 4-2: View of the typical timber pile bent configuration. The bent is comprised of 4 driven piles, single timber head stocks and corbels. The bent is also supported by a double cross bracing system with sashes at halfway and timber wales at the bottom. Overall, the timber bents were found to be in a poor to very poor condition. Note the surface brown rot fructing bodies on the faces of some of the cross braces -orange brown colour.

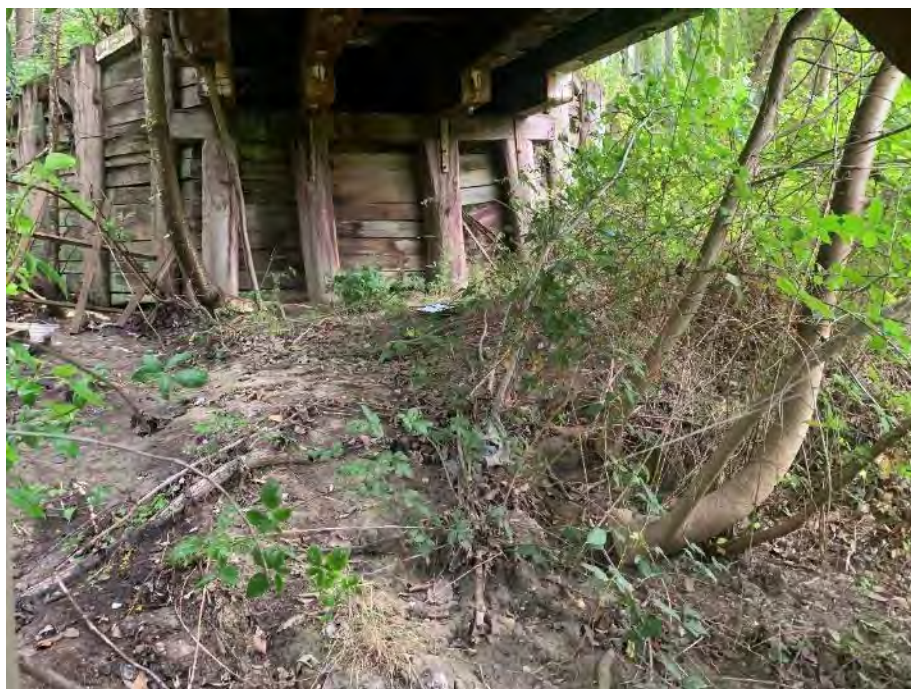
Figure 4-3: Both abutments consist of 4 timber piles, timber headstock, timber corbels and timber sheeting. It was noted that the bottom section of several piles has started to undergo decay. Note abutment sheeting is rotted and failing. Timber pile and sheeting wing walls present on both sides of each abutment. Once the moisture content in the timber elements reaches 22%, decay causing fungi are activated and the decay process begins. Large trees need to be cleared as their root systems apply lateral pressure on the substructure elements as will the branches and trunks on super structure elements.

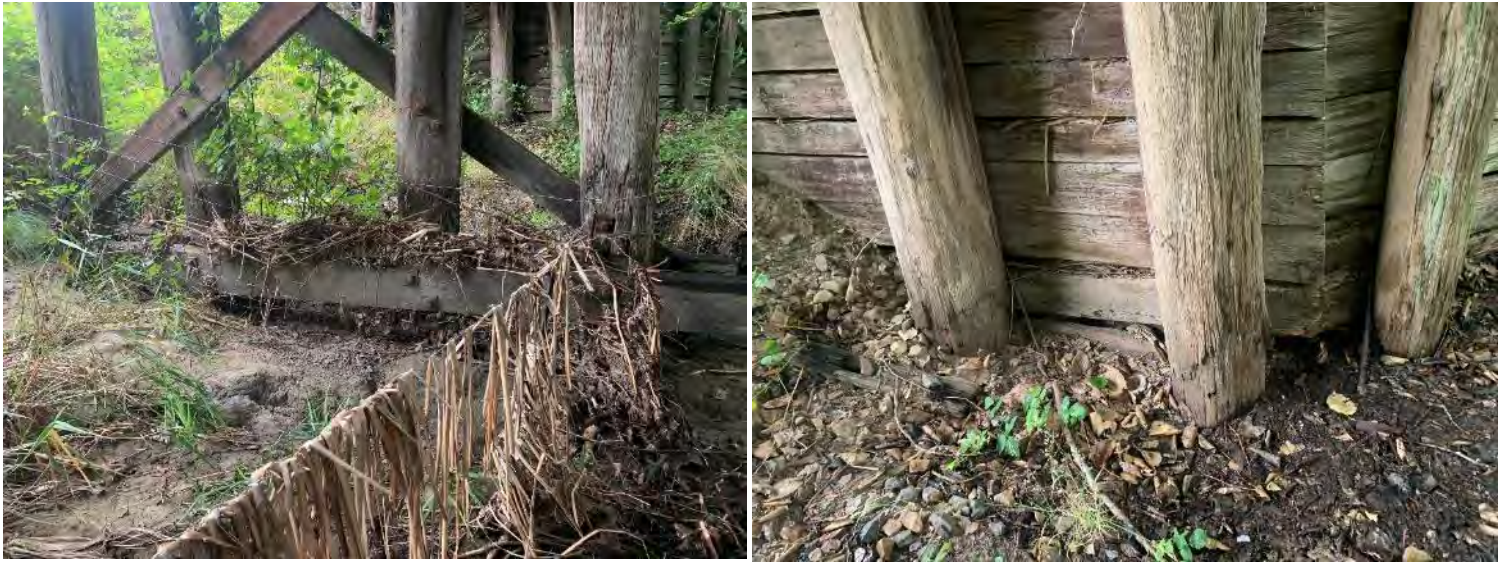
Figure 4-4: The bottom sections of the timber piles were determined to be a ‘hotspot’ for decay, this is caused by the moisture retained by debris increasing the moisture content in timber members. Sapwood decay in the timber piles is photographed on the right-hand side. Refer to Section 4.1 below for a full list of recommended repair options for refurbishment to a pedestrian/cycle bridge.

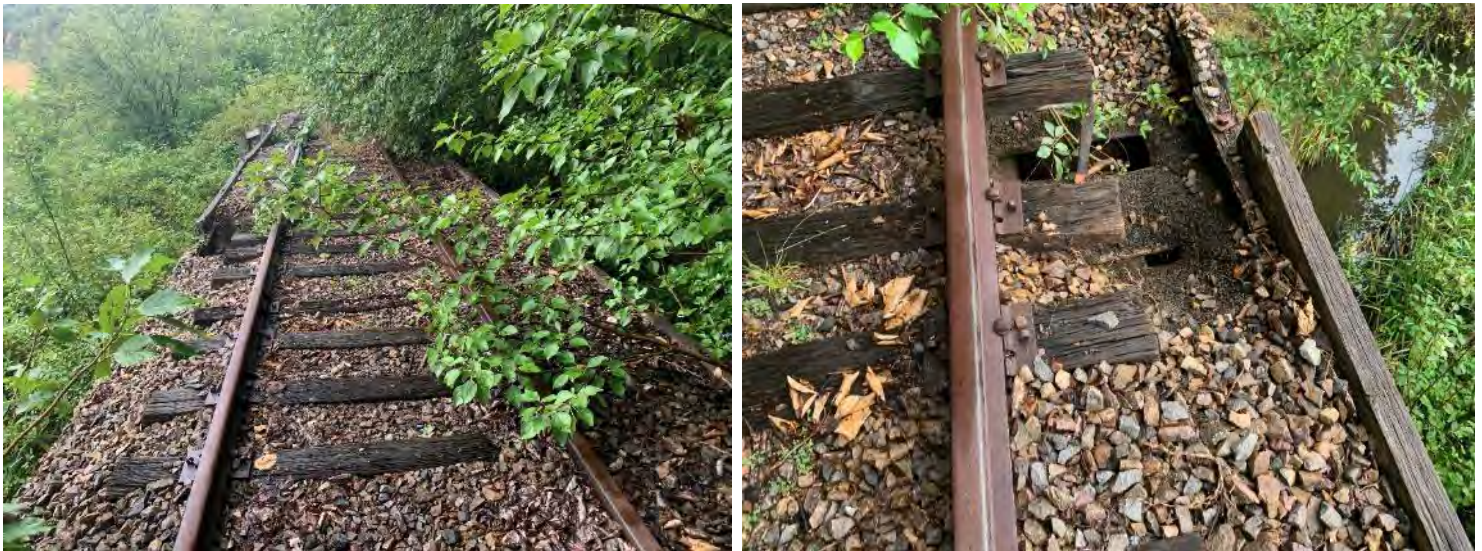
Figure 4-5: The timber transoms were found to be in a very poor (unsafe) condition. The timber ballast tray side walls and rock ballast were in poor condition with erosion of material found in several locations. If the bridge was to be repurposed for pedestrian and cycle use the timber transoms, railway line and rock ballast would need to be removed. Depending on the condition the existing ballast tray side boards they can left in place to act as a kerb/kick rail in the re-purposed bridge. To meet the current standards and Australian codes; vertical balustrade panels and a 1.4m high cycle rail will need to be installed. Note: Significant vegetation growth. The ballast tray will provide a great subgrade for the walking track.

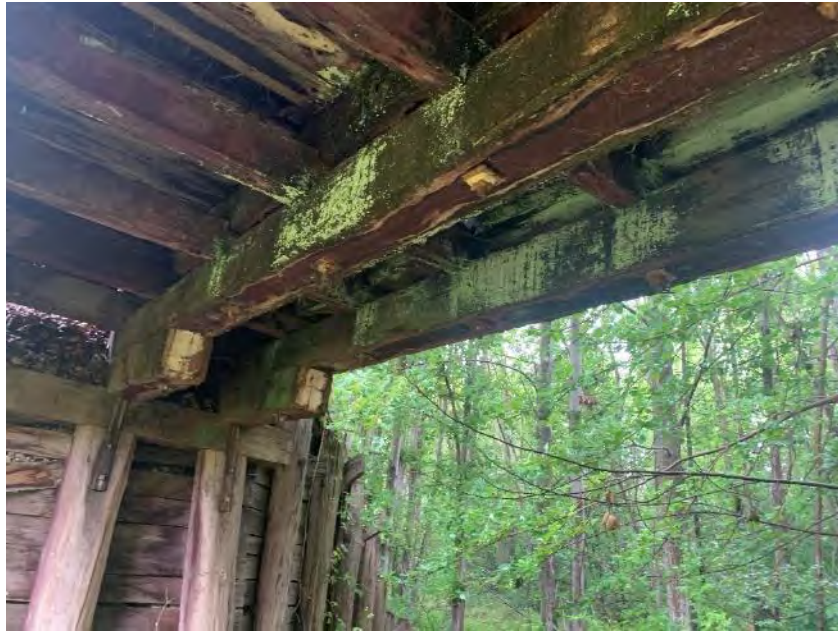
Figure 4-6: View of 2/4 girders. Consists of 4 girder lines which are double stacked with the top girder serving as a lateral bearer beam end stabilizer as well increasing the elevation of the ballast tray floor. All girders exhibited major water stains and decaying fungal growth. Girders were found to be in poor to very poor condition.

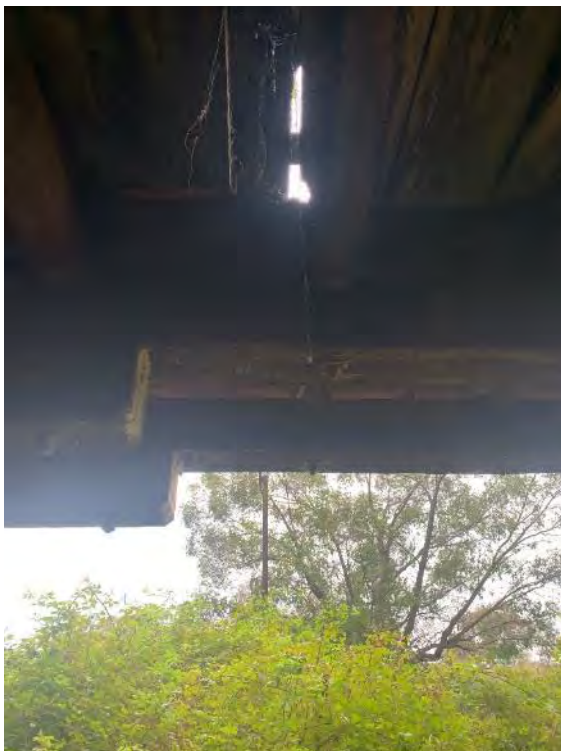
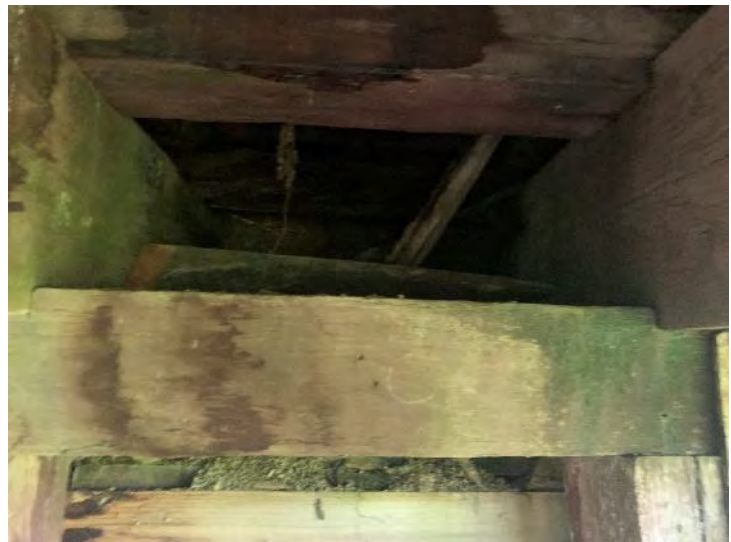
Figure 4-7: The photo on the left shows a failed deck plank from below. The photo on the right shows another failed deck plank located above the abutment. Decking failure causes the above rock ballast to erode and elements below experience excess weathering and load. These planks will require replacement before the bridge can be reopened for pedestrian and cycle use.

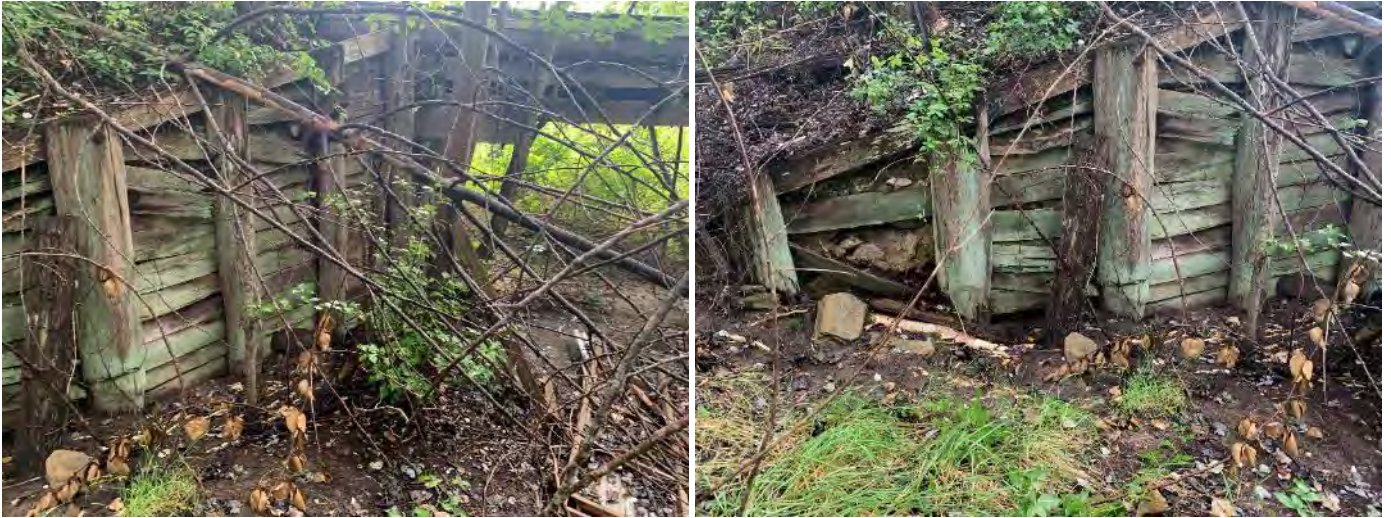
Figure 4-8: The timber wingwalls have undergone significant deterioration with timber sheathing completely rotted and failing in several locations. Due to this the walls' ability retain the approach fill material is poor leading to erosion and excessive loading.

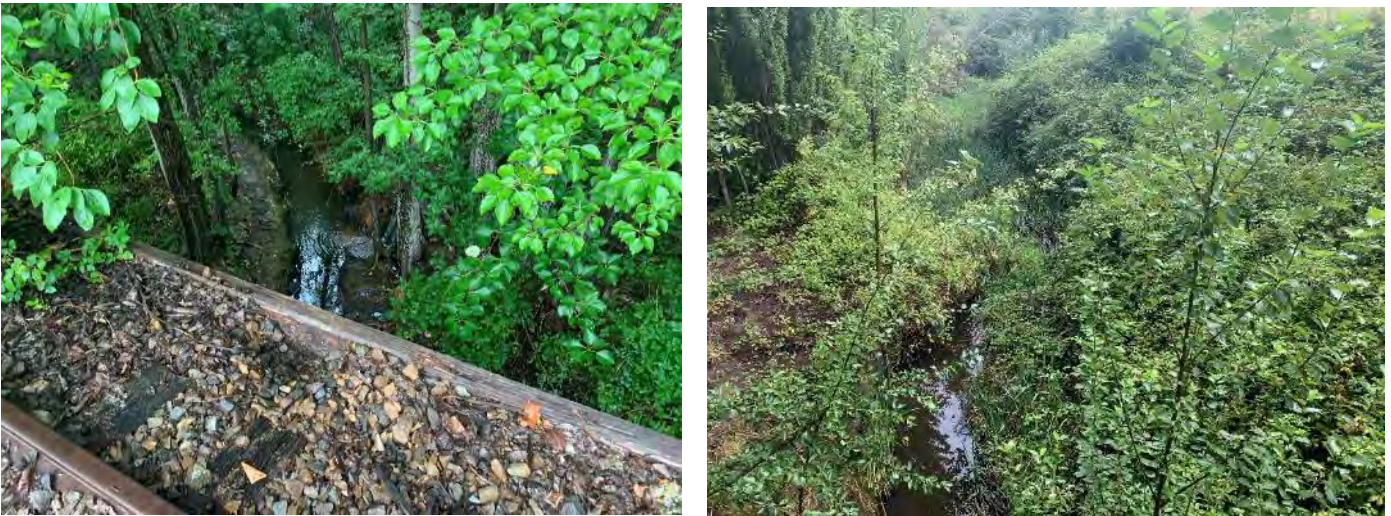
Figure 4-9: Left photo is the general downstream view from bridge deck & photo on the right is the upstream view.

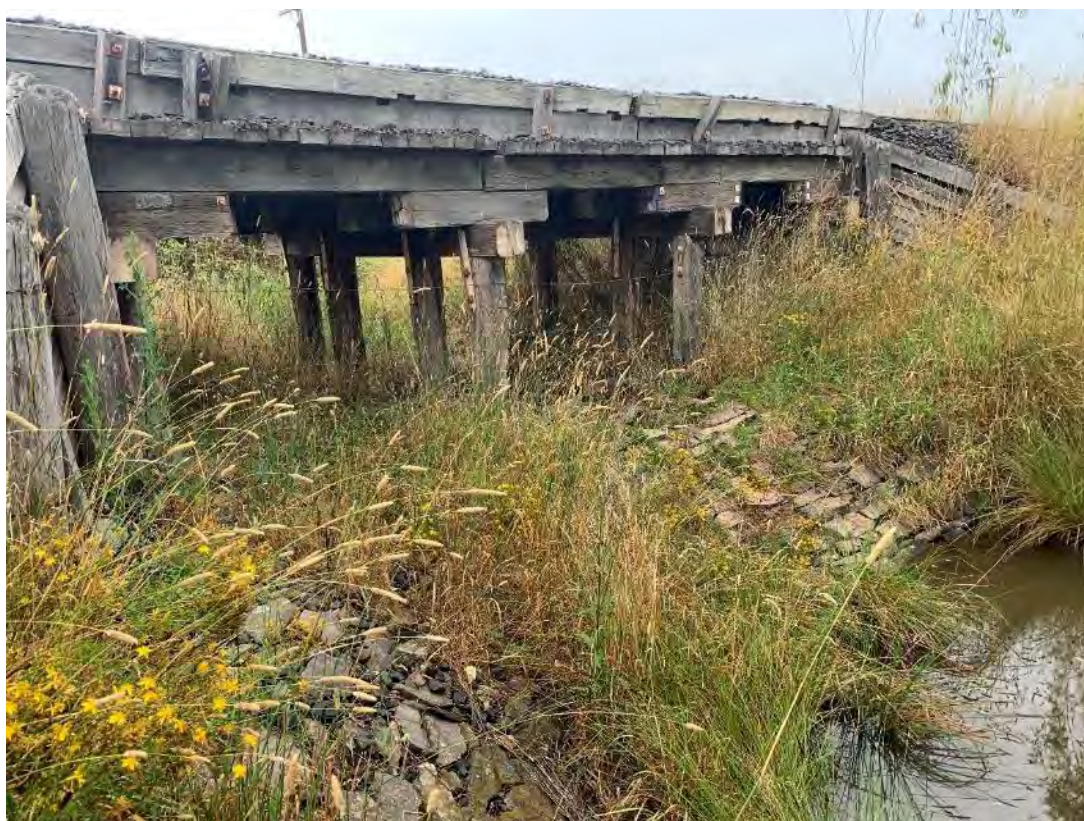
Figure 5-1: The top image shows a general view of the minor 10m Bridge from an abutment. The timber girder under bridge consists of 3 spans of 3.3m. Each bent consists of 4 driven timber piles and a single headstock. Headstocks are attached to the piles using a vertical steel bracket on either side. Note kerb support completely split vertically through middle.

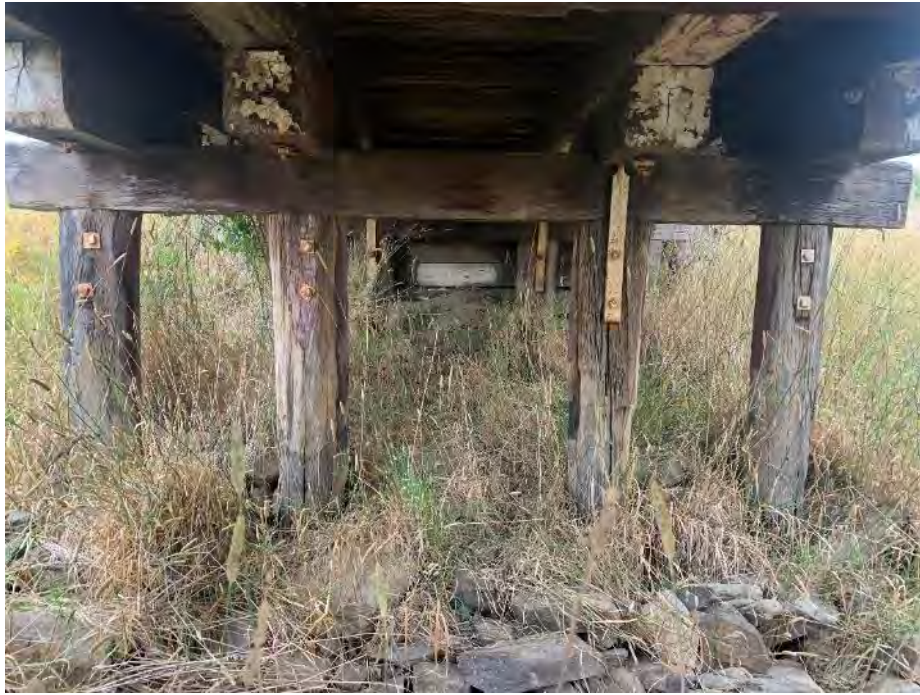
Figure 5-2: General configuration of each pile bent. Large vegetation growth and cobbles located around the base of piles. All piles were found to be in very poor condition with large splits and sapwood decay are present in majority of piles, predominately at ground level. Excess vegetation growth leads to an increase in moisture content within timber members resulting in accelerated decay.

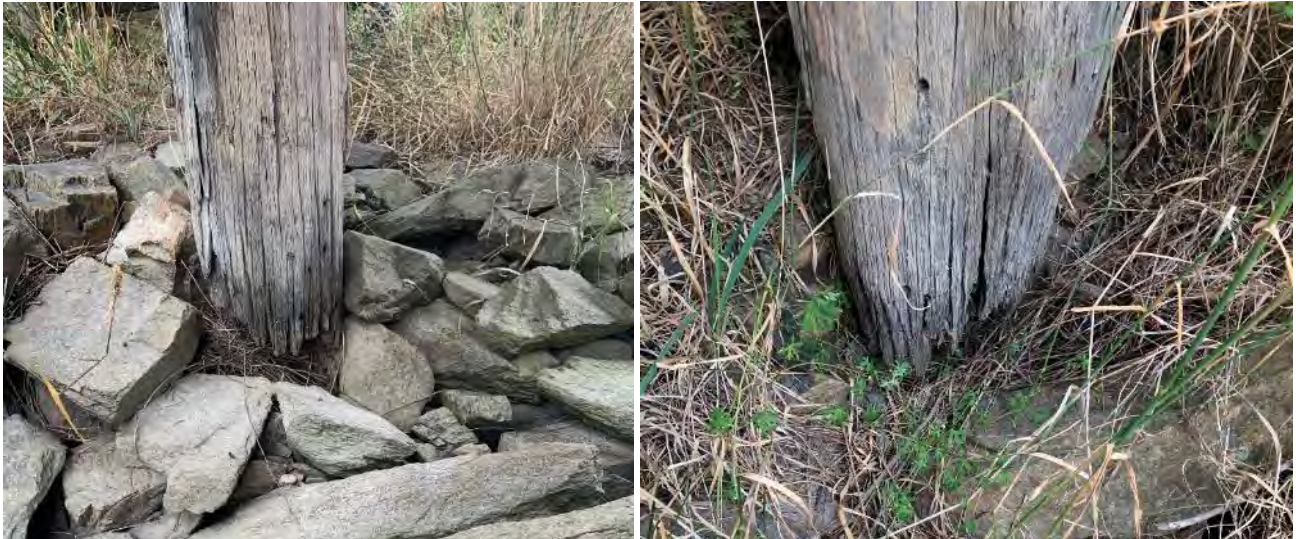
Figure 5-3: View of piles at PB1, pile 3 and PB2 pile 4, both are in very poor condition and were found to be completely decayed at ground level and hanging freely above ground.

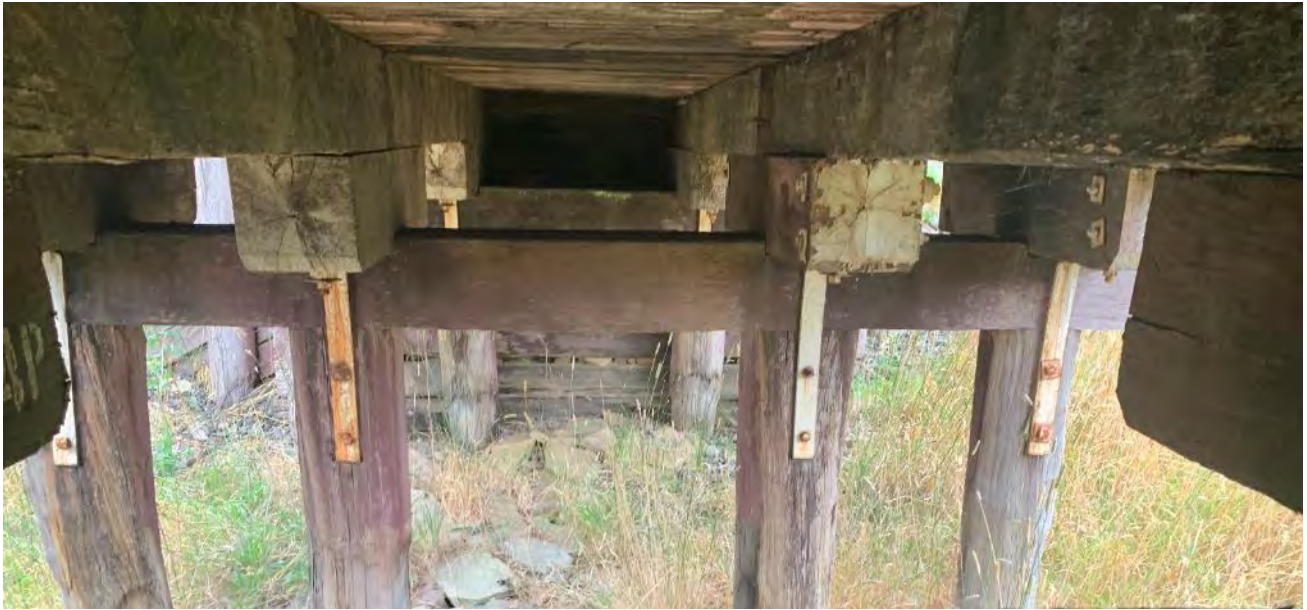
Figure 5-4: View from in between internal girders, all girders were found to be in fair condition with no major deterioration present. Corbels and bent caps were found to be in fair to poor condition throughout with evidence of minor decay present. Brief NDT testing was completed using non-destructive methods, such as EPHOD® Stress Wave Technology. Refer to Appendix A for more information of this type of testing method. Readings for girders were found to be between 300-500 μ s, Corbels – 400-100 μ s and caps 300-800 μ s. This is the time taken for the compression wave to travel across the section of the member tested. This was recorded on most elements and aids in verifying the condition of the elements. The pile tops are in better condition due to the use of horizontal connectors with side plates.
