Monaro Rail Trail

Trail Development Plans – Stage 1a

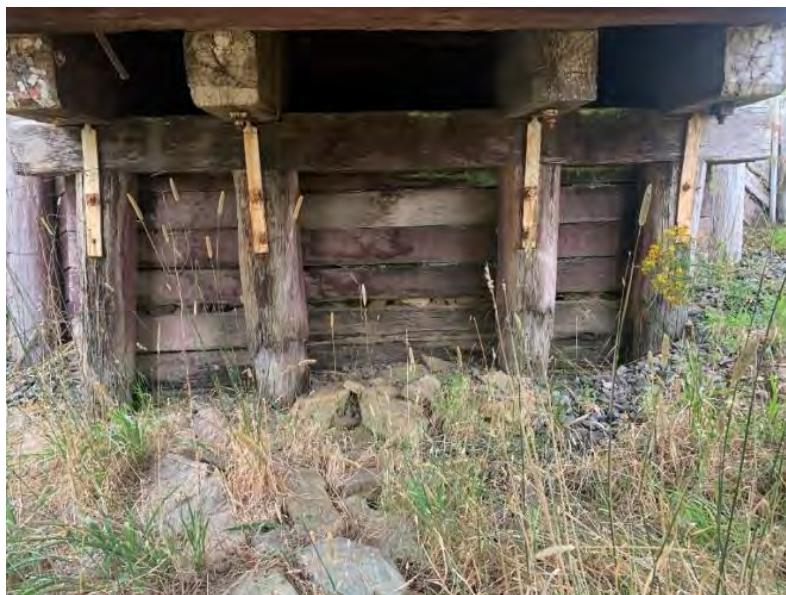
Figure 5-5: View of abutment shows the general formation. The timber sheeting was found to be in poor condition, with water stains and decaying fungi growth present. Significant sapwood deterioration was located on members near the ground. Gaps between lower planks show minor erosion of backfill material. The breast wall planks are spiked to the backside of the piles which has resulted in their shrinkage producing gaps and subsequent loss of fines. They should be stitched.

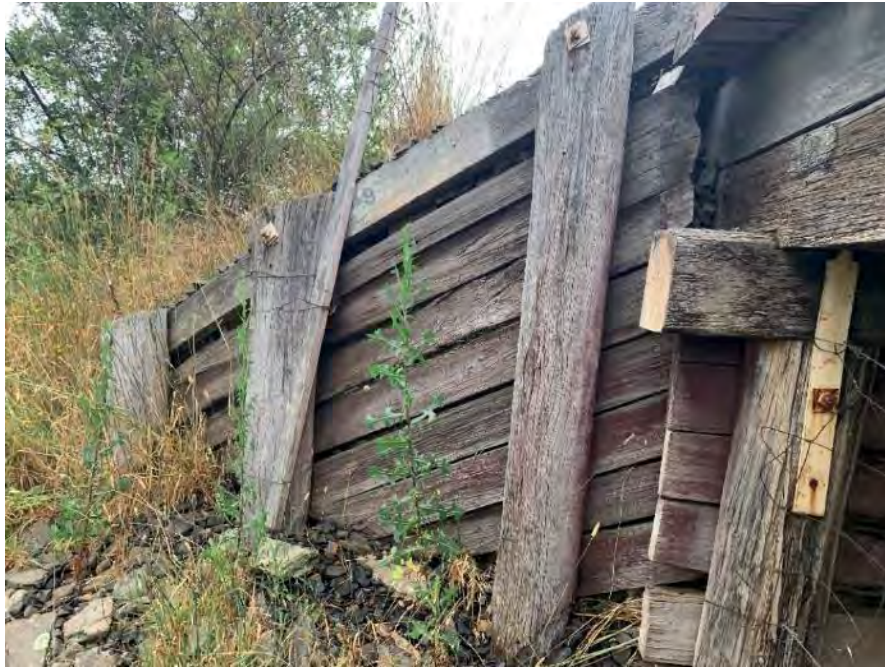
Figure 5-6: A view of abutment wingwall. The wingwall was found to be in fair to poor condition with minor deterioration present throughout all components. Minor deformation was present at top of wall due to bearing load of ballast.

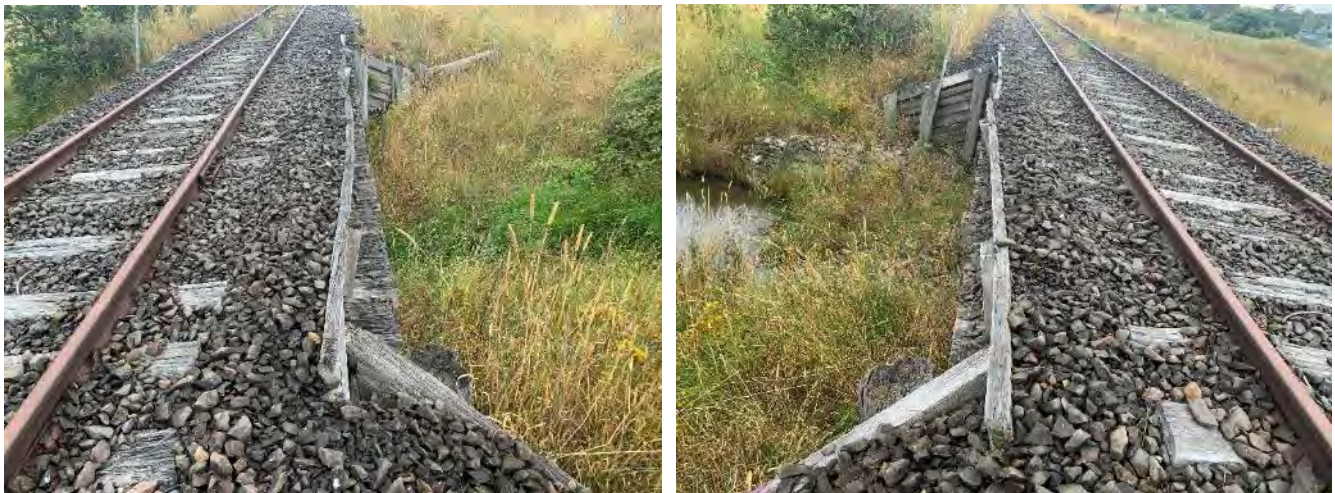
Figure 5-7: View of both ballast tray side walls. Both side walls were found to be in fair to poor condition, with minor deterioration of sapwood present at all lengths. Photo on the right shows the side walls support leaning backwards creating a deformation in side wall length. Photo on the left shows a significant bow in middle length due to bearing the load from the rock ballast.

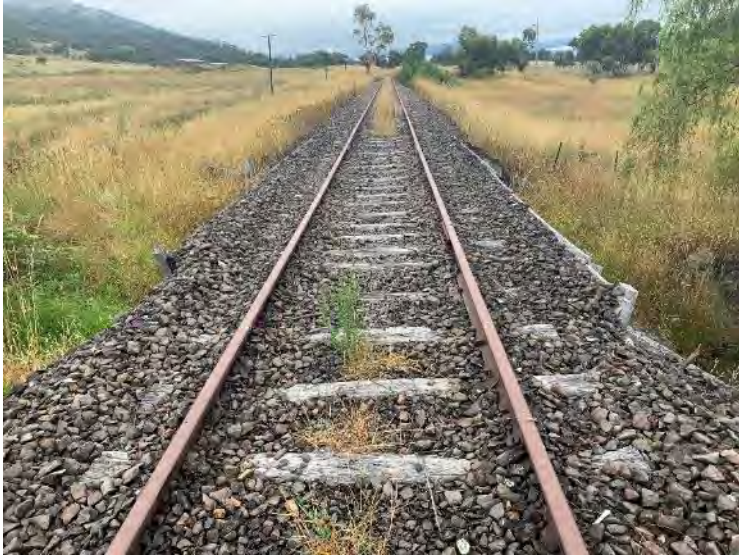
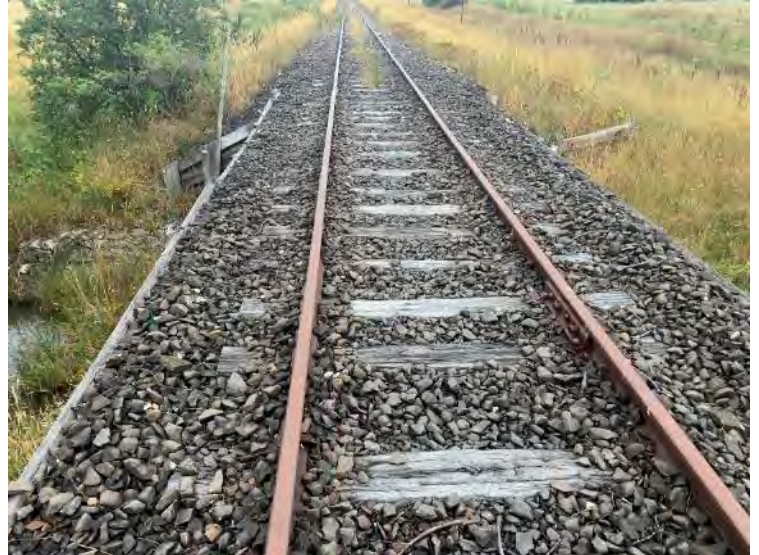
Figure 5-8: Top view of rock ballast looking in opposite directions. The rock ballast was found to be in fair condition with no major erosion present, no holes were found in bridge decking. Transoms were found to be in fair to poor condition with moderate deterioration and decay found.

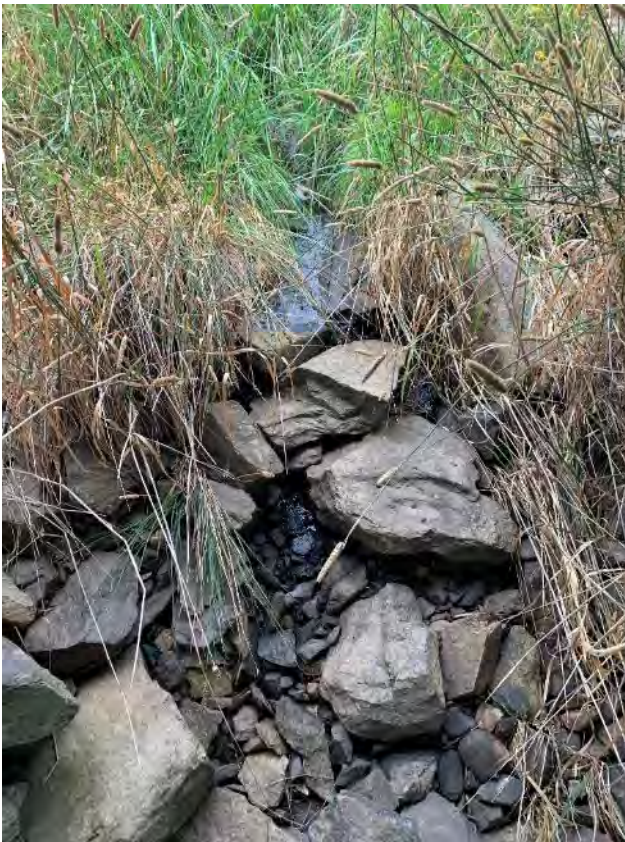
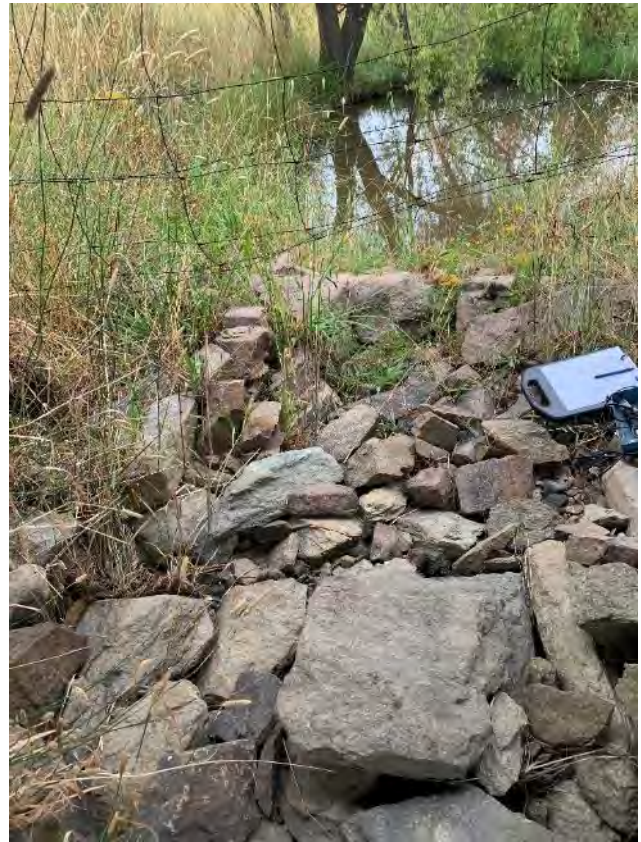
Figure 5-9: View of small inlet creek that trickles through rocks under the span 2 into a pool on the opposite side.

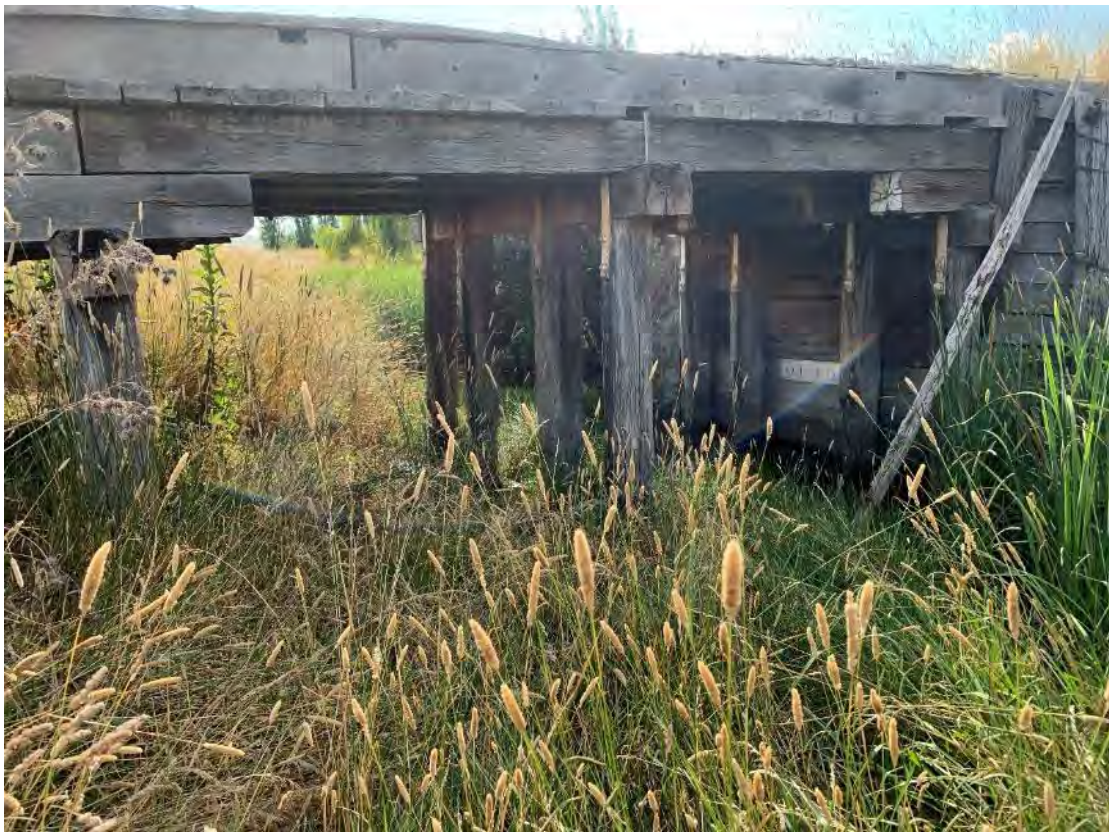
Figure 6-1: General view of Lobbs Hole Creek Bridge from the side of the bridge. The Creek that flows underneath span 1 at the time of inspection was flowing very slowly/still. The configuration of the bridge is a girder under and consists of 3 spans, 2 abutments and 2 pile bents. The span length is 3m equating to a total length of 12m. Note: abutment 1 and abutment corbels as does one of the bents.

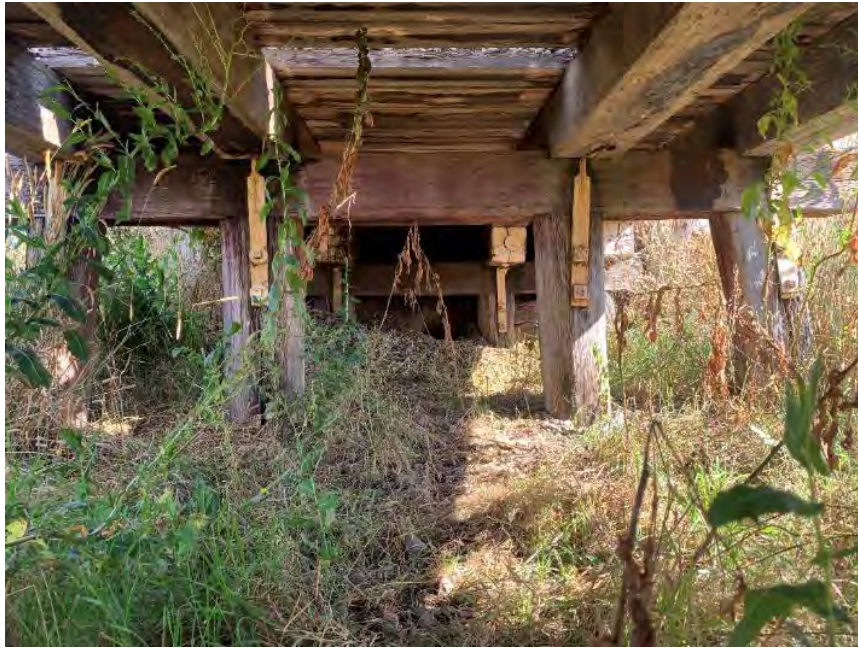
Figure 6-2: View of the typical timber pile bent configuration with each bent varying in height. The bent comprises of 4 driven piles a capsule (cap) and at bent 2 4 corbels located directly underneath girders. Overall, the timber bents were found to be in fair to poor condition. Note: large Wombat hole at abutment 2 between pile 2 and 3 and the significant amount of vegetation growth surrounding the substructure elements. Note that the use of horizontal bolts in the side plates have let to improved pile top condition. Also note the notches in the caps for the girders to drop into.

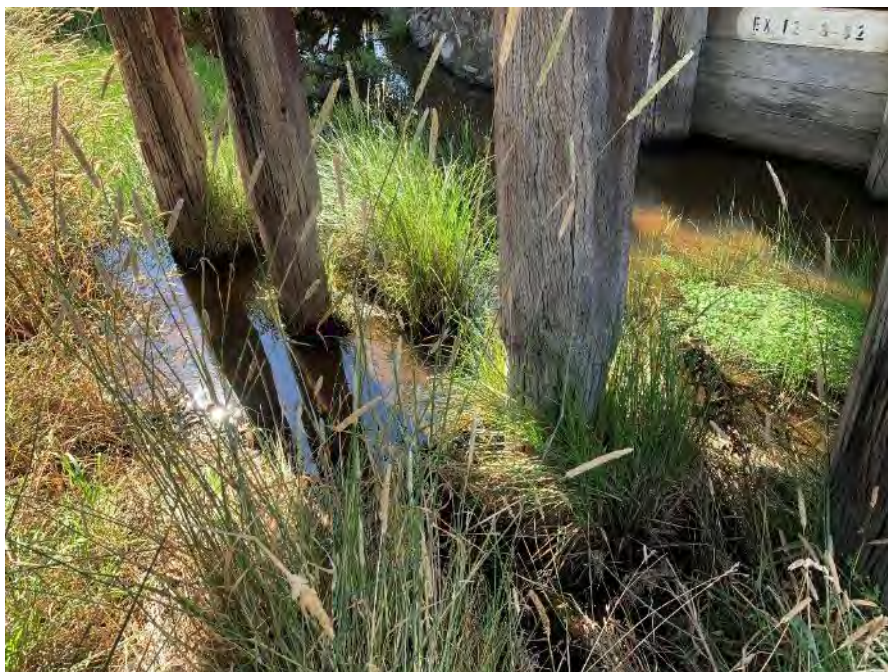
Figure 6-3: A view of Bent 2 shows the timber piles were driven into the creek. Significant sapwood decay is present in the lower length of each pile as seen by the noticeable change in cross section. This is seen as a length that is subject to temporary exposure to moisture which causes accelerated decay compared to constant saturation. Once the moisture content exceeds 22%, timber consuming fungi are activated, and the decay process begins. Refer to Figure 3-2 for a detailed description of how and where the decay occurs due to these vertical bolts.

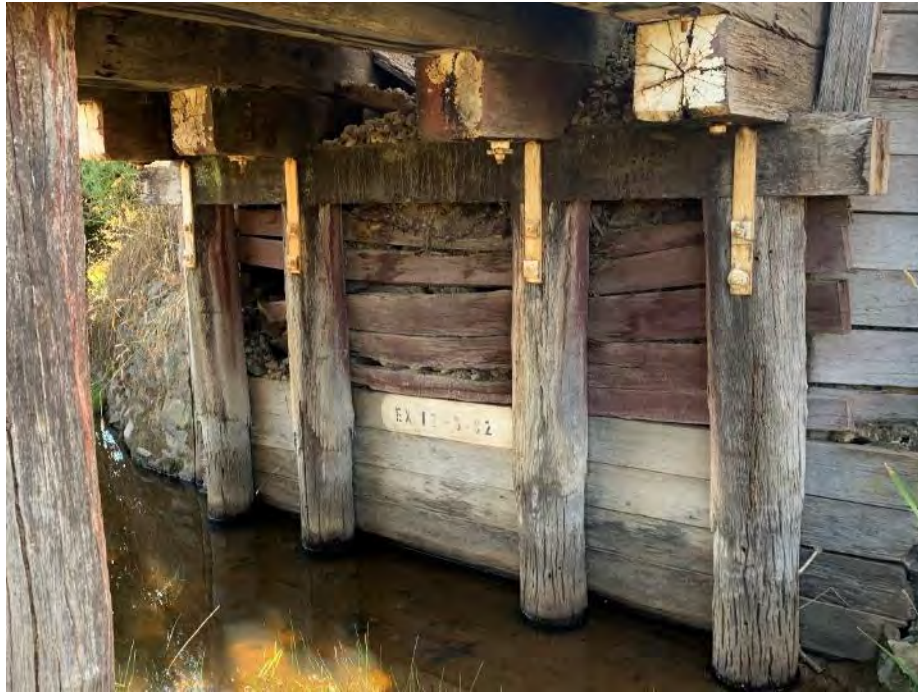
Figure 6-4: General view of Abutment 1 shows the timber sheeting in very poor condition as top half is failing and backfill material is eroding. Note: Hole in decking above abutment causing significant material loss from rock ballast above.

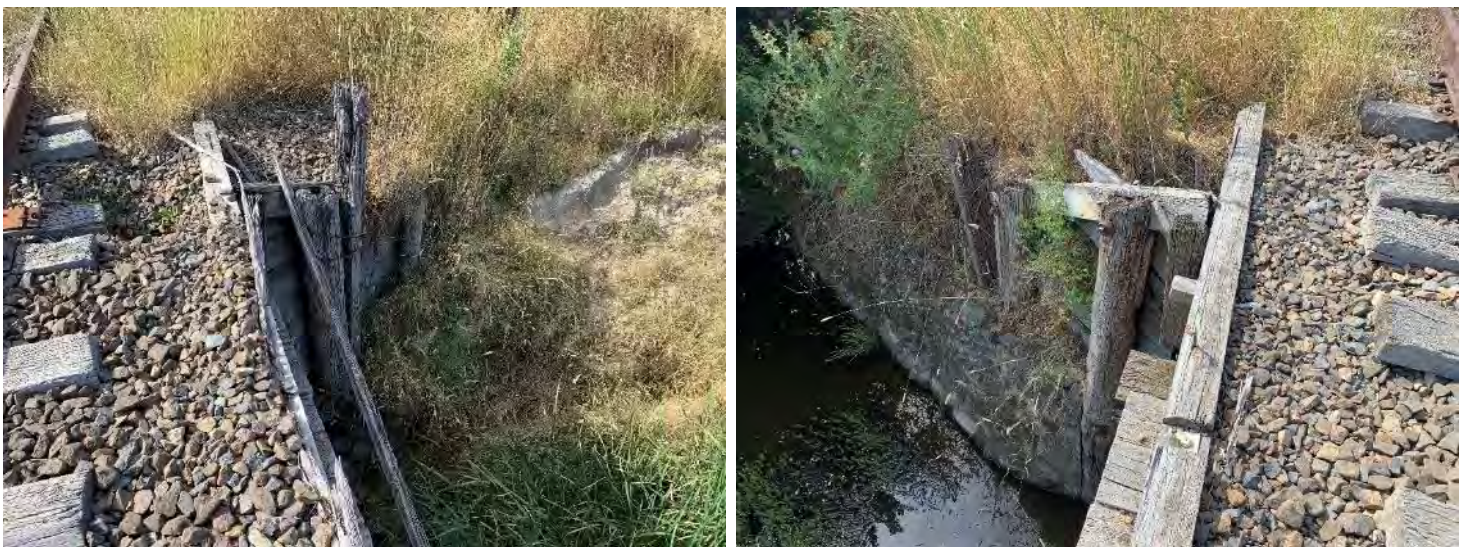
Figure 6-5: Above photos show the existing condition of the wingwalls. The wingwalls were found to be in a poor to very poor condition, multiple members had failed, and significant deterioration was present throughout.

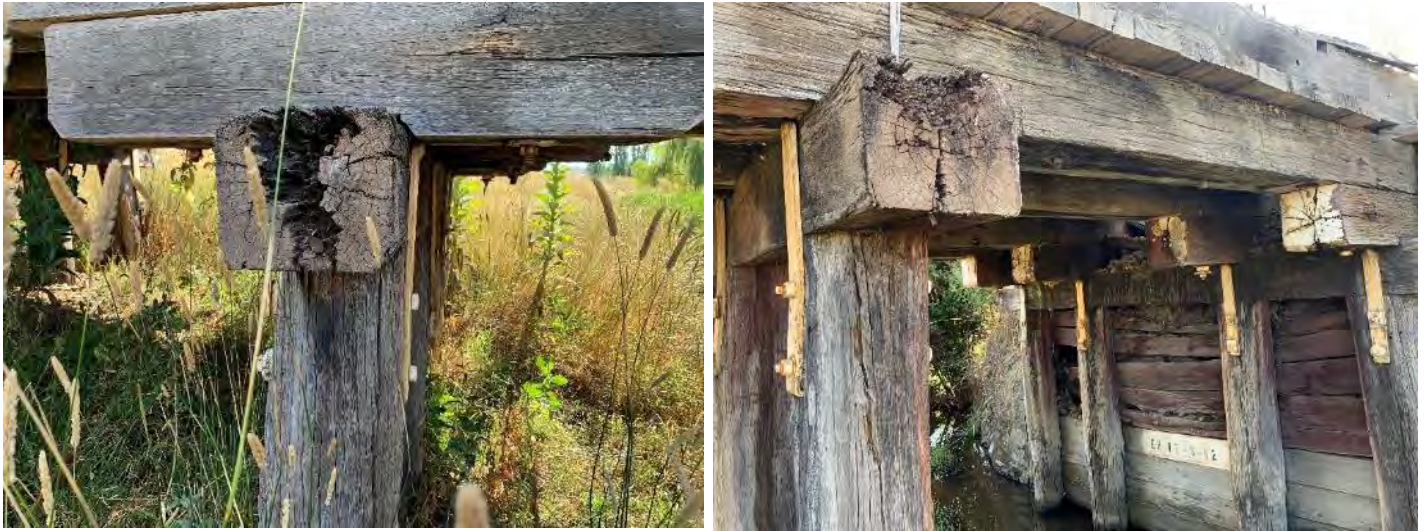
Figure 6-6: Above photos show the ends of the pile bent caps at PB1&2. Minor deterioration and cavities were found at all ends of caps. Overall, the caps were in poor condition. Brief NDT testing was completed at the mid length using non-destructive methods, such as EPHOD® Stress Wave Technology. Refer to Appendix A for more information of this type of testing method. Readings for bent caps were found to be between 200-1000 μ s. This is the time taken for the compression wave to travel across the section of the member tested. This aided in verifying the overall condition of the elements.

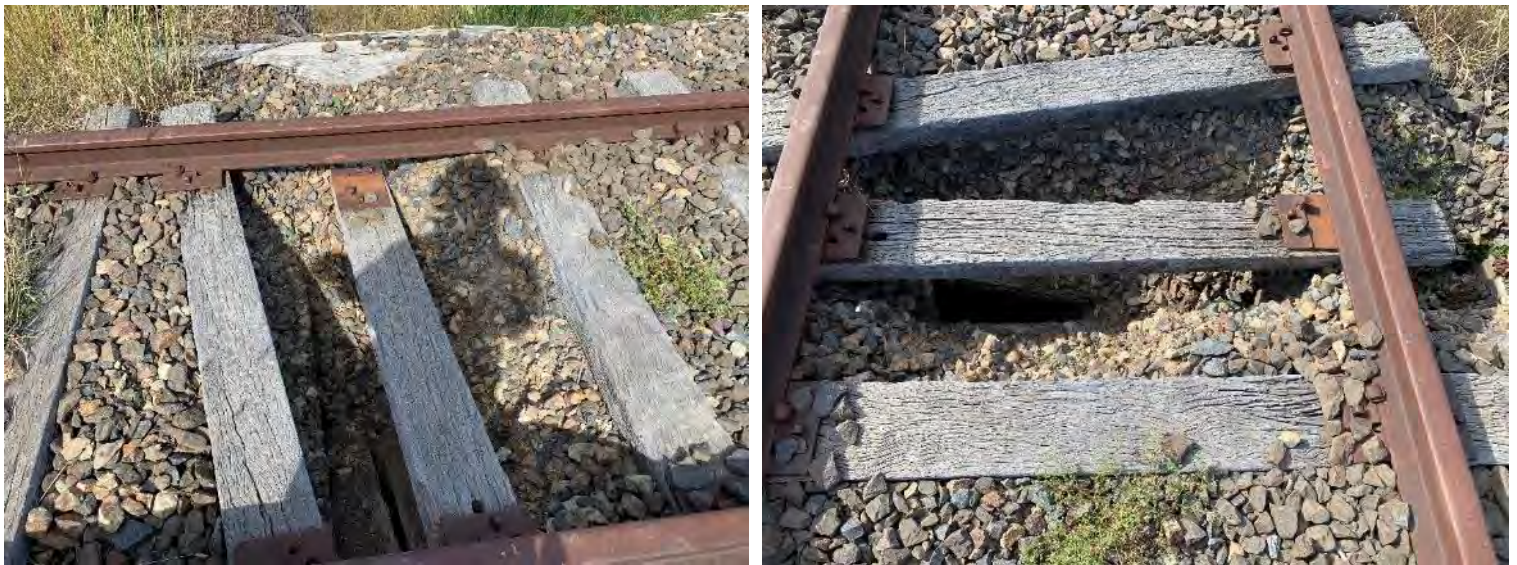
Figure 6-7: Above two photos show 2 of 3 deck collapses. The ballast tray floor boards are in very poor condition with major deterioration and rot present throughout.

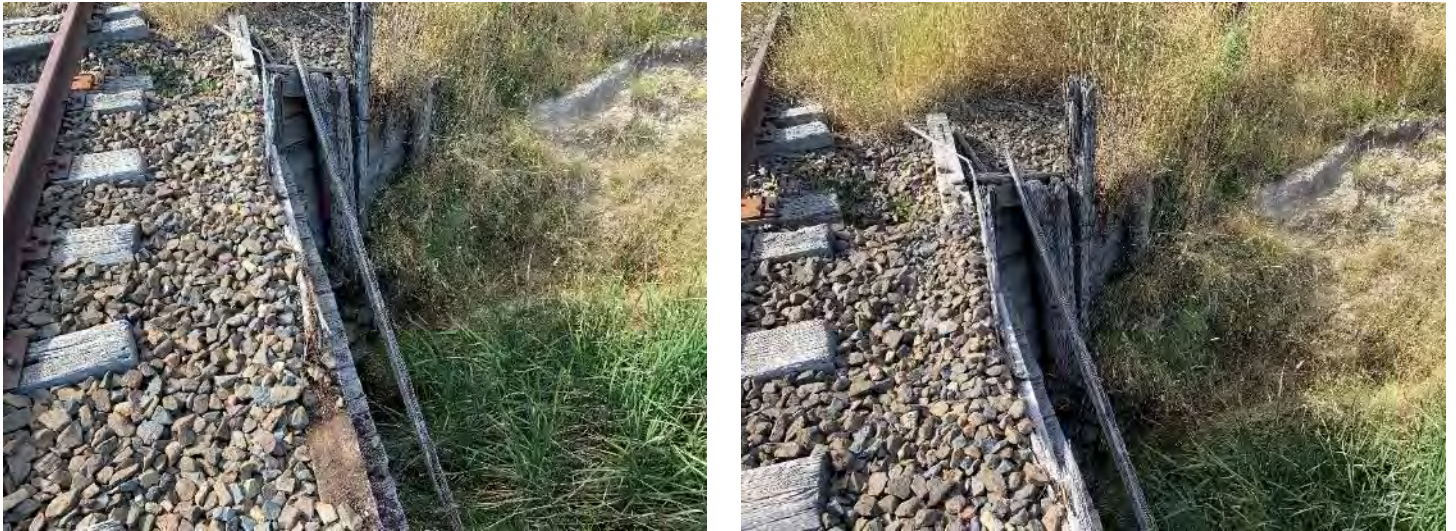
Figure 6-8: View of timber ballast tray side walls, spacing between side walls was 3.5m. Side walls were found to be in very poor condition with significant rot and decay present.

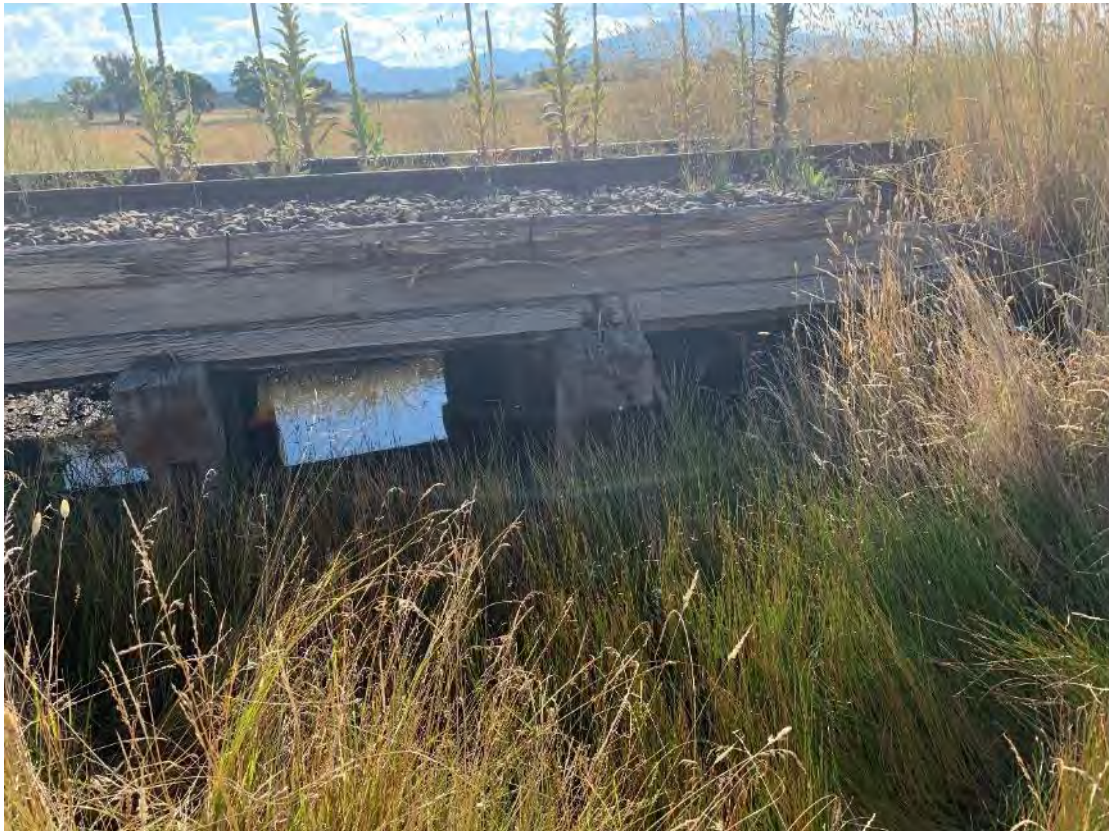
Figure 7-1: The image above shows a general view of the 7m minor bridge (Williamsdale Rd). The consists of 3 spans each span is 2m in length, substructure includes 2 pile bents and 2 abutments that each have 4 driven piles, a pile cap and 4 girders. At the time of inspection there was water approximately 0.5m deep in Spans 1-3. There is a large amount of vegetation growth around the substructure which keeps the moisture content high in the timber. When the moisture level in the timber is above 22%, decay-causing fungi can start to grow; when the moisture content drops below this level, the fungi become dormant, and decay will be arrested until the moisture content rises again.

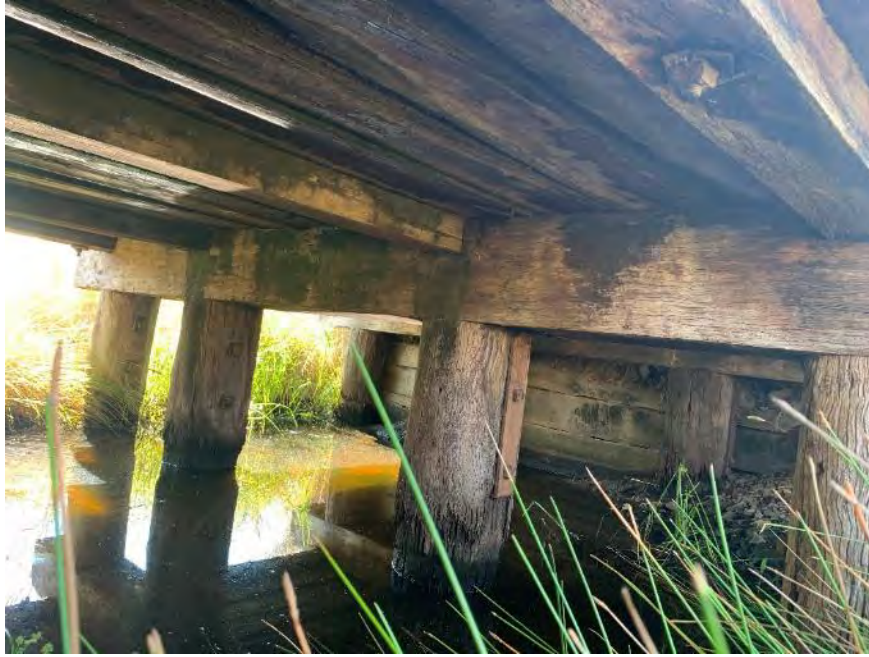
Figure 7-2: Shows the general configuration of the pile bents. Piles are approximately 1m high and in fair condition. Minor deterioration of sapwood is present at water level due to increased moisture content. Water stains and fungal growth present. Note: top plank in abutment sheeting has failed leading to erosion of backfill material.

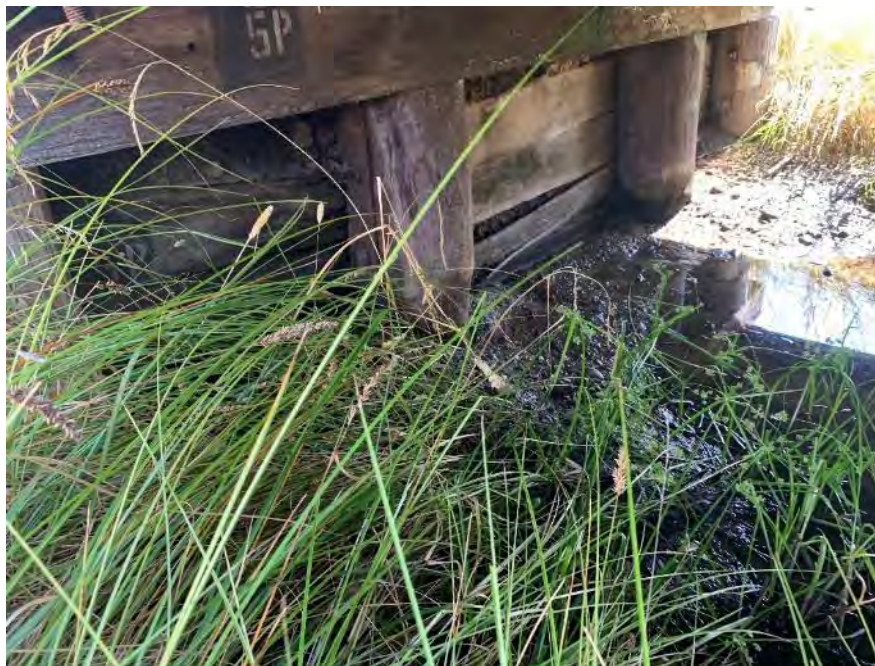
Figure 7-3: View of abutment 2, overall, in a poor condition. Sheeting planks have separated due to spiking to the pile backs in the breast wall, causing loss of fines in the approach fill material through gaps.

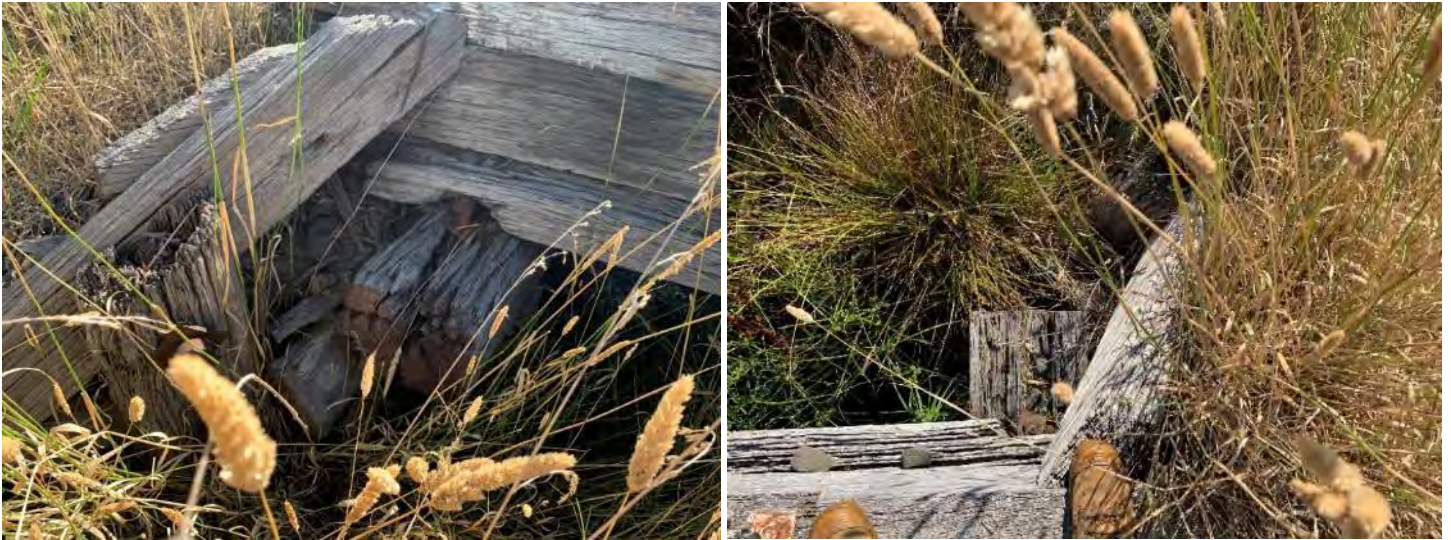
Figure 7-4: Top view of abutment cap connection. Cap is in very poor condition; severe deterioration is present in the ends and at the vertical connection. When a vertical connection is not sealed appropriately it exposes the heart wood to excess moisture accelerating decay. As seen in the photo a large crack is present at the end and a cavity is present at the top of the vertical connection.

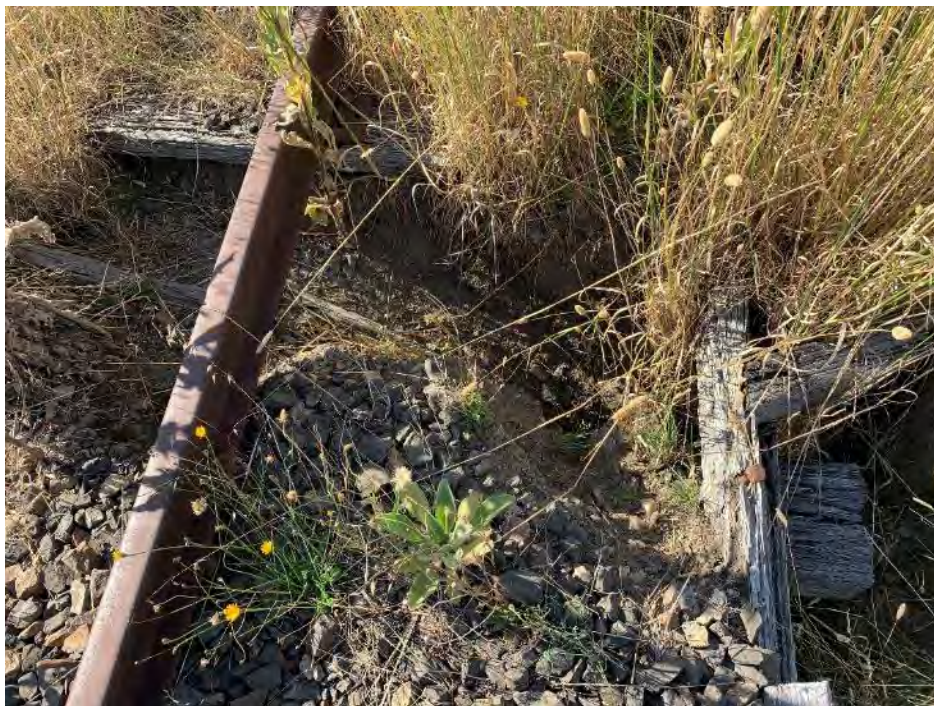
Figure 7-5: Top view of floorboards in the ballast tray at abutment. Large hole caused by abutment/ballast tray failure allowing significant erosion of ballast to occur.

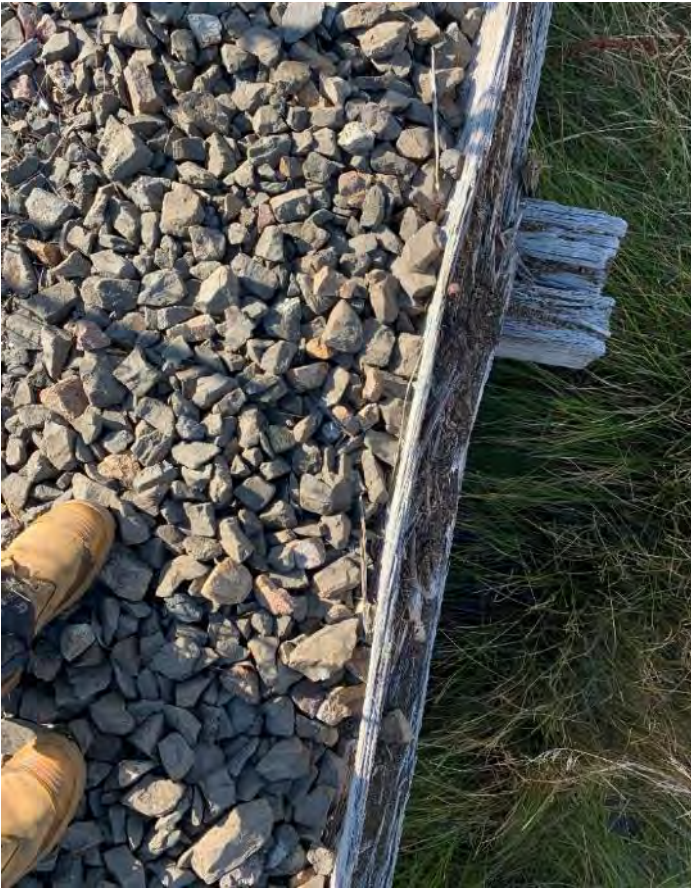
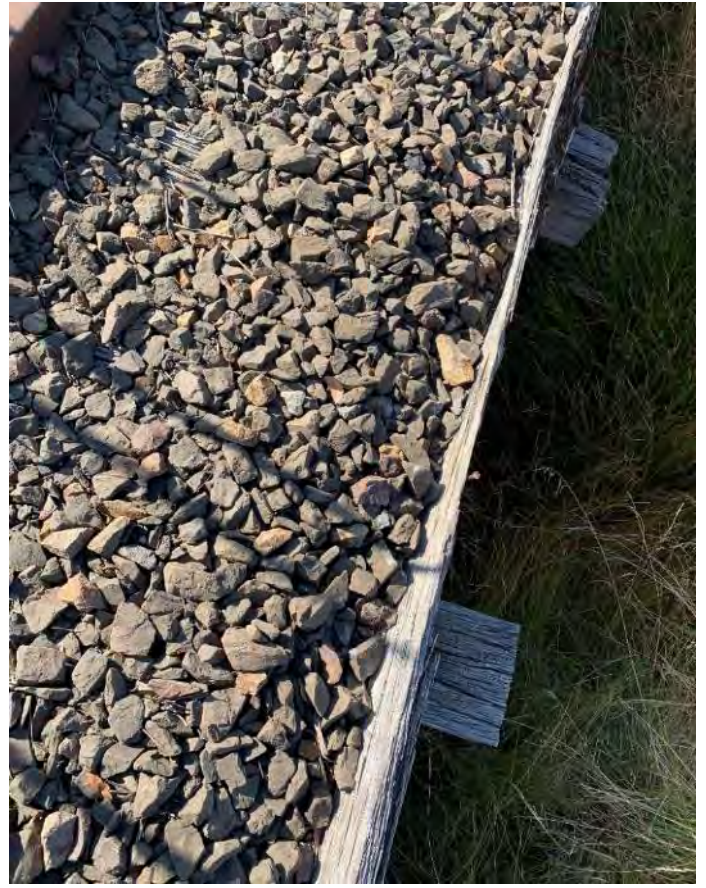
Figure 7-6: Above photos show a ballast tray side wall lengths that have completely rotted away, significantly reducing its ability to retain the ballast material.

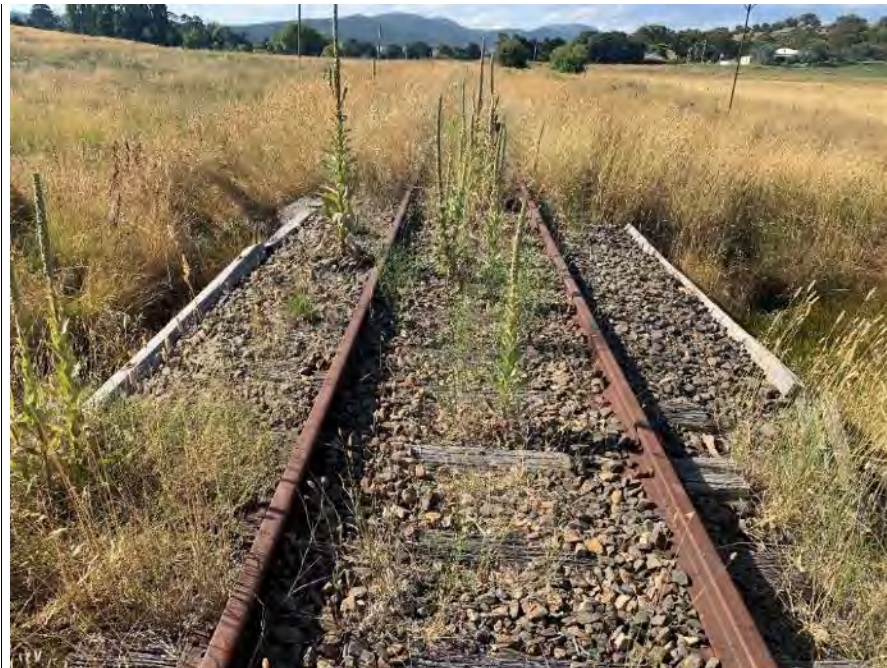
Figure 7-7: The photo above shows the general view down the rail line. Significant overgrown vegetation present through rock ballast and surrounding the substructure. Note: Ballast is 450mm thick.

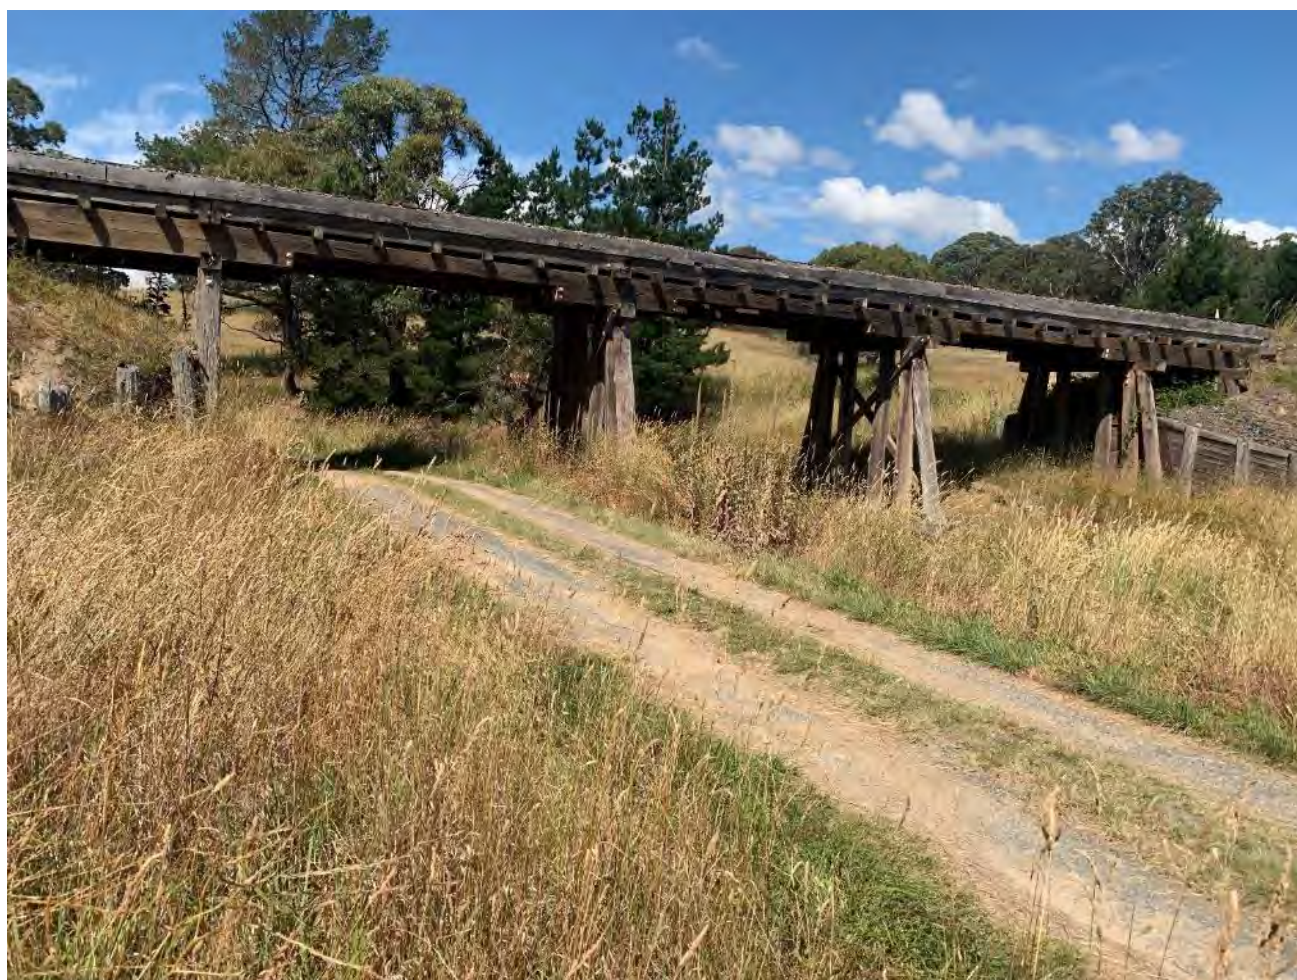
Figure 8-1: General view of Deep Creek Bridge from abutment 1 looking towards abutment 2. The timber bridge is 5 spans long and approximately 32 metres in length (Spans 1 & 5 – 4m and spans 2, 3 and 4 – 8m). Note span 2 passes over the road (4.2m Clearance) and span 3 passes over a creek 2m wide and 0.5m deep.

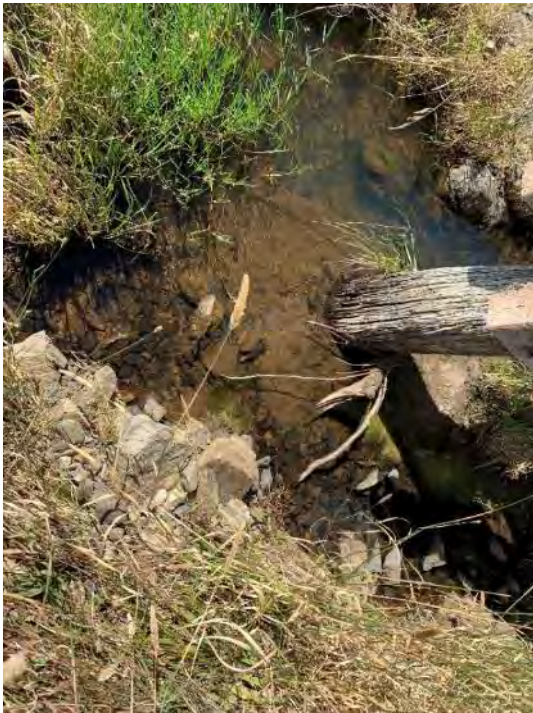
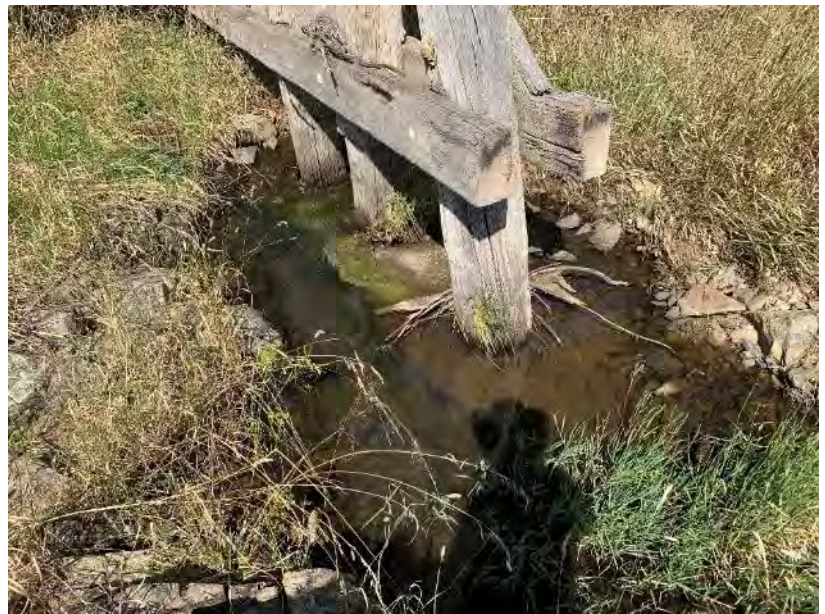
Figure 8-3: General view of pile bent 3 bearing on a concrete sill, piles were found to be in poor to very poor condition. The bottom sections of the timber piles were determined to be a ‘hotspot’ for decay and determined to be an ideal area to test using non-destructive methods, such as EPHOD® Stress Wave Technology. The timber piles were estimated to produce SWT data ranging between 300-1400 μ s. Readings above 700 μ s indicates that there is significant decay present and are required to be monitored. Reading of above 1000 μ s indicate severe decay is present resulting in the member being unable to support its own dead load.

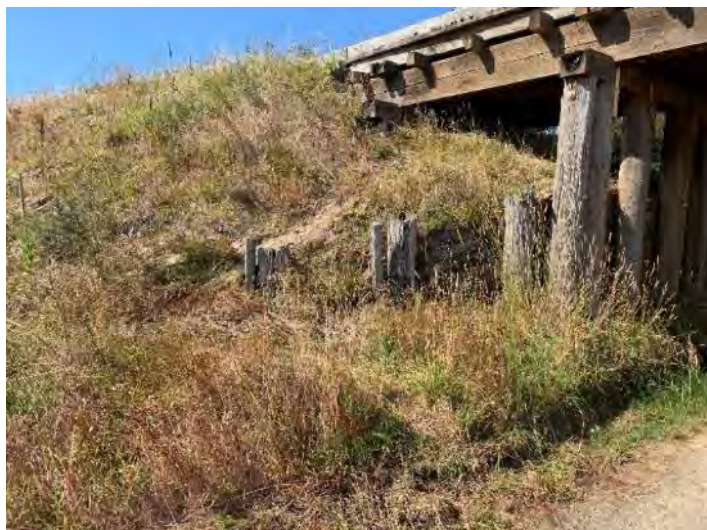
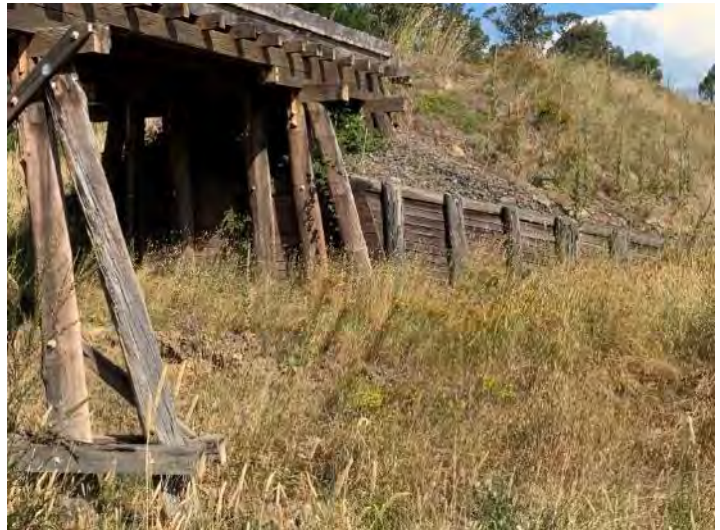
Figure 8-4: The images above show the condition of the breast wall at PB1 & 4. The left photo shows the breast wall at PB1 to be poor to very poor condition with significant decay in timber elements present, surrounding overgrown vegetation and erosion of back fill material. The right image shows the breast wall at PB4 to be in fair to poor condition, it was noted that the back fill material had forced the wall to “lean” forward. Note: Severely decayed batter pile at PB3.

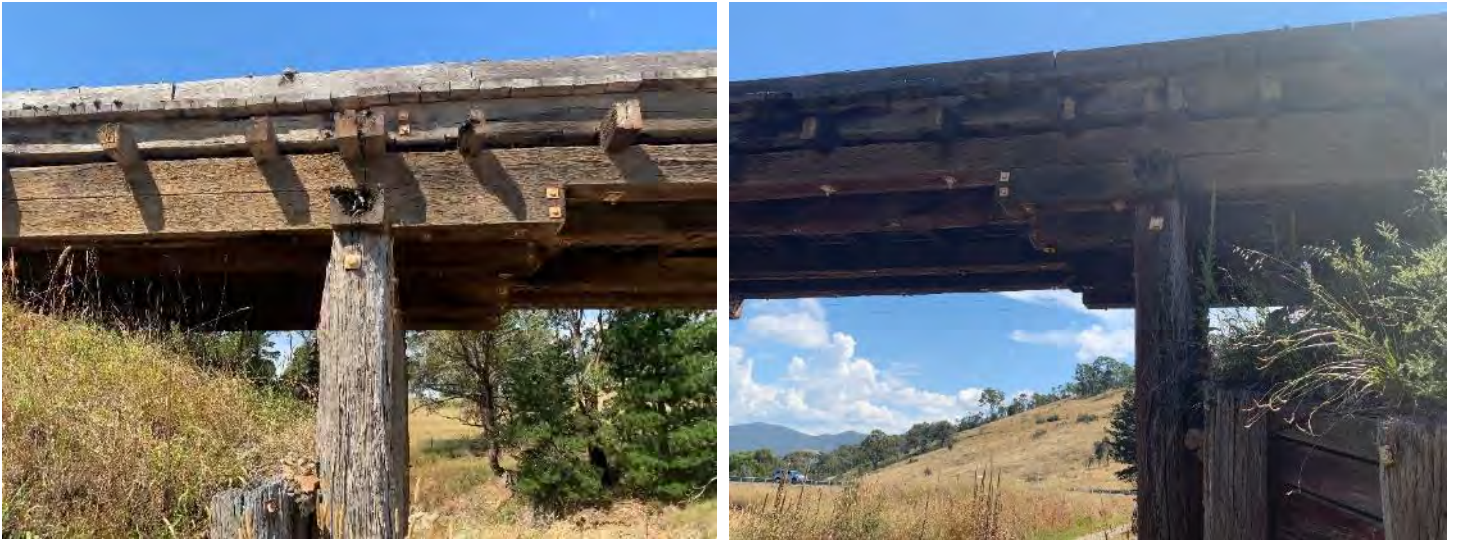
Figure 8-5: View of pile caps at PB1 & 4. Caps were found to be in very poor condition due to the significant cavities present in both ends of each cap. Note: The right photo also shows the backfill from PB4 pushing the breast wall forward.

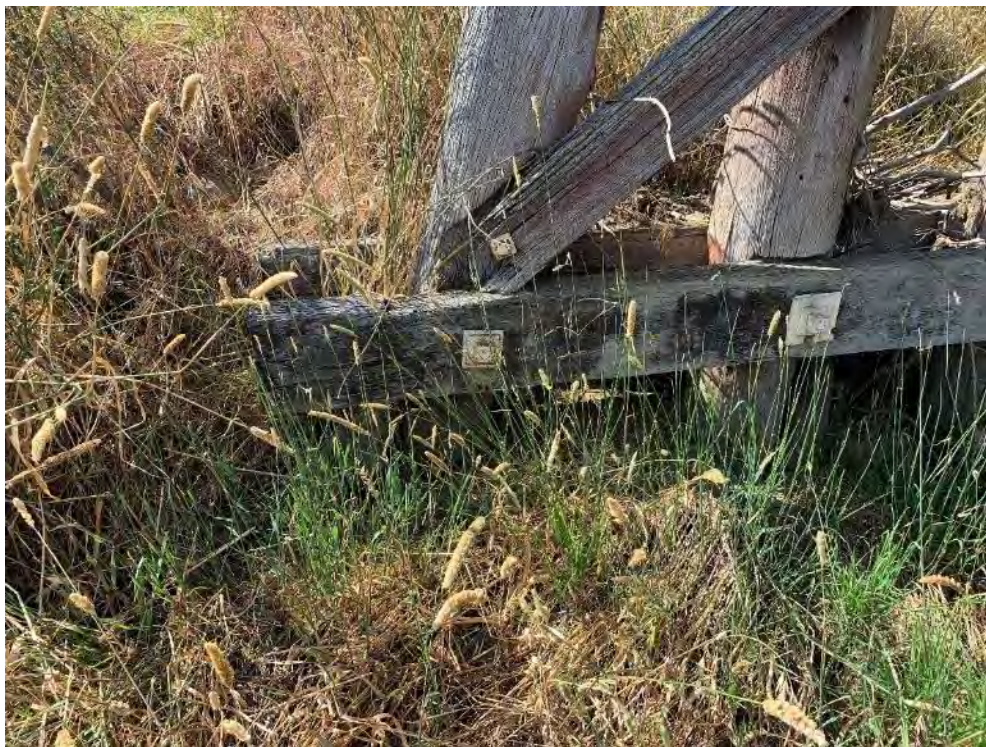
Figure 8-6: A view of a cross bracing plank connection. Plank was found to be in very poor condition as the end has completely decayed away to the connection point. Timber wales were found to be in poor condition with significant water stains and decay present throughout.

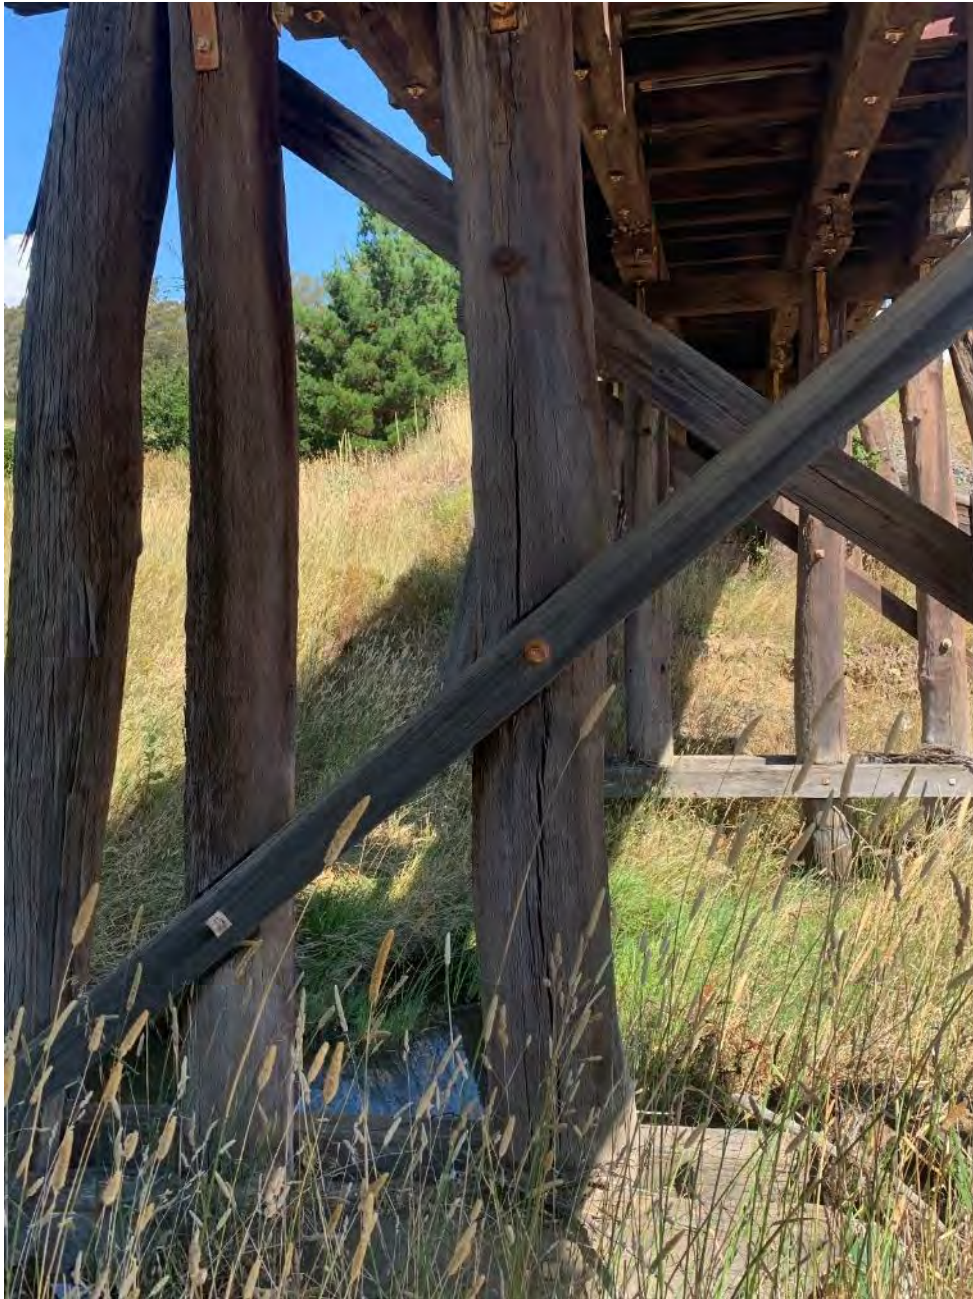
Figure 8-7: View of timber pile and cross bracing connection.
