Monaro Rail Trail

Trail Development Plans – Stage 1a

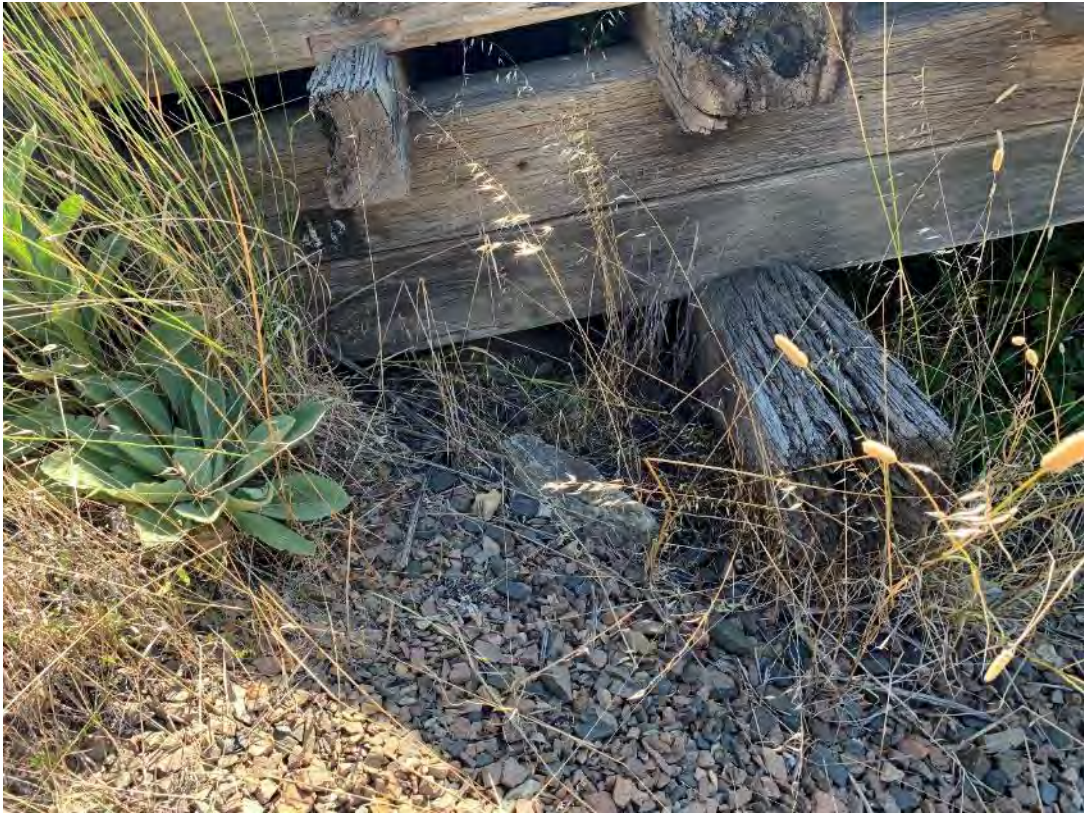
Figure 8-8: View of Abutment cap and spacing logs, cap is in very poor condition due to the large cavity and significant decay present at both ends. Spacing members were found to be in fair to poor condition with sapwood decay and cavities present.

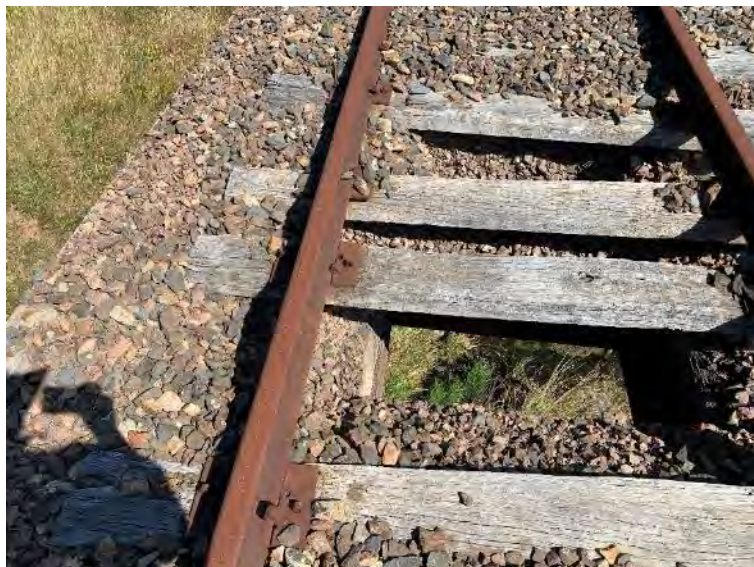
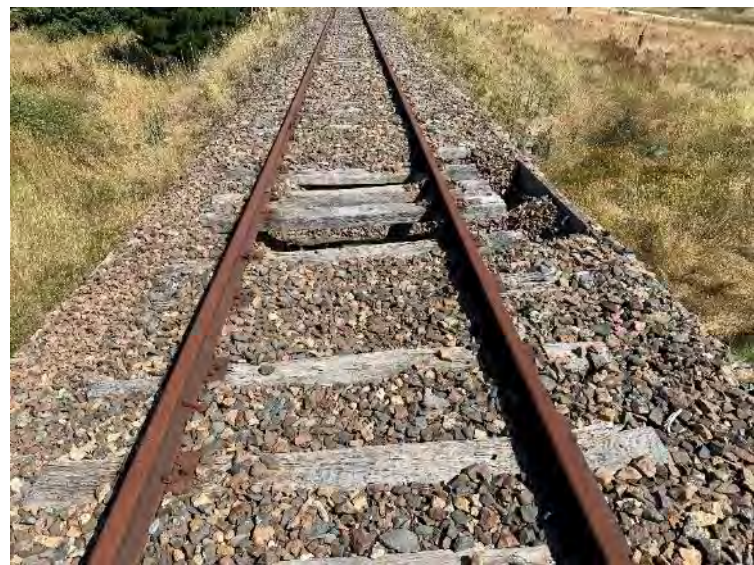
Figure 8-9: Top view of ballast, found to be in very poor condition due to bridge ballast tray floor board degradation and failure leading to a significant hole in the ballast. Transoms appear to be in fair to poor condition with no major decay or defects present.

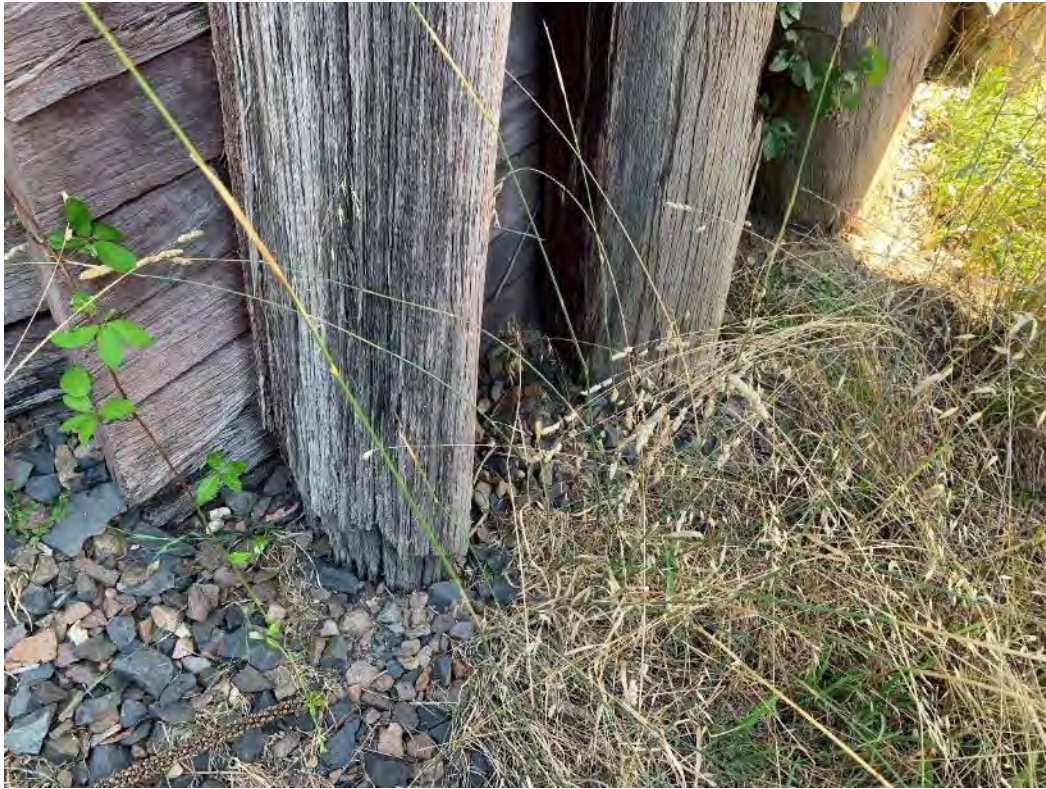
Figure 8-10: View of pile at PB4. Pile was found to be in very poor condition with significant decay present. Decay of approximately 50% of the cross section.

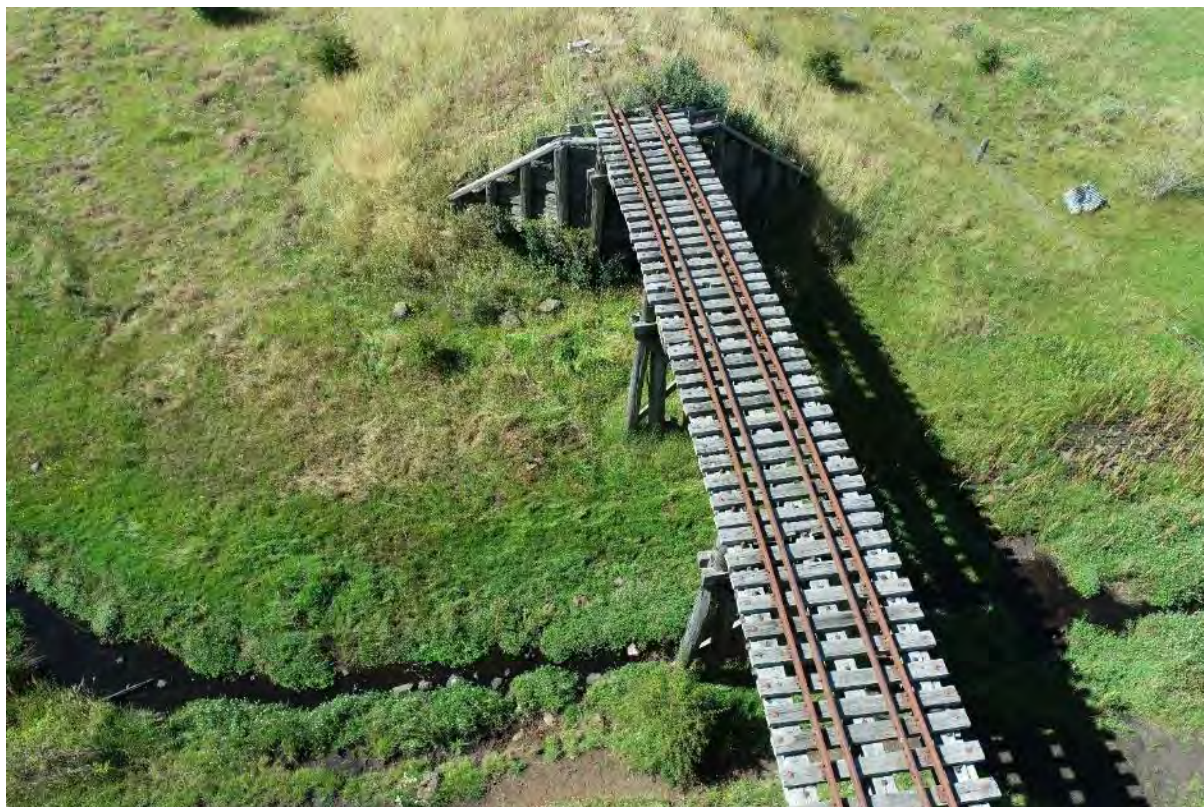
Figure 9-1: General view of Bobundara Creek Bridge from abutment 1 looking towards abutment 2. The timber bridge is 3 spans long and approximately 22.5 metres in length (7.5m spans). Note Bobundara creek runs underneath span 2 and is approximately 1m wide and 1ft deep. note the inner guard rail to prevent derailment leading to the train going off the bridge when train operations were occurring.

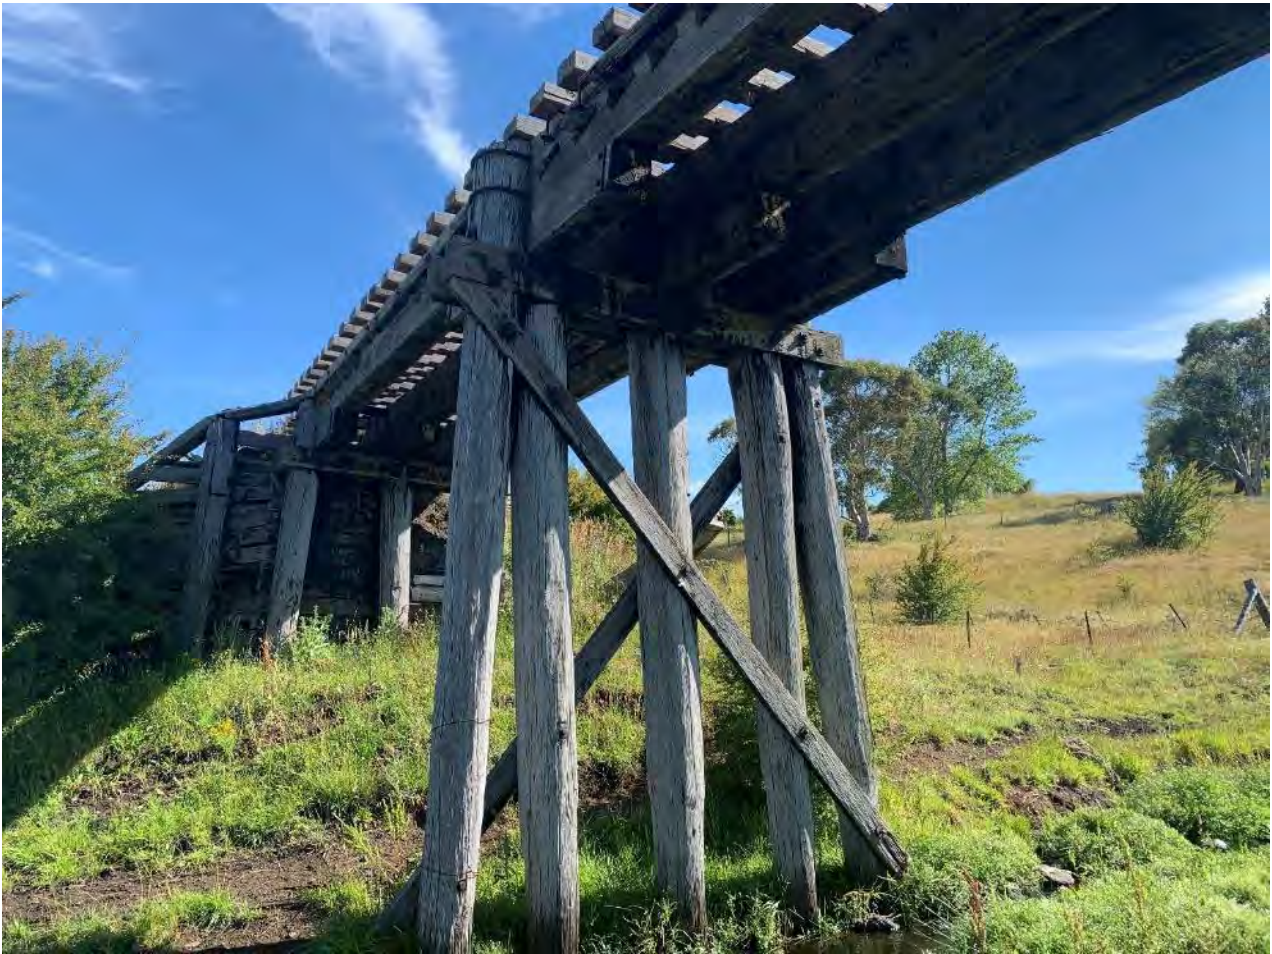
Figure 9-2: View of the timber pile bents configuration. PB 2 and 3 comprise of 5 driven piles (3 Plum piles directly under the girders and 2 batter piles on either side). Pile bent 2 and 3 are supported by cross bracing. The two abutments do not contain the cross bracing and are support by timber sheeting to retain backfill. It was noted that the bottom section of several posts has started to undergo decay. This can be expected due to the timber posts being exposed to increased moisture in overgrown vegetation, debris, and the nearby creek. Once the moisture content in the timber elements reaches 22%, decay causing fungi are activated and the decay process begins. Overall, the timber bents were found to range from poor to very poor condition.

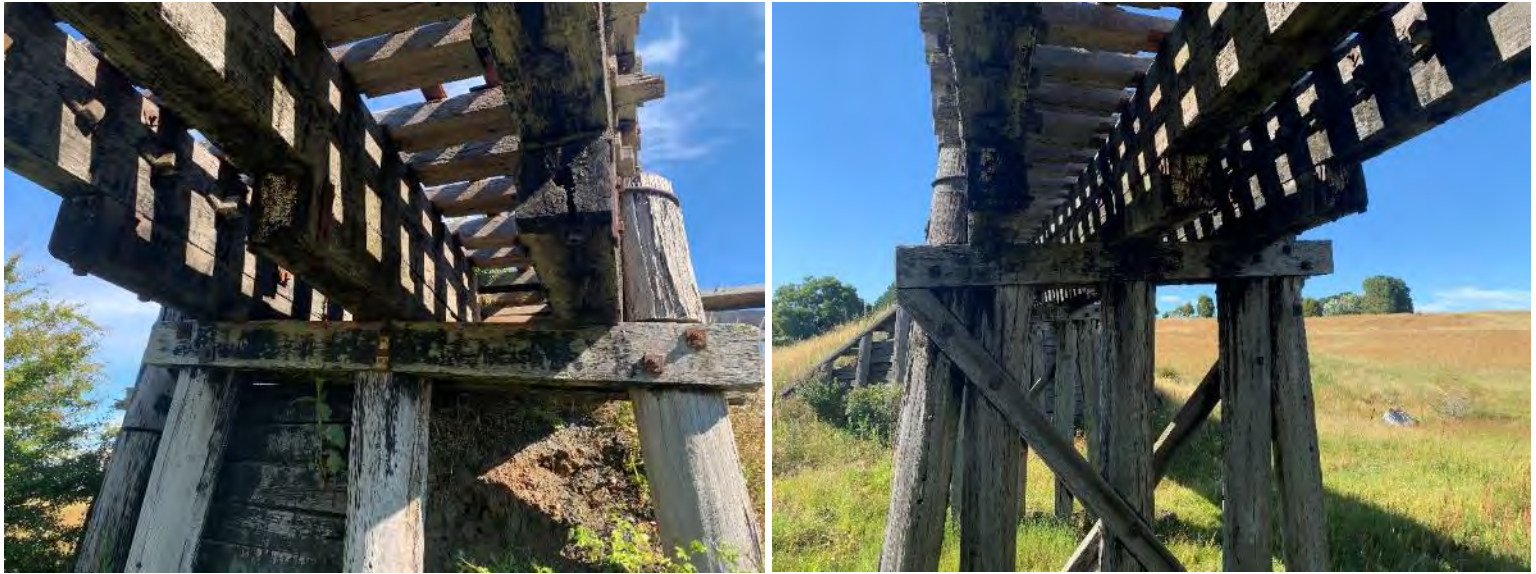
Figure 9-3: The images above show the substructure configuration. It is seen that double stacked girders have been used in addition to split headstocks and corbels. Both images show significant water stains and decaying of corbel ends. The left image identifies a large cavity present in the end of corbel 1 AB1. It was noted that AB1 sheeting has failed.

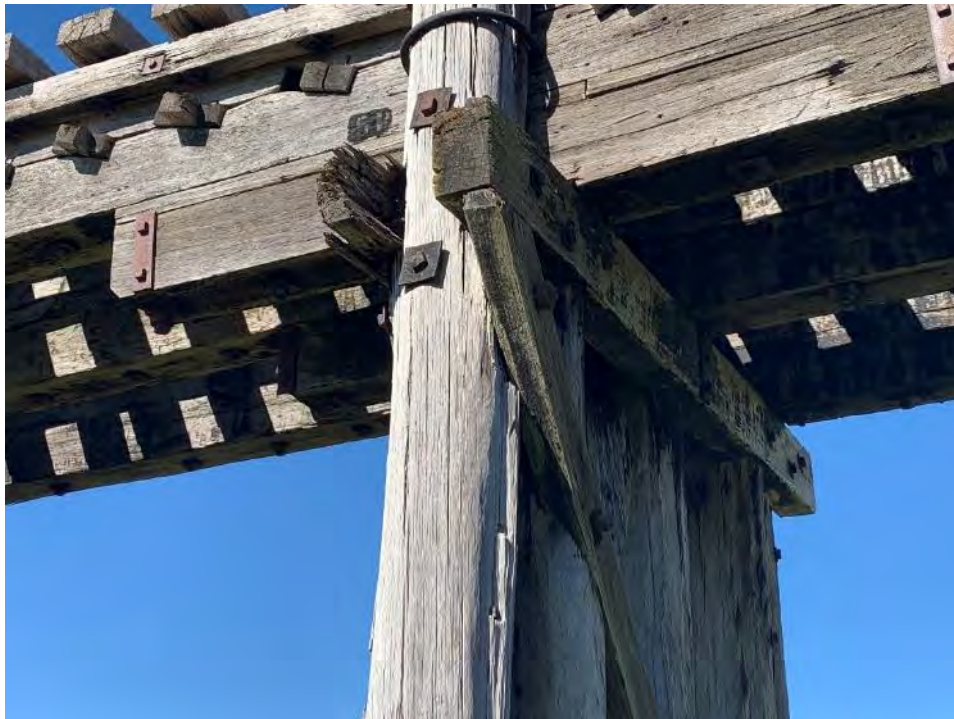
Figure 9-4: The images above show the condition of the split headstocks. The majority of headstocks were found to be in poor to very poor condition. The left member in the image above is completely decayed through the end and in very poor condition.

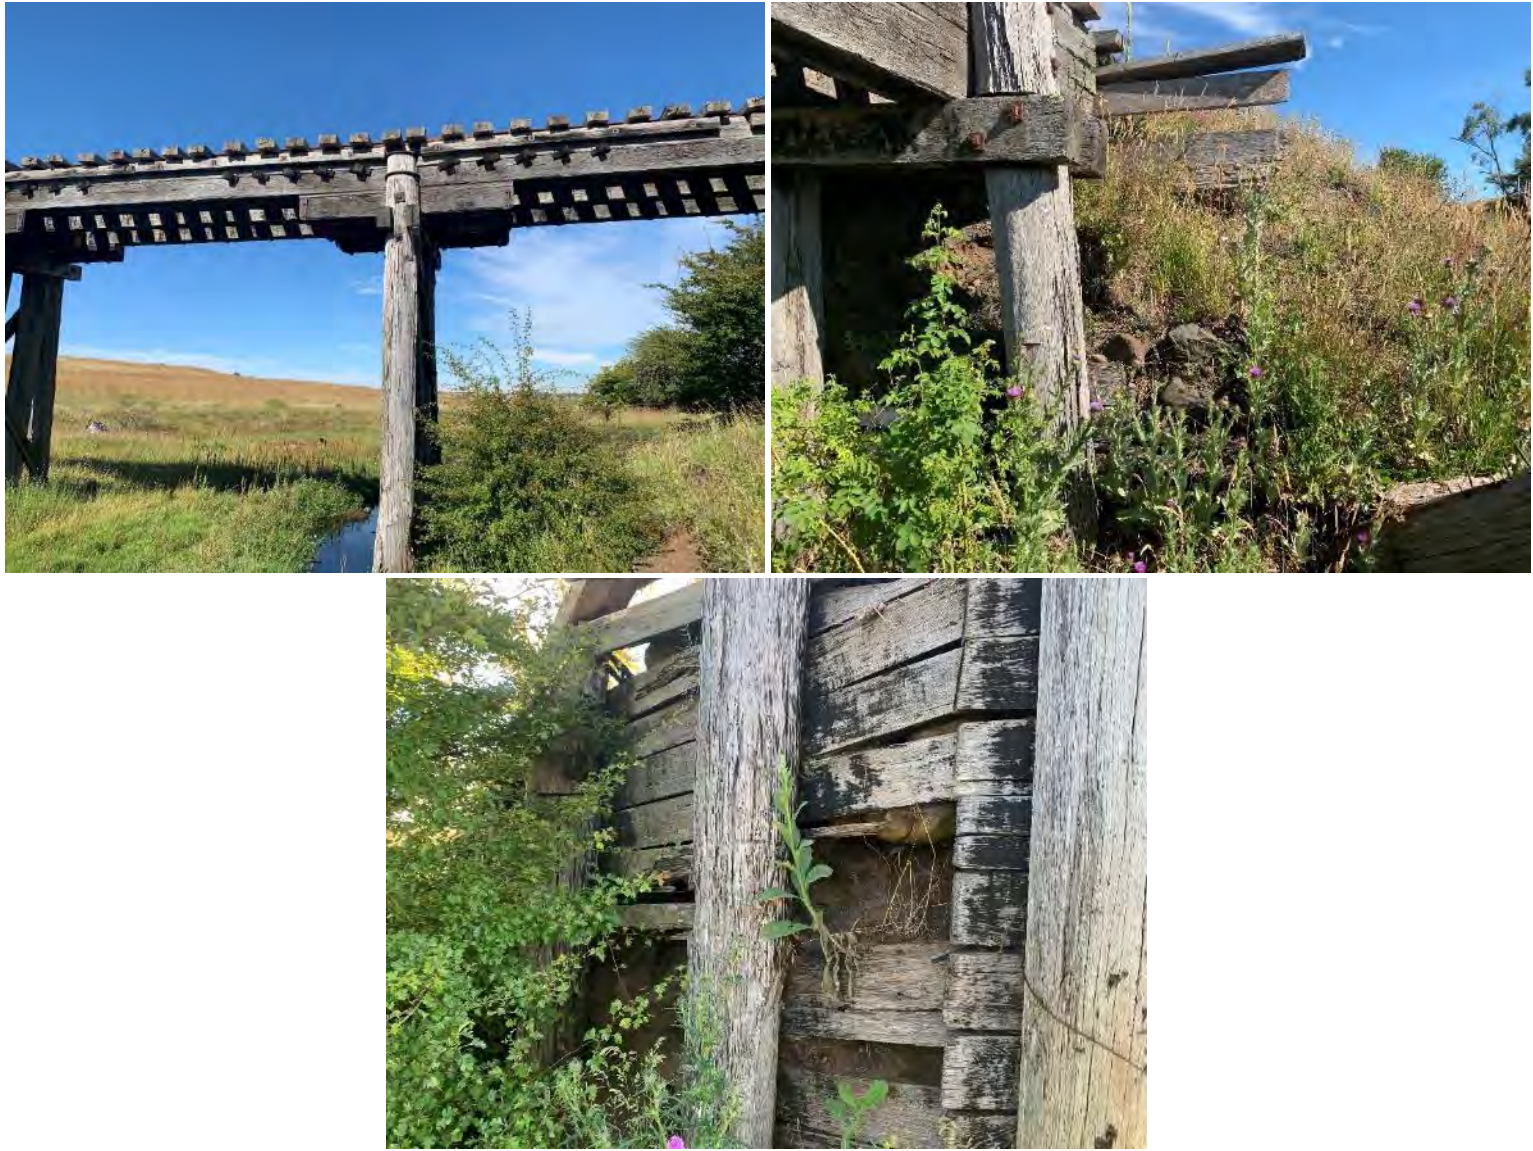
Figure 9-5: Large amounts of sapwood decay is present throughout the structure piles. It is recommended that this is monitored and removed appropriately.

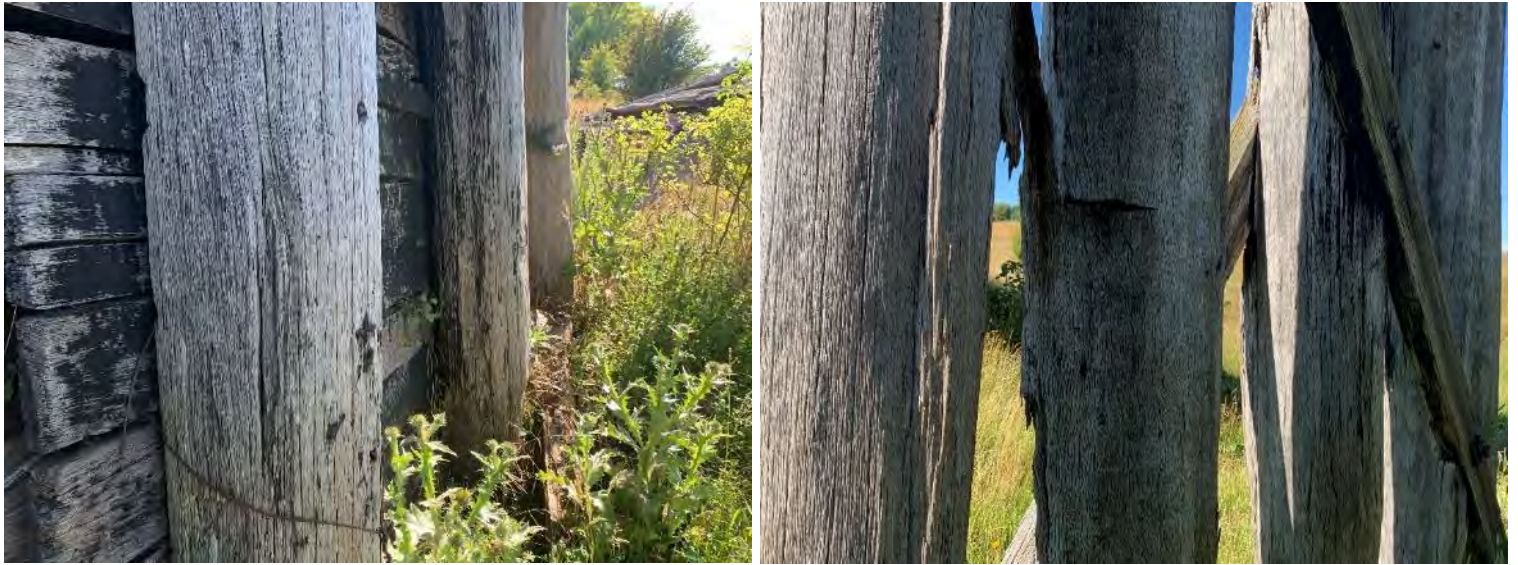
Figure 9-6: A view of two pile defects located at AB1 and PB2. The left image shows decay of sapwood forming a vertical cavity. The right image shows significant deterioration of sapwood (Peeling off).

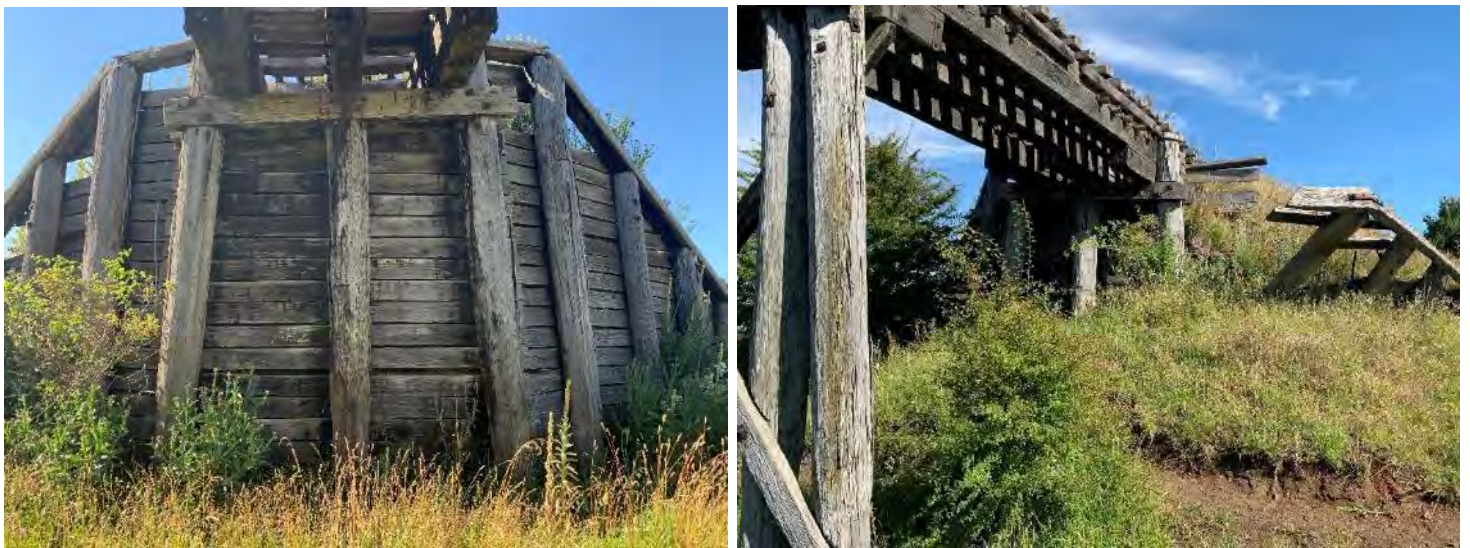
Figure 9-7: View of Abutment 1 and 2 and respective wingwalls. Abutment 1 breast/wingwall was found to be in poor condition due to the missing members and gaps between planks causing erosion of backfill. Abutment 2 was found to be in very poor condition with missing elements throughout and the right side wingwall had failed (collapsed).

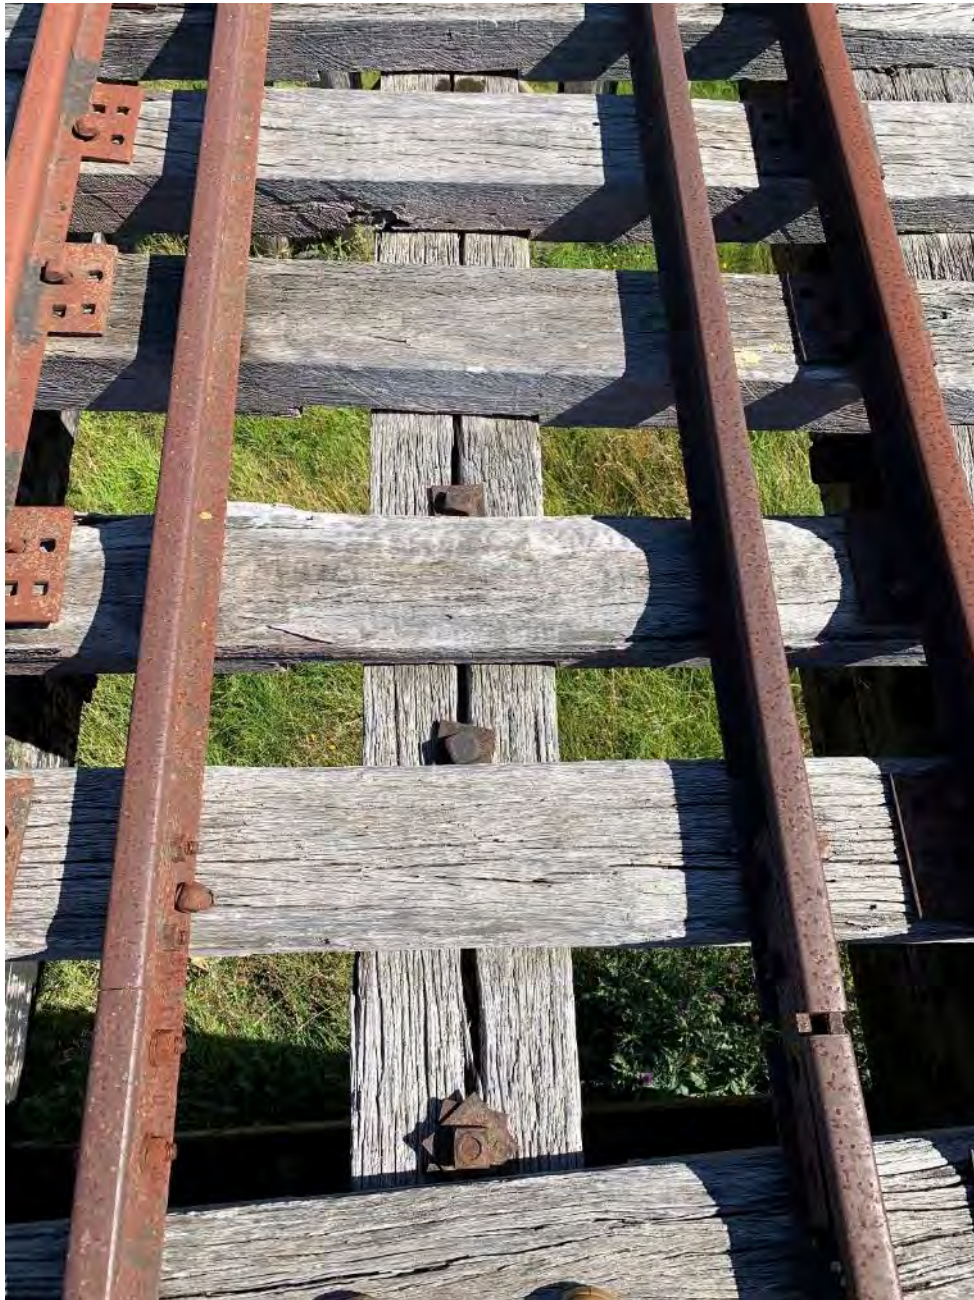
Figure 9-8: Top view of bridge surface, found to be in poor to very poor condition due to major vertical crack through the middle girder and major decay present in all other girder lengths. Vertical connections expose the bright wood to weathering and funnel watering, this leads to accelerated decay and higher moisture content. Transoms appear to be in fair to poor condition with no major decay or defects present. Note the smaller guard inner guard rail on this open deck railway bridge

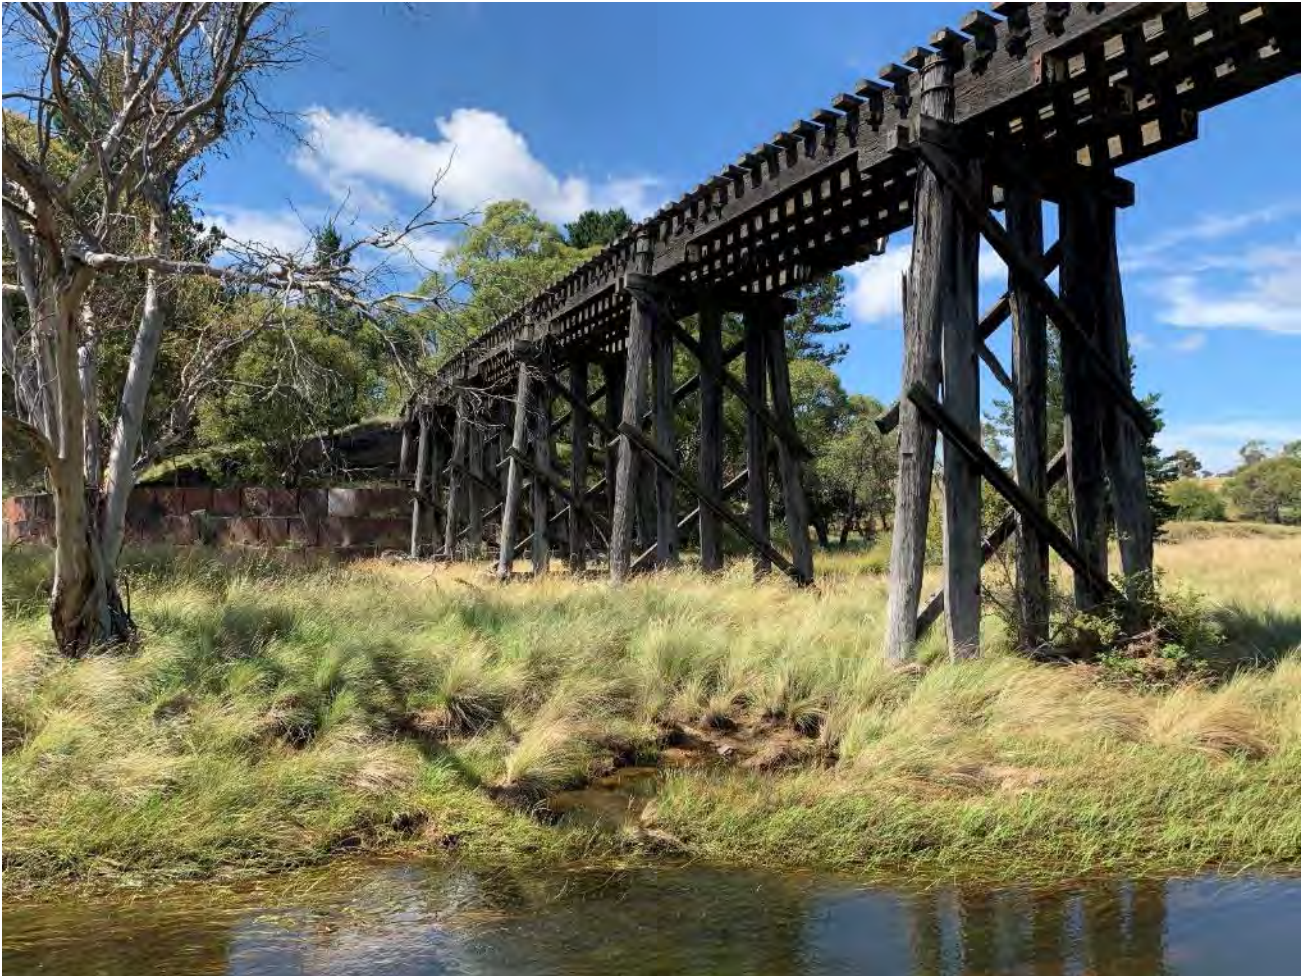
Figure 10-1: General view of MacLaughlin River Bridge from abutment 2 looking towards abutment 1. The timber bridge is 8 spans long and approximately 60 metres in length (7.5-8m spans). Note MacLaughlin River runs underneath span 3 and is approximately 3m wide and 0.7m deep. It was also noted that the bridge curved left and had appropriate camber. Note the double cross bracing on the bents as well the absence of a sash brace.

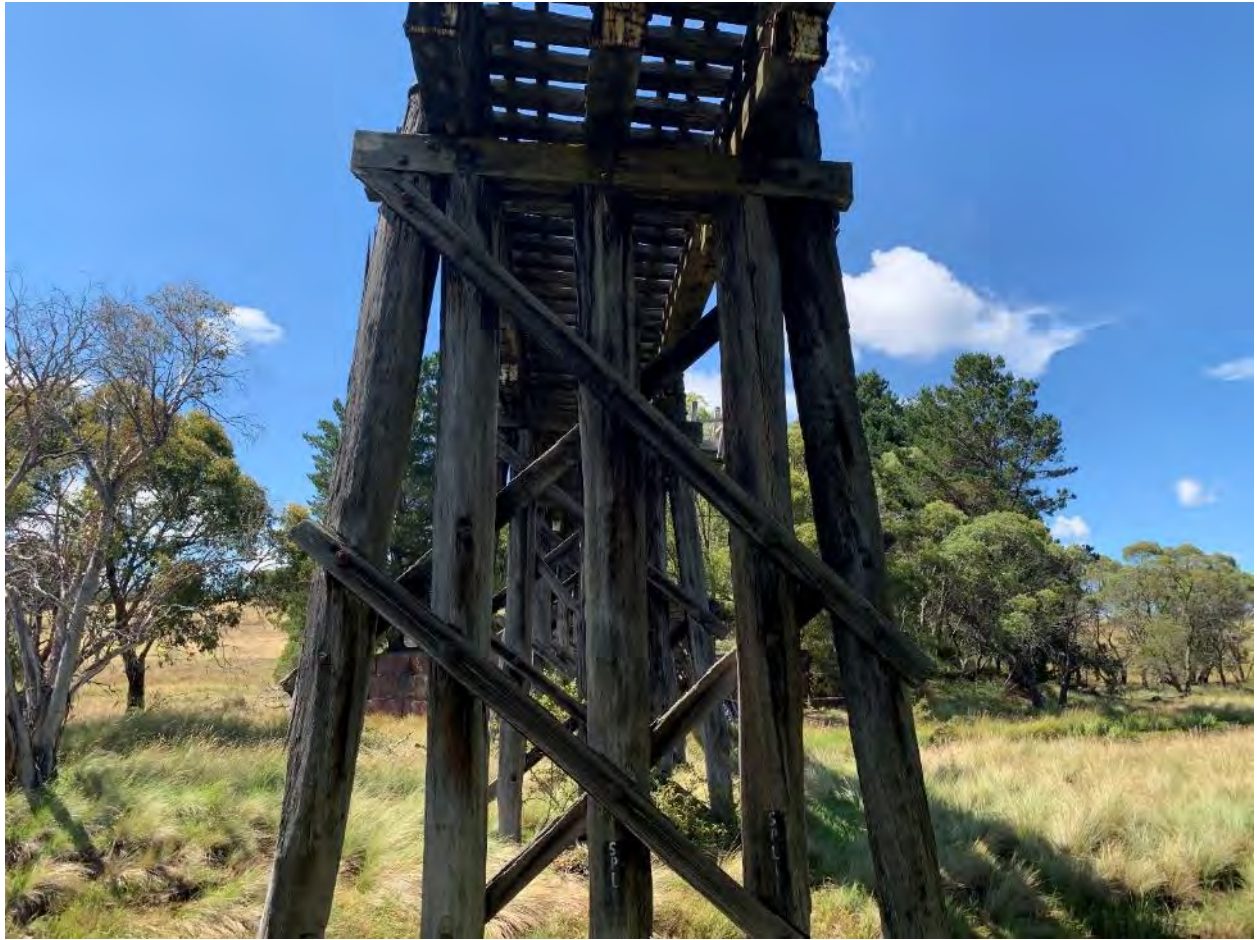
Figure 10-2: View of the timber pile bents configuration. Each pile bent comprises of 5 driven piles (3 Plum piles directly under the girders and 2 batter piles on either side) and are supported by double cross bracing (“X” at top and bottom of piles) and timber wales at the bottom. The two abutments do not contain the cross bracing and only exhibit 3 plum piles. It was noted that significant water stains were present on all timber members of each pile bent. This indicates a high moisture content, when timber elements reach 22%, decay causing fungi are activated and the decay process begins. Overall, the timber bents were found to range from fair to poor condition. Sapwood decay is present at on the piles within the image above. Note that the cross braces do not go all the way to the head stocks.

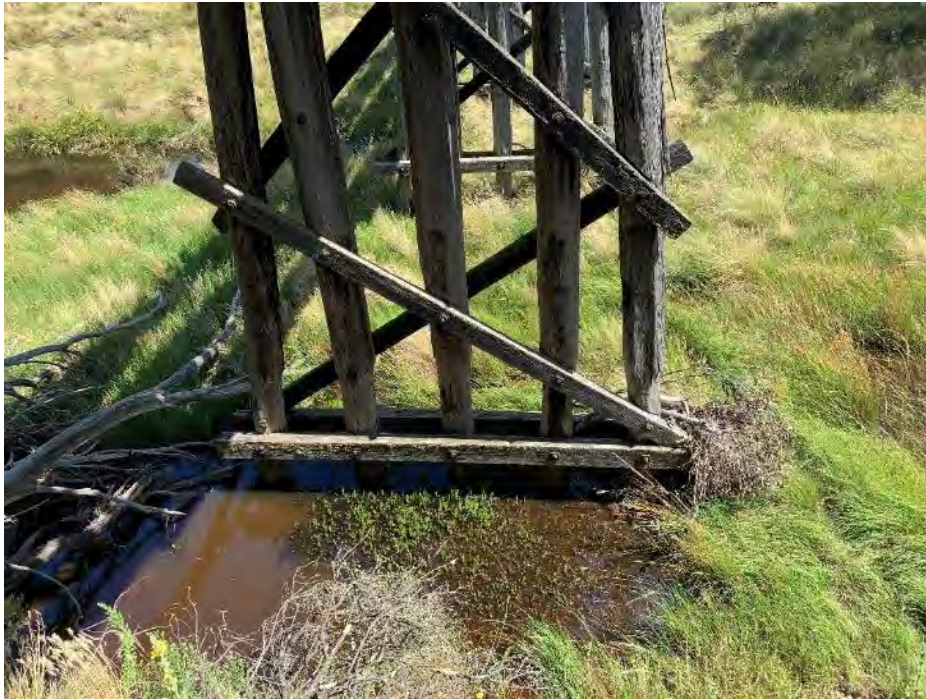
Figure 10-3: Significant decay is present on all piles in above image. Large decrease in pile cross-section on the bottom end of the piles located in the river (Body of water). Debris is caught up in the wales and surrounding areas of pile bents. It is recommended that deteriorated sapwood be removed appropriately.

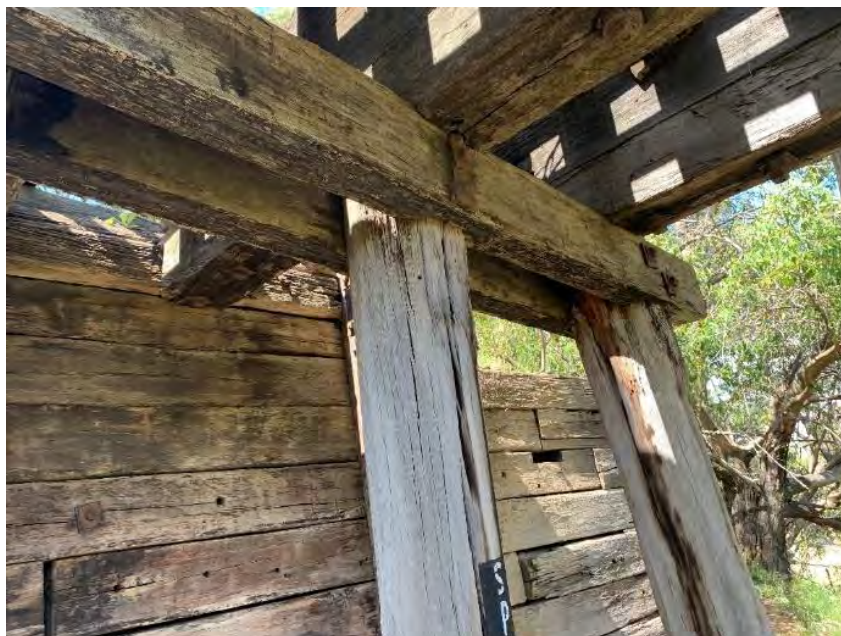
Figure 10-4: The images above show the condition of the split headstocks and the abutment breast wall. The headstocks were found to be in poor to very poor condition, exhibiting significant decay. The breast wall is in poor condition with missing members and weathered elements with splits and cracking throughout. Note: major vertical crack down middle pile exposing bright wood and accelerating decay. Typically, these decay cracks are initiated by fastener systems

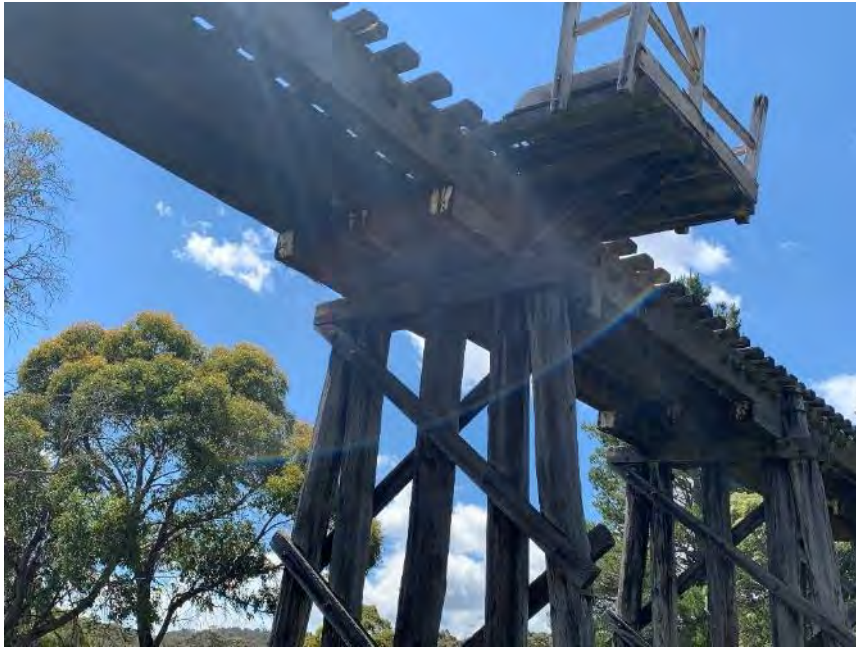
Figure 10-5: View of the walk out standing platform. Platform appears to be in poor to very poor condition with missing/failed members. This would not be safe to stand on. All timber appears to exhibit significant decay.

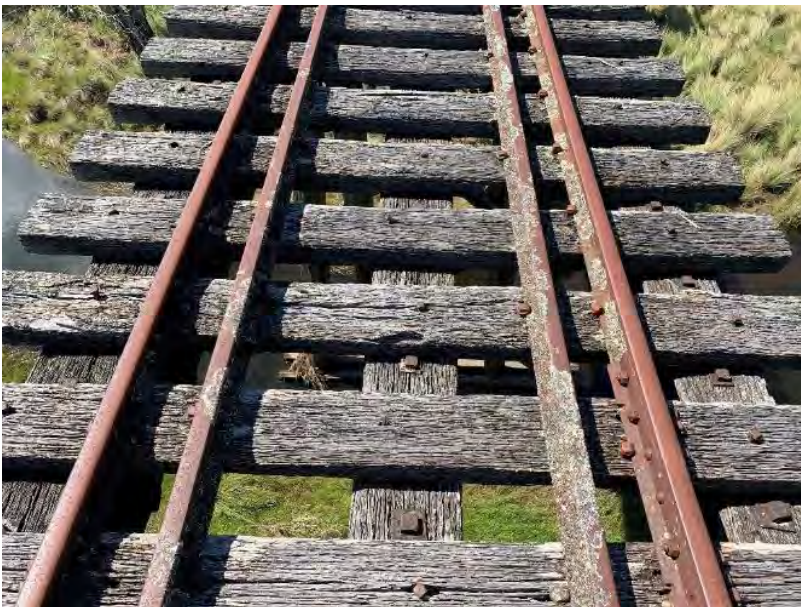
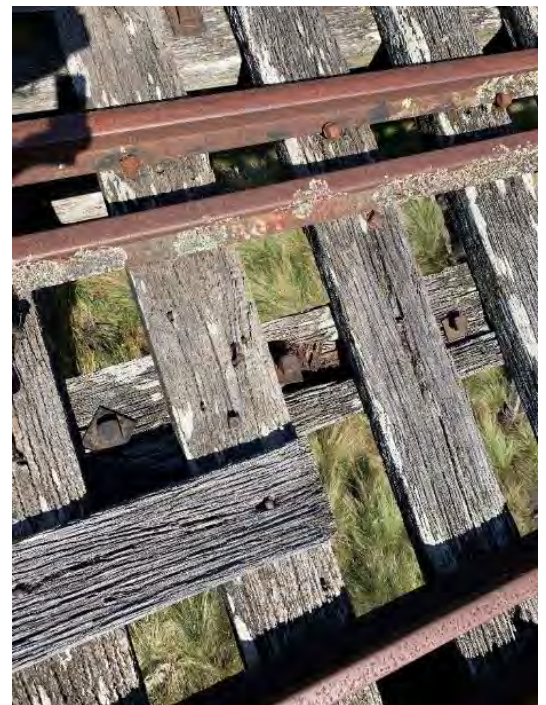
Figure 10-6: Top view of bridge open deck. Transoms and girders can be seen to be in poor to very poor condition, with significant deterioration present in all elements. This is seen to be caused by the vertical connections used in construction. If not sealed appropriately they are seen to funnel water and become moisture traps, when moisture content within timber exceeds 22%, decay causing fungi are activated and the decay process begins. Note: Large cavity around vertical connection in right side photo.

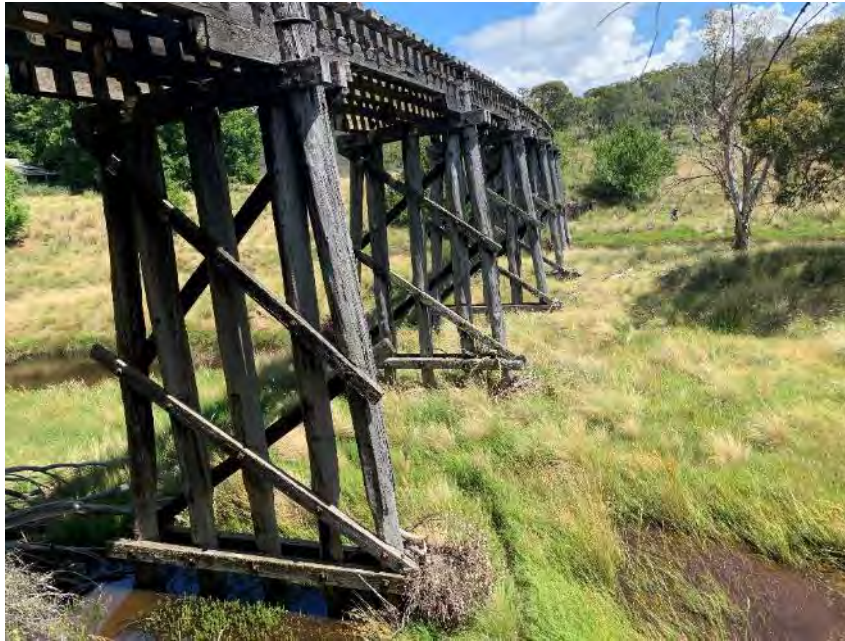
Figure 10-7: Above image shows the left curve and camber in the bridge. The bent configuration is also highlighted, it was noted that significant overgrown vegetation and debris build up was present at the base of all bents. This increases moisture retention leading to accelerated decay of the lower timber elements.

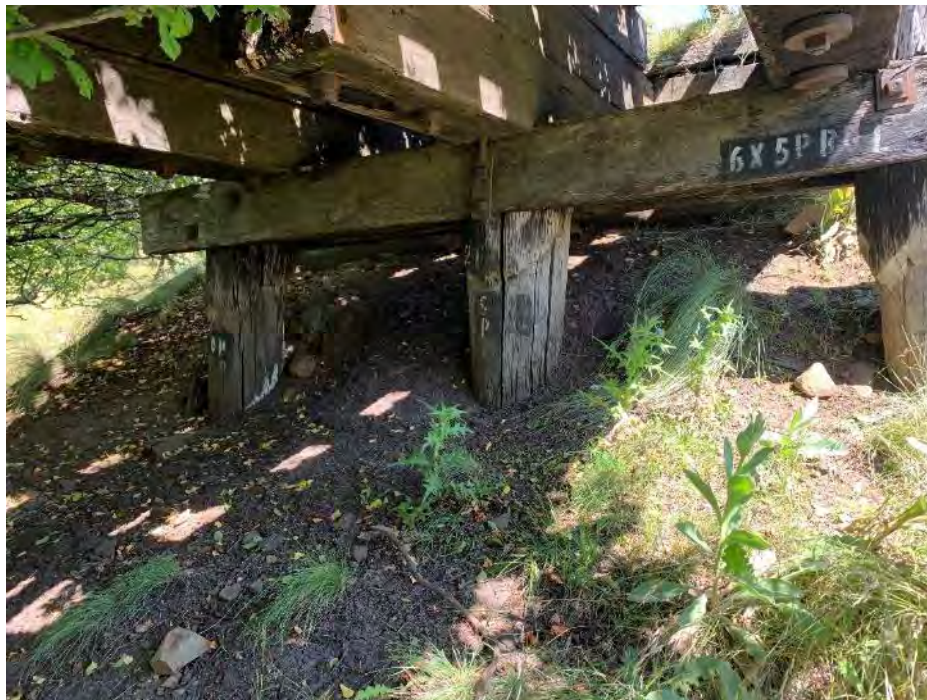
Figure 10-8: View of abutment 2 configuration, the abutment was found to be in poor condition with significant decay present. It was noted that the left two piles had large vertical splits in them, whilst the right pile had significant decay of sapwood.

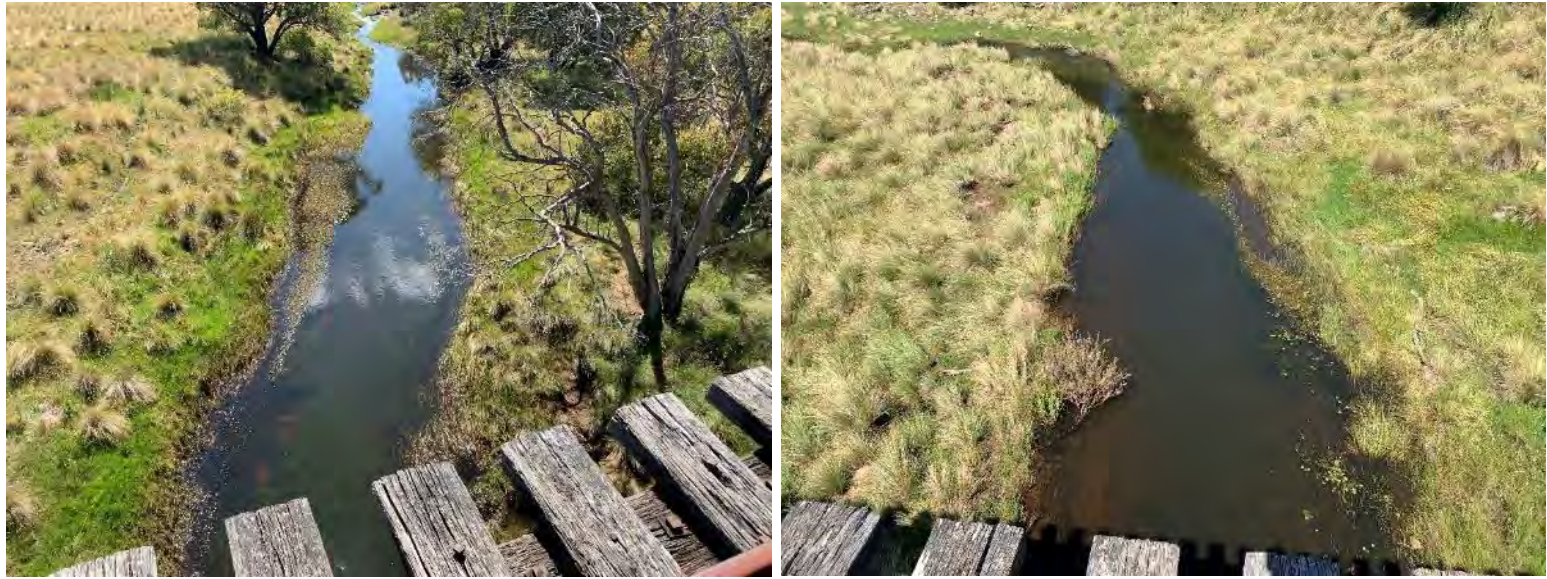
Figure 10-9: Left side image shows the view looking upstream and the right-side image shows the view downstream of the bridge of the edge of the open deck bridge.

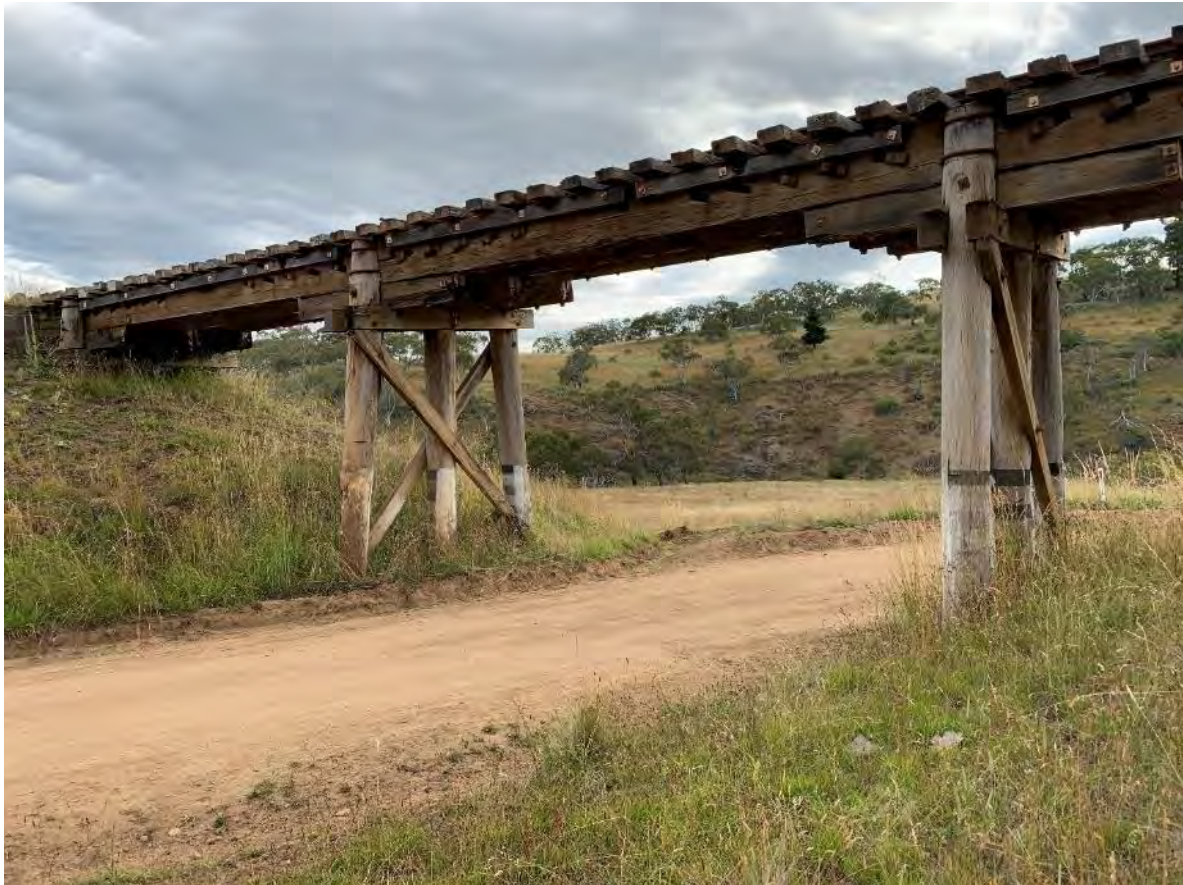
Figure 11-1: General view of Old Bombala Rd Bridge from abutment 1 looking towards abutment 2. The timber bridge is 3 spans long and approximately 22 metres in length (Sp1=7.8m, SP2=6.8m & SP3=6.6m). Note span 2 passes over the road (4.1m Clearance).

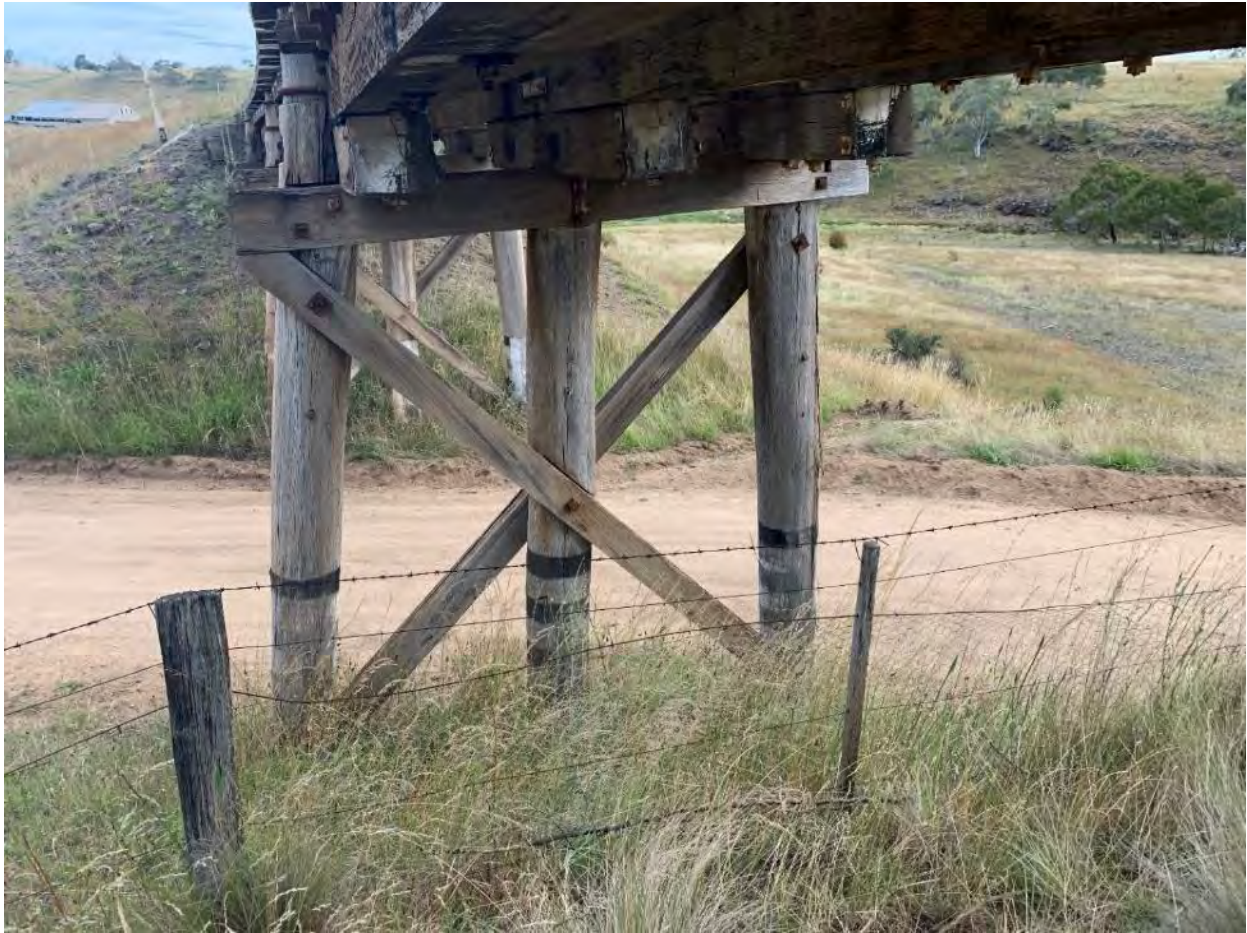
Figure 11-2: View of pile bent 1 configuration. The bents comprise of 3 driven piles. Pile bent 2 and 3 are supported by cross bracing. The two abutments do not contain the cross bracing but are supported by sheeting planks to retain backfill. It was noted that several piles and headstocks have started to undergo decay. It can be seen on pile 3 significant sapwood decay occurring.
