Monaro Rail Trail

Trail Development Plans – Stage 1a

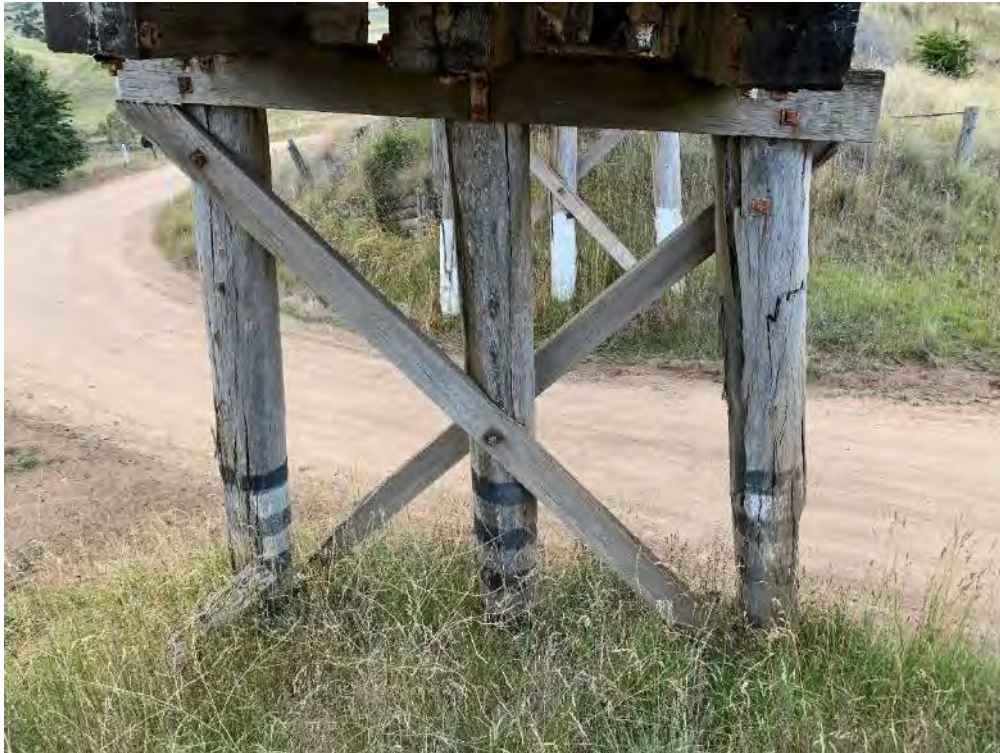
Figure 11-3: General view of pile bent 2. piles were found to be in poor condition. With significant sapwood decay present in all piles, it was noted that all piles have large vertical splits through the horizontal connections. The bottom sections of the timber piles were determined to be a ‘hotspot’ for decay due to increased moisture retained by the overgrown vegetation.

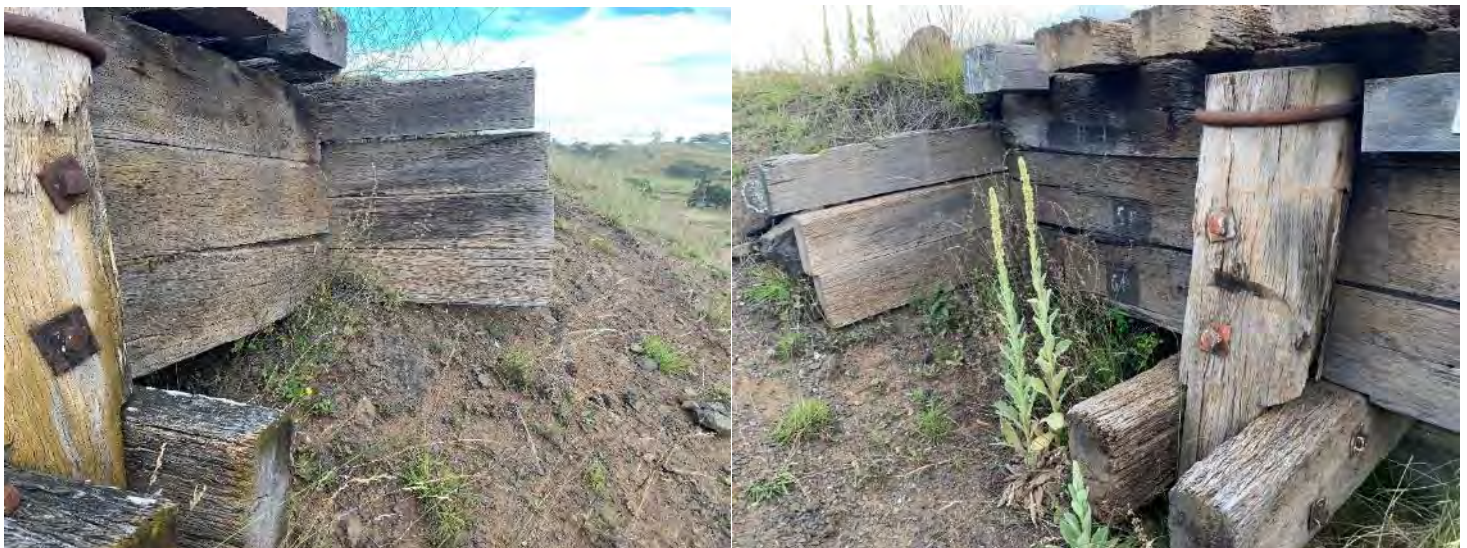
Figure 11-4: The images above show the condition of the breast wall at AB2. The abutment sheeting was found to be in fair condition with minor decay of the sapwood present. The headstock ends were in poor condition with decay and cracking present.

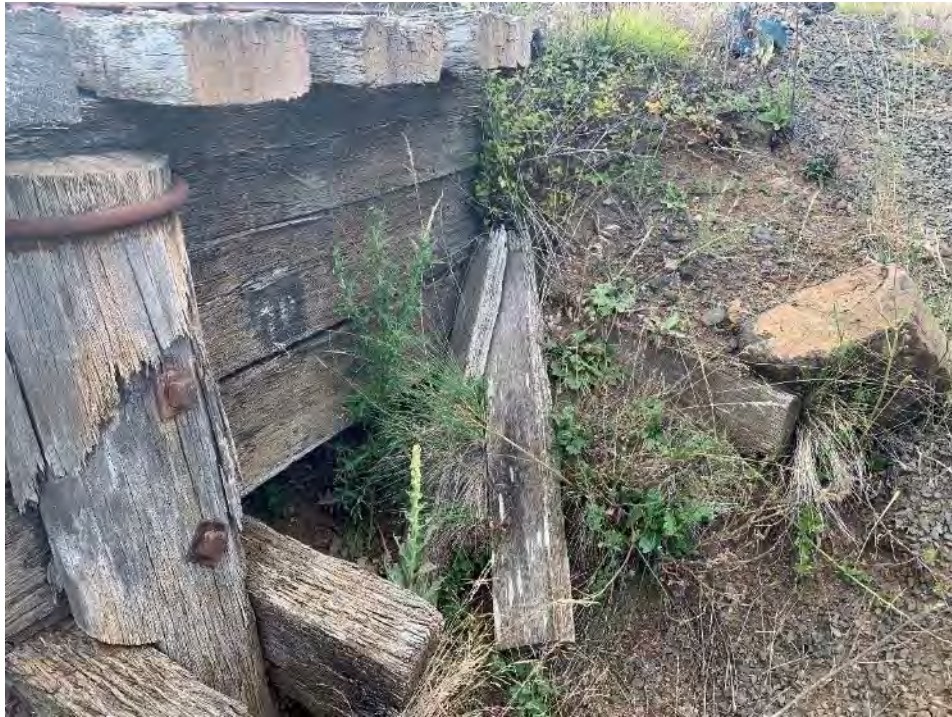
Figure 11-5: View of abutment 1, found to be in poor condition with major decay of sapwood present in piles and broken/missing elements in abutment sheeting.

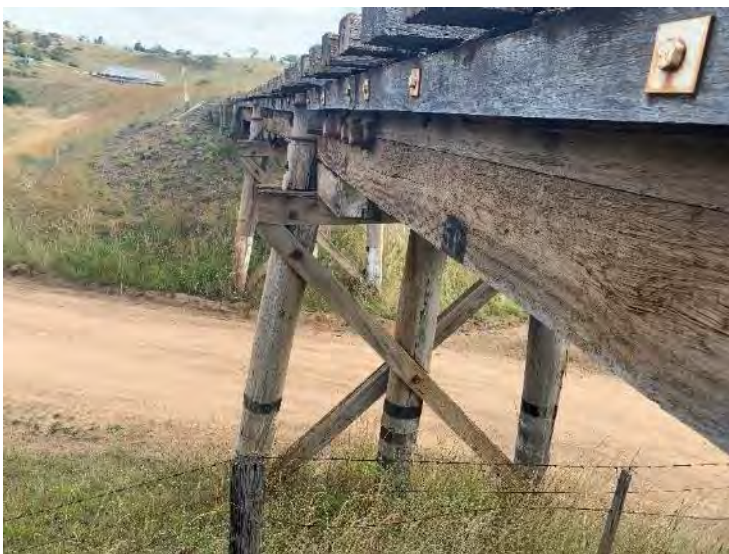
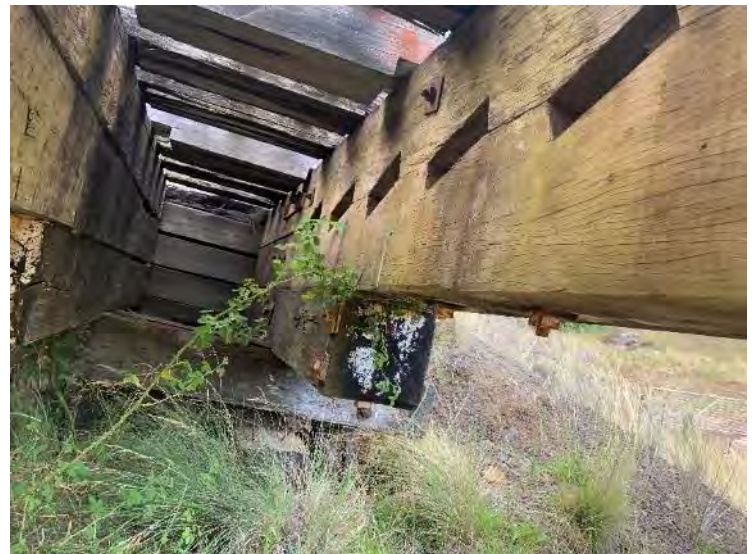
Figure 11-6: A view of girders formation and condition. Girders were found to be in fair to poor condition, the left photo shows a horizontal crack that is seen to be progressively increasing in size. The right photo shows sapwood decay of the internal girders.

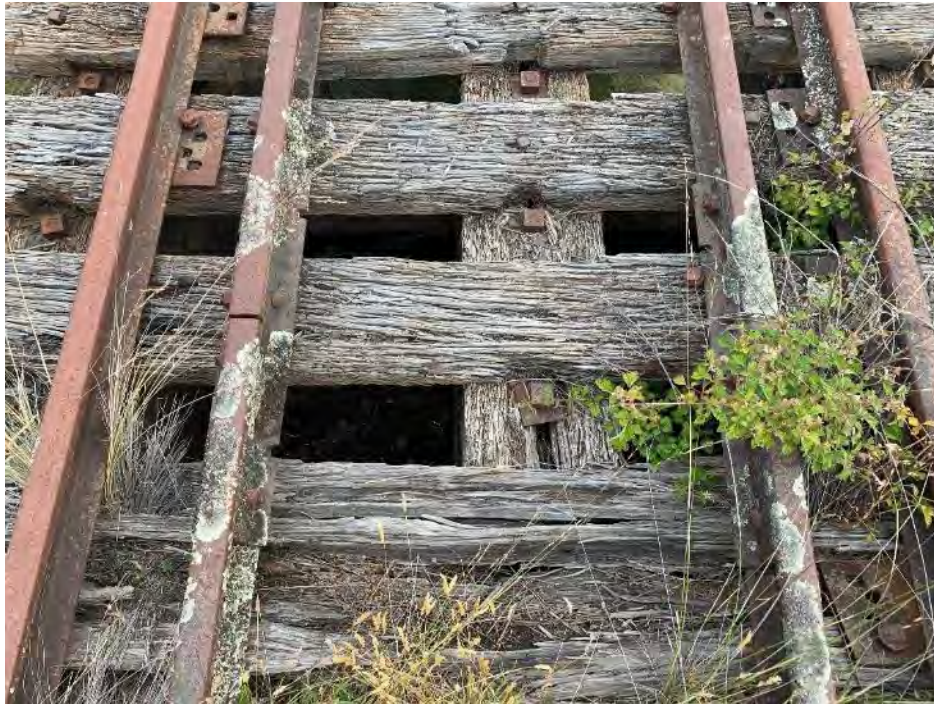
Figure 11-7: View of the bridge open deck, transom sleepers were found to be in poor to very poor condition with significant decay, cavities and severely damaged members present throughout. It was noted that the vertical connections to the top girders were seen to funnel moisture and increase the moisture content present in both elements causes significant decay. When the moisture content exceeds 22%, timber consuming fungi are activated, and the decay process begins. Top girders were found to be in poor to very poor condition.

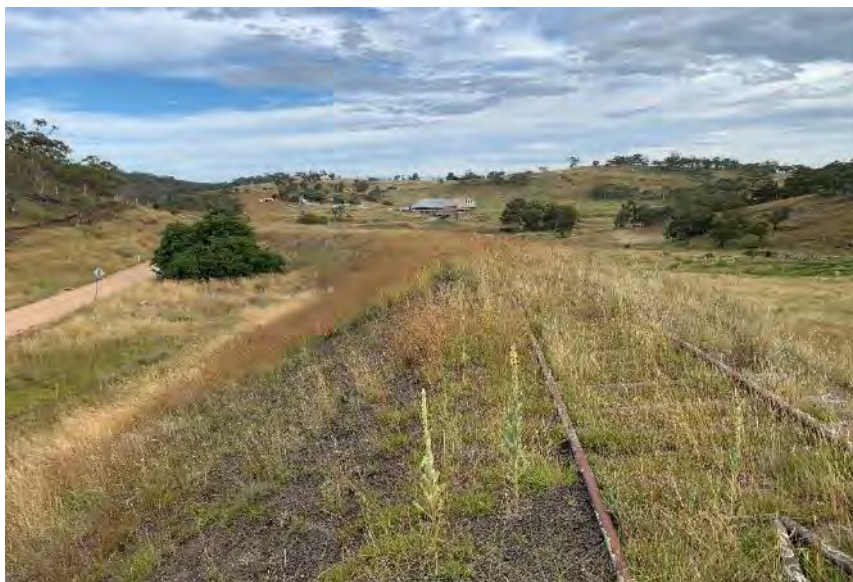
Figure 11-8: View of overgrown approach.

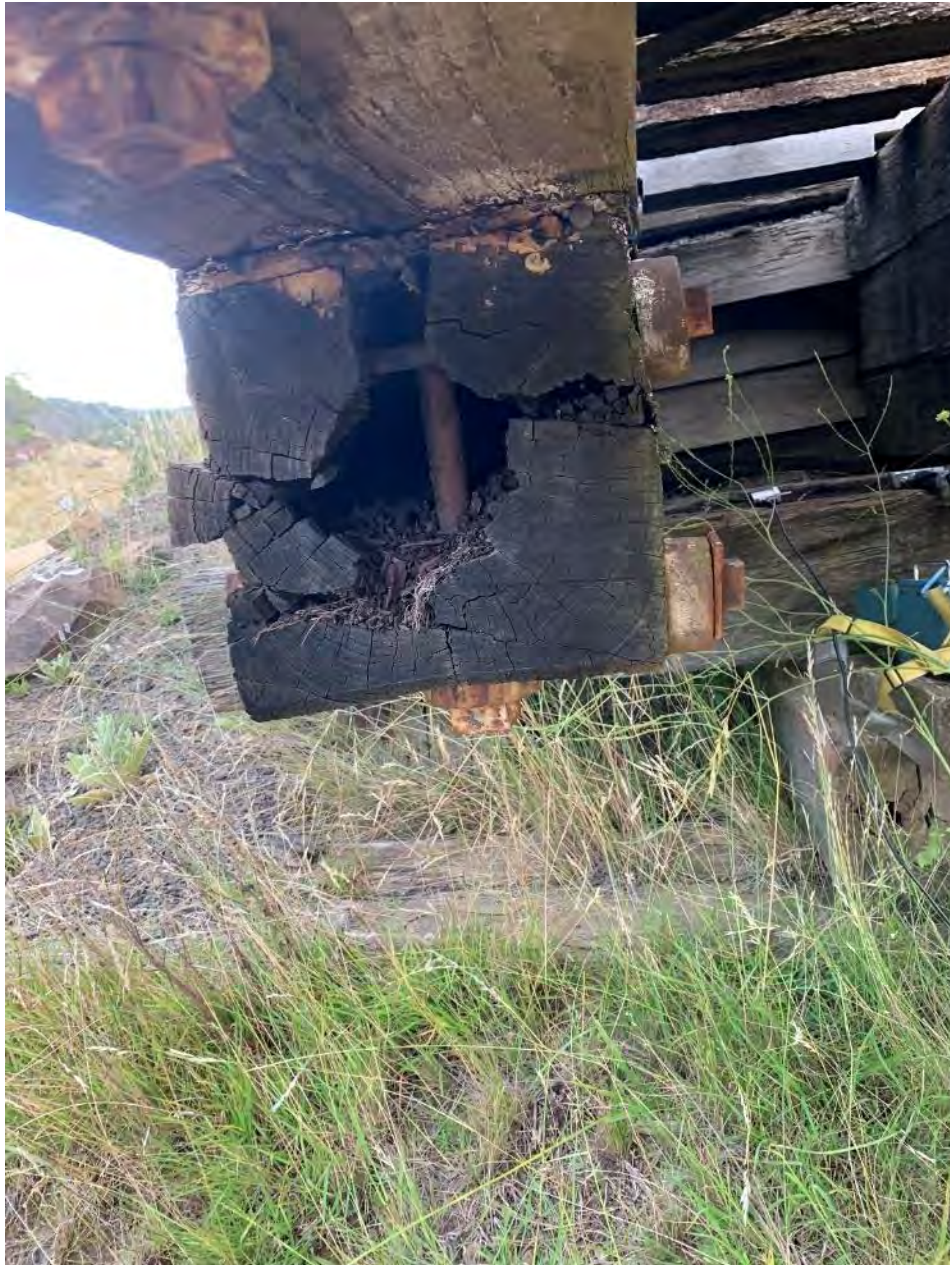
Figure 11-9: View of corbel 3 at abutment 1, Corbel was found to be in very poor condition with a large cavity present in the end. The vertical connection is visible highlighting the depth. The corbel needs replacement due to multiple failure points. Note the vertical fastener has split the corbel and the anti-splitter bolts have done the same thing. So many of these old details contributed to higher maintenance costs and reduced longevity.

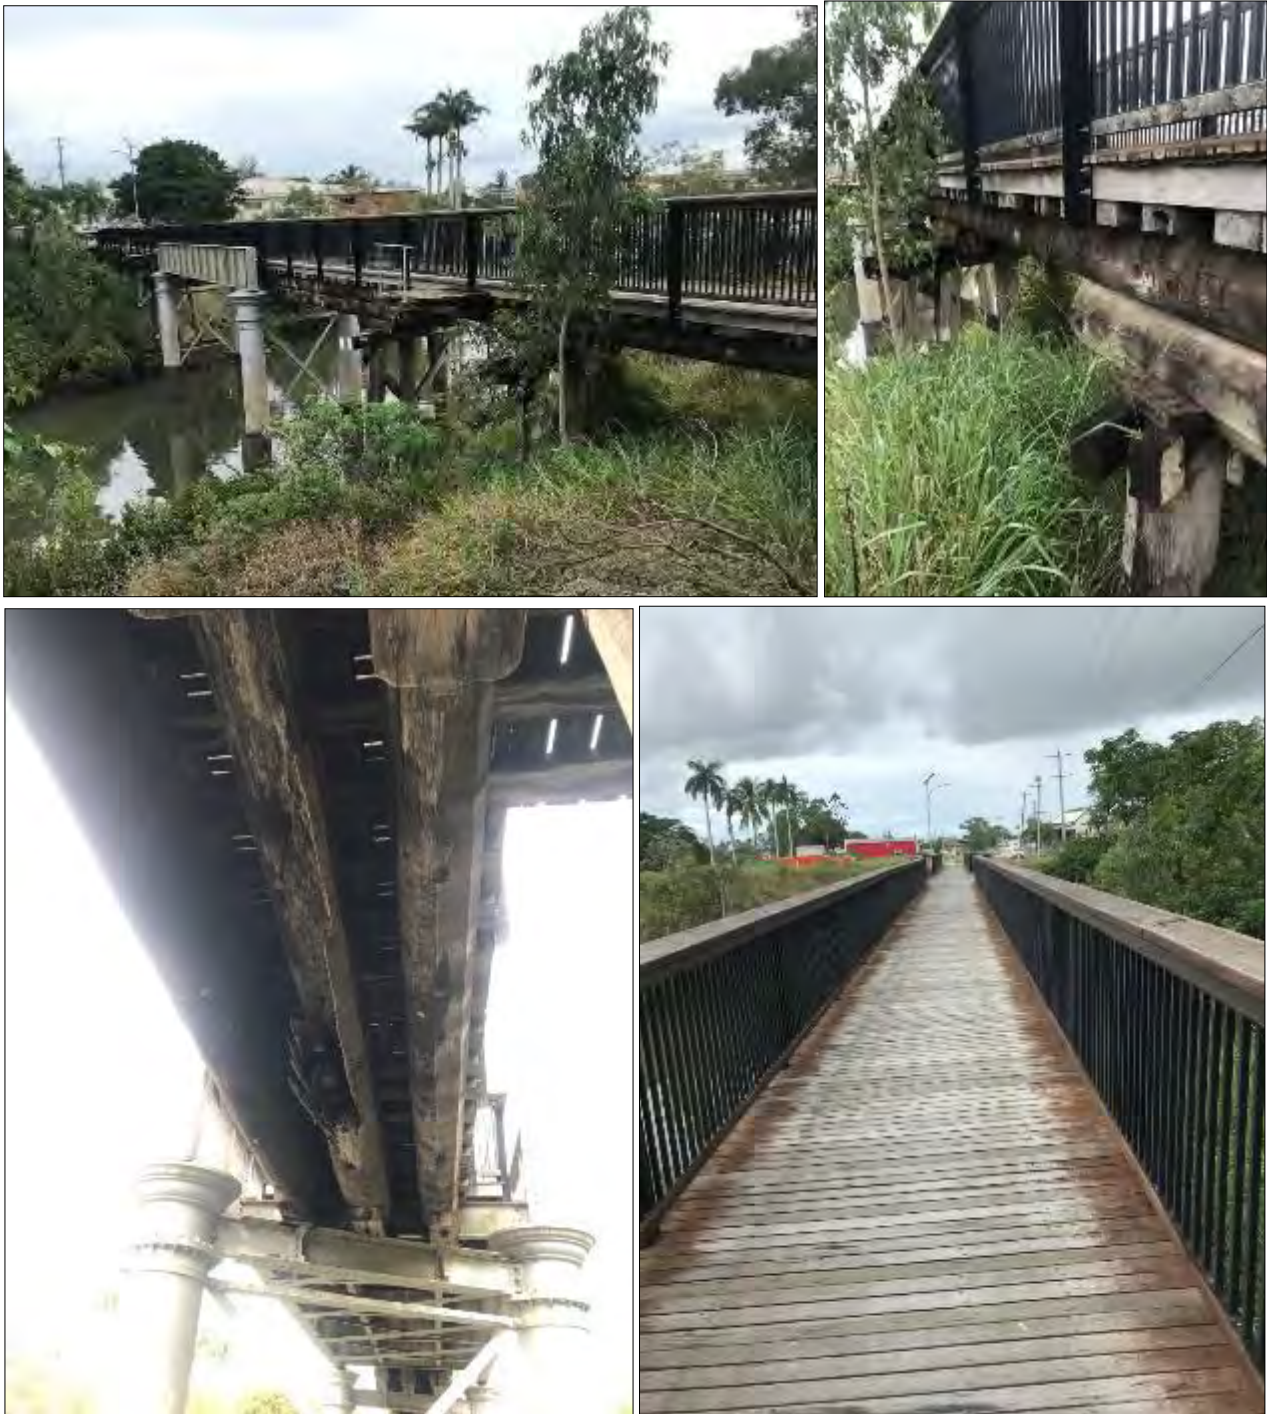
Figure 12-2: The above photo series demonstrates a similar repair to Option 1 type of refurbishment (build off existing railway bridge) used for the construction of a pedestrian bridge in Bundaberg CDB. The existing railway bridge was left un-touched and a new hardwood deck system with handrails was installed. Six 100mm x 250mm timber joists were placed on top of the existing transoms (rail ties) with a 38-50mm thick hardwood deck installed on top. This option will likely be the lowest cost but also carries the shortest expected lifespan. As seen in the bottom left photo above, one of the girders has failed and fallen out creating a ‘weak’ point along the bridge. Due to a high residual capacity of timber and the continuous joists, a complete failure of the bridge (span) hasn’t occurred yet but is only a matter of time unless extensive maintenance is undertaken.

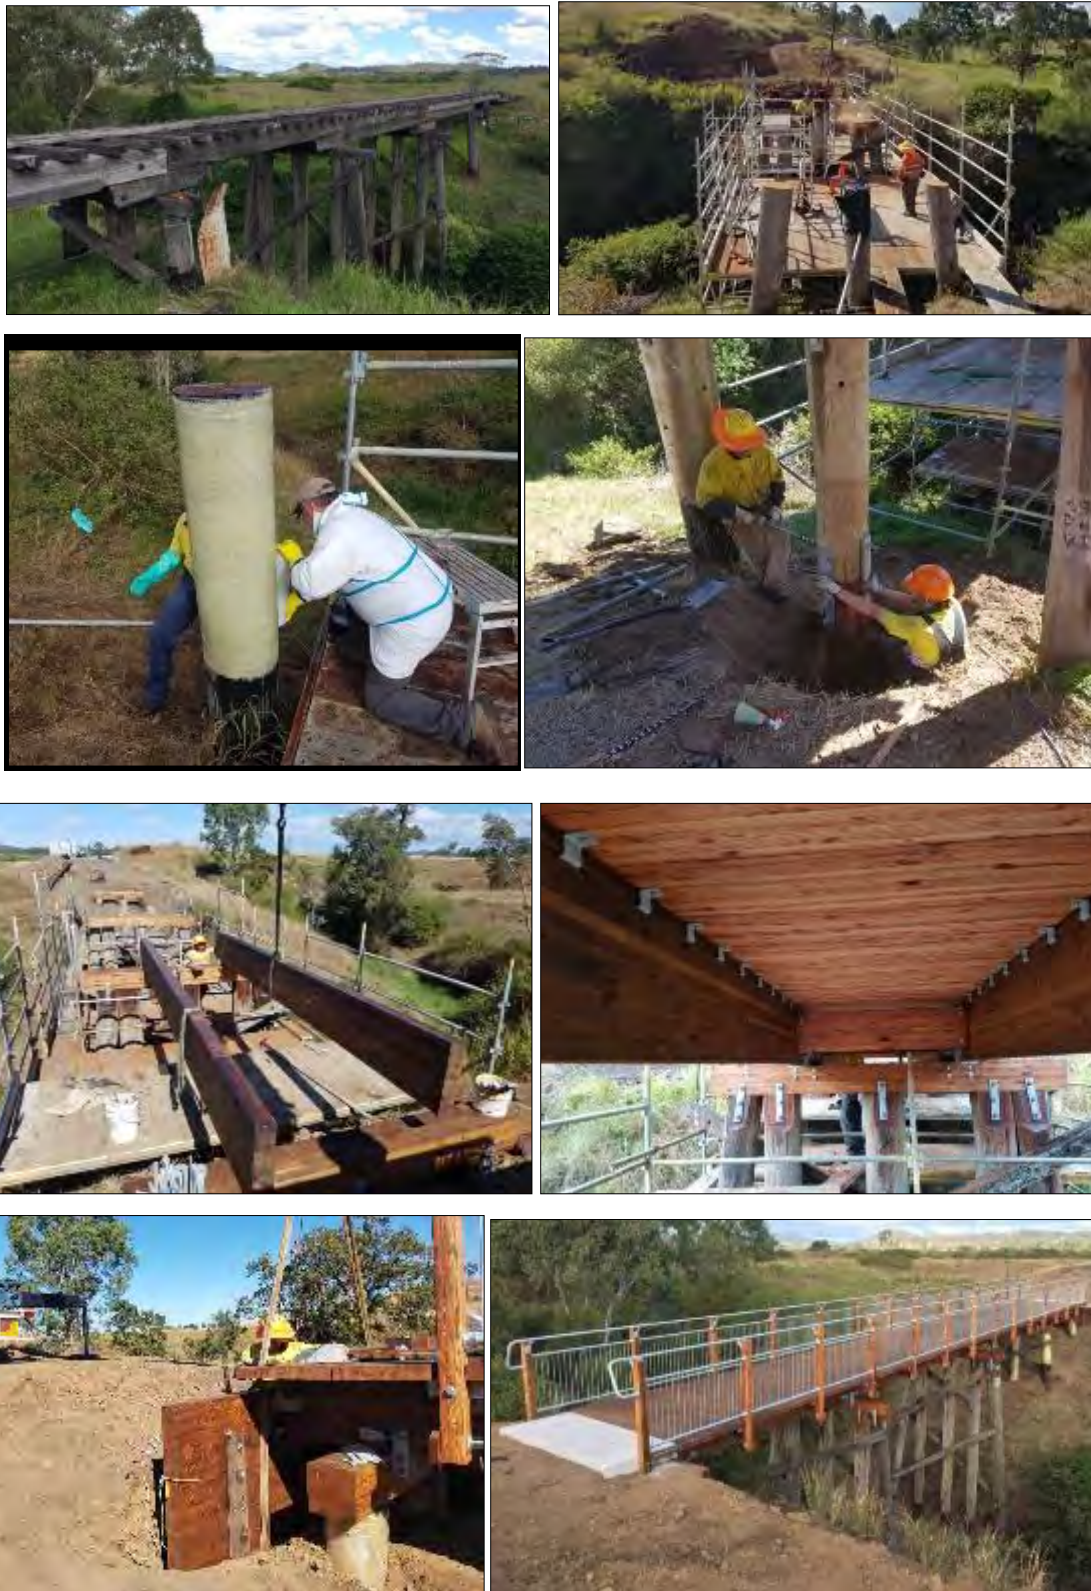
Figure 12-4: The photo series above demonstrates Option 3 type of fix that was completed on Jimmy Gully Bridge along the BVRT. The existing poor condition superstructure was removed, and the piles were repaired with high strength fibre or posted with new section. New glulam back wall, caps, girders and deck system were installed utilising a horizontal connection detail.

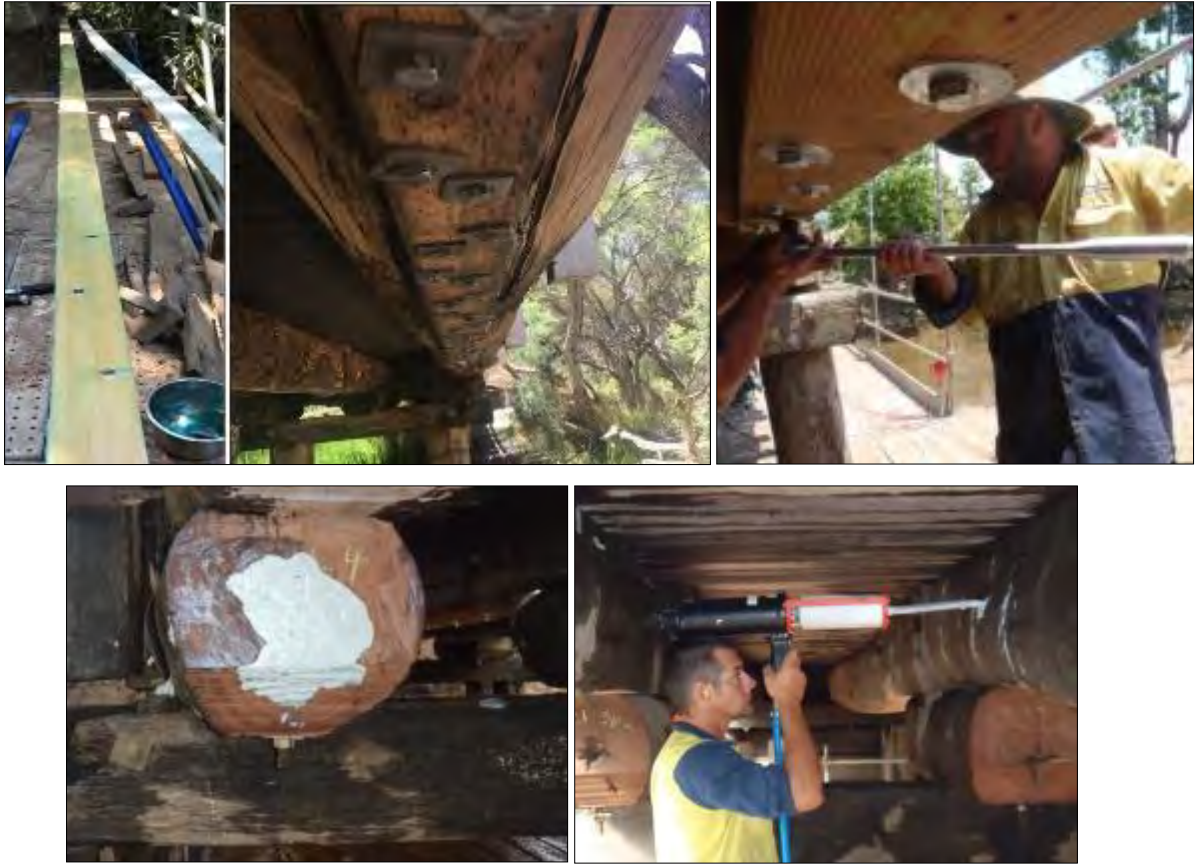
Figure 12-5: The repair of Meachams Bridge in Cassowary Coast. The bridge was retrofitted with fibre reinforcement on the bottom of the girders, some corbels and girders were injected with a high strength epoxy. Some piles were also wrapped with high strength fibre and injected with epoxy, then the entire bridge was diffused with borate salt rods to neutralize decay growth.

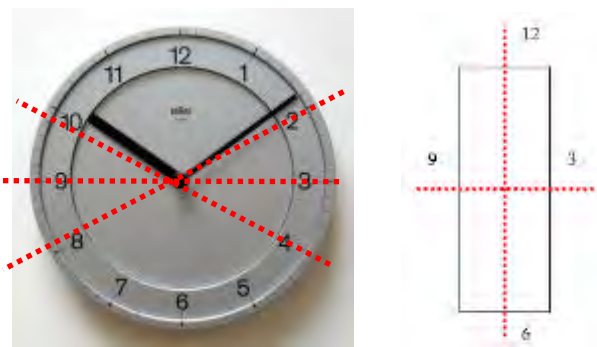
Figure 12-6: SWT configurations for round and rectangular timber

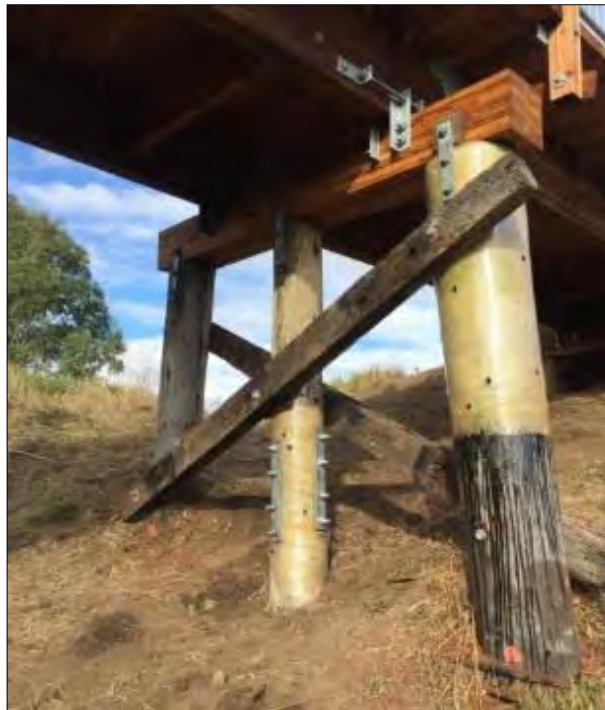
Figure 12-8: Diffuser (Borate Salt) rods are installed in the remaining hardwood elements to resist further deterioration of the timber caused by fungi growth. Note the red bungs are the decay ‘hotspots’ where the timber is prone to have a higher moisture content. These holes are required to be checked for rod depletion as per the issued maintenance manual (typically every 2-5 years depending on environmental conditions).

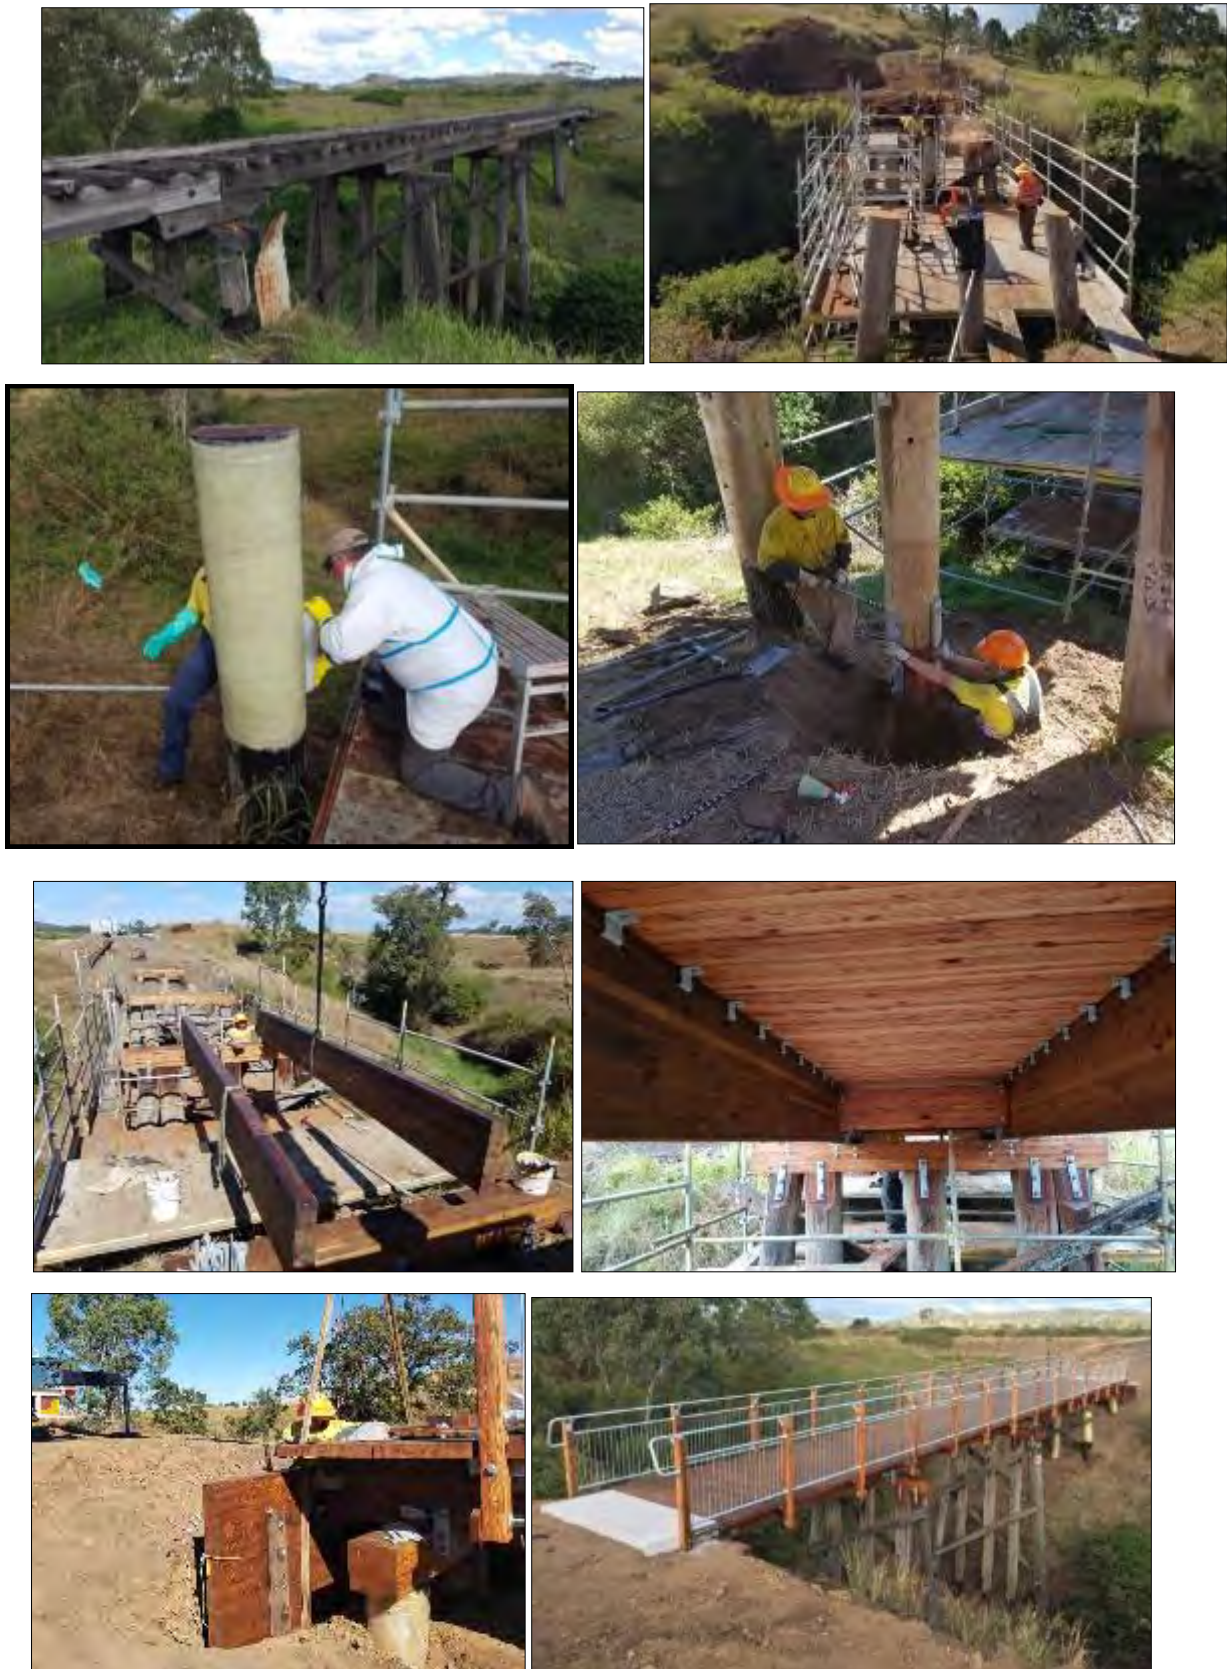
Figure 12-9: The photo series above demonstrates an Option 2 type of fix that was done for Jimmy Gully Bridge along the BVRT. The existing poor condition superstructure was removed, and the piles were repaired or posted with new section. New glulam back wall, caps, girders, and deck system were installed utilising a horizontal connection detail.

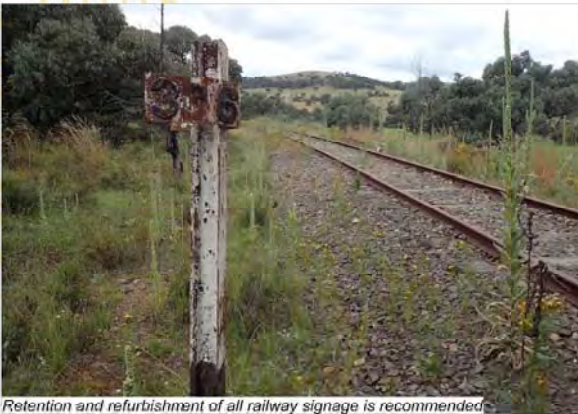
Retention and refurbishment of all railway signage is recommended

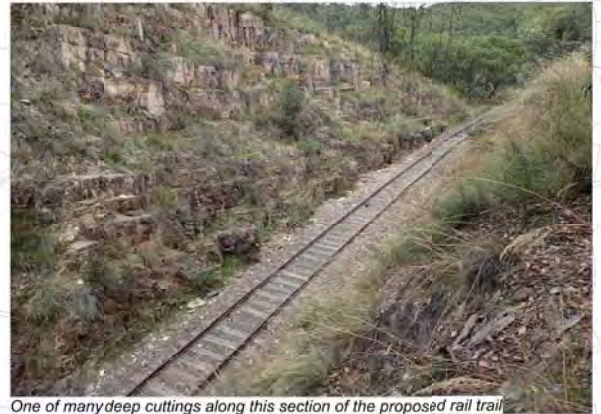
One of many deep cuttings along this section of the proposed rail trail

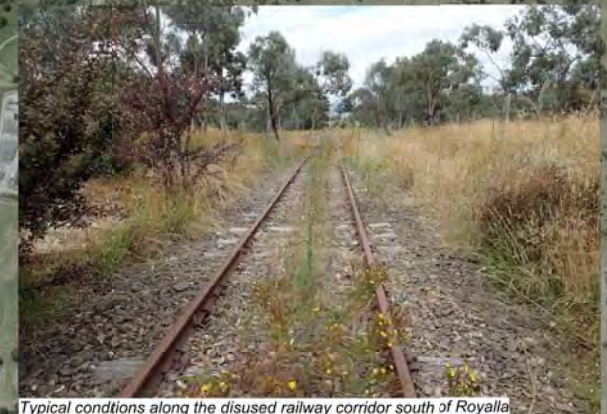
Typical conditions along the disused railway corridor south of Royalla

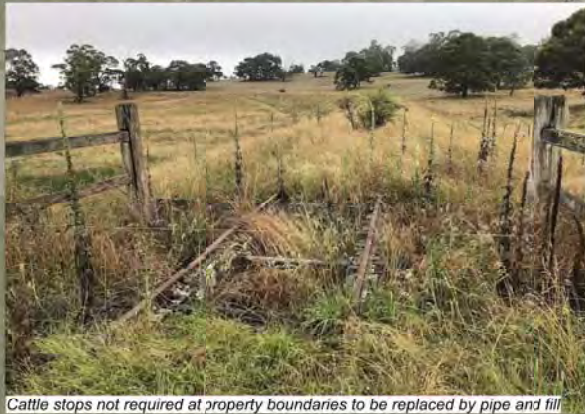
Cattle stops not required at property boundaries to be replaced by pipe and fill

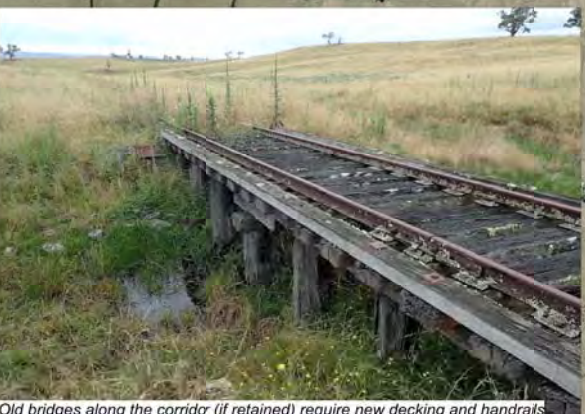
Old bridges along the corridor (if retained) require new decking and handrails

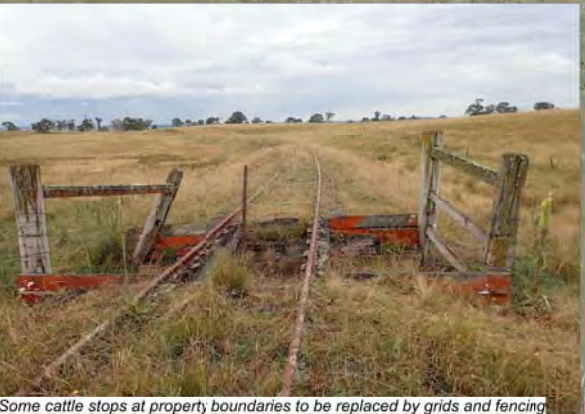
Some cattle stops at property boundaries to be replaced by grids and fencing

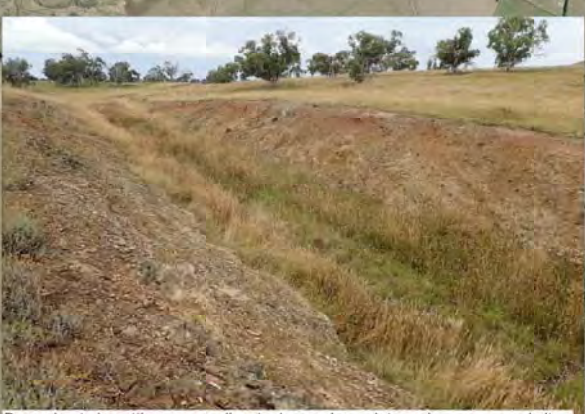
Box culverts in cuttings can be livestock crossing points and emergency shelters

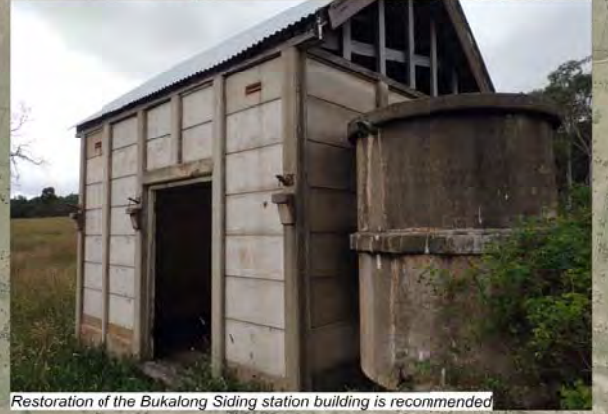
Restoration of the Bukalong Siding station building is recommended

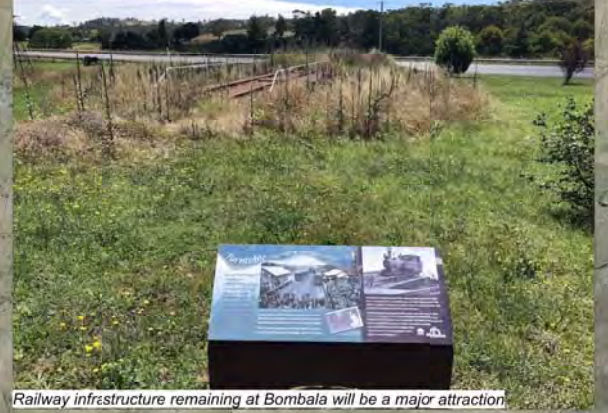
Railway infrastructure remaining at Bombala will be a major attraction
